**RE: Closure Request  
Corral Canyon Federal Central Tank Battery  
Remediation Permit Number 2RP-4643  
Eddy County, New Mexico**

LT Environmental, Inc. (LTE), on behalf of XTO Energy, Inc. (XTO), presents the following Closure Request report detailing site assessment, soil sampling, and excavation activities at the Corral Canyon Federal Central Tank Battery (Site) in Unit P, Section 5, Township 25 South, Range 29 East, in Eddy County, New Mexico (Figure 1). The purpose of the site assessment, soil sampling, and excavation activities was to address impacts to soil after a release of crude oil and produced water at the Site.

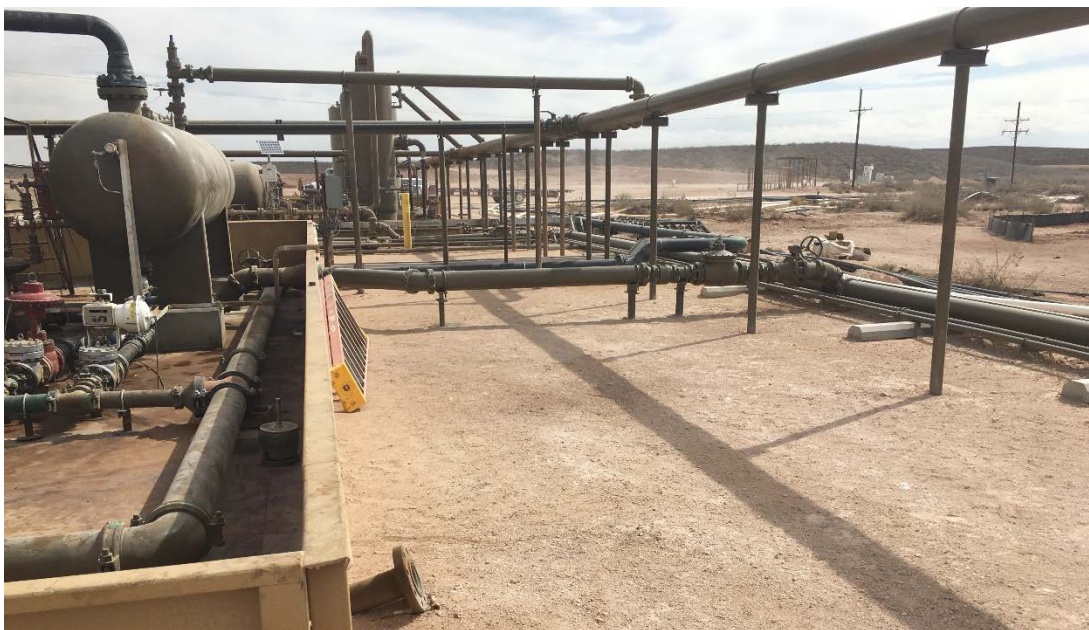
**Photograph 1:** View of process equipment area.

During April 2018, LTE personnel inspected the Site to evaluate the release extent. Surficial staining was visible in the process equipment area. Based on visible staining and field screening activities, excavation and site assessment activities were scheduled.

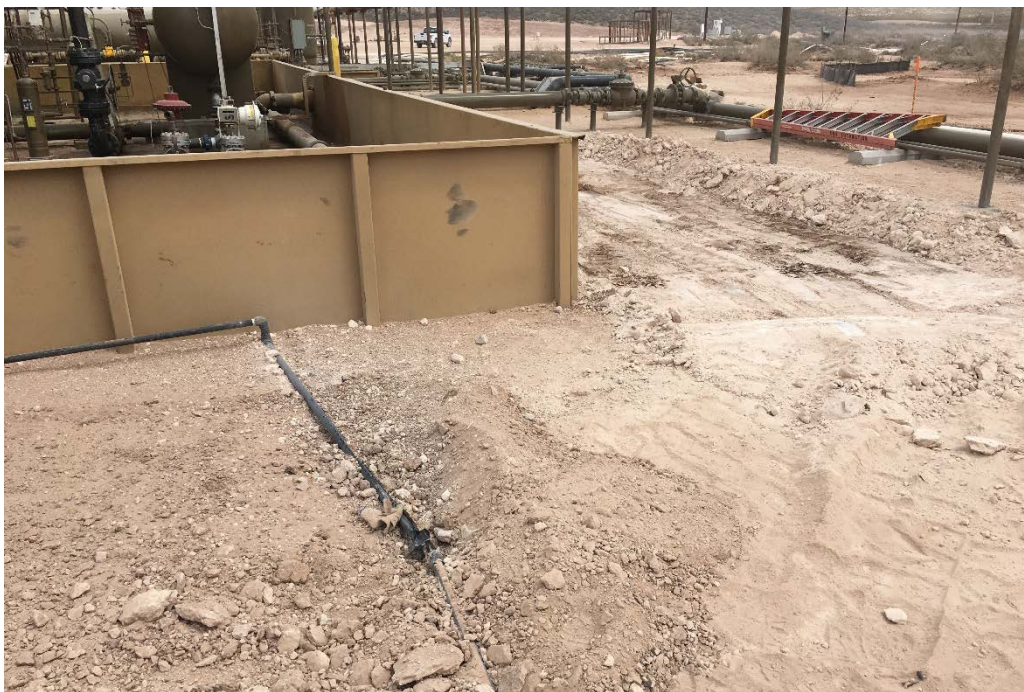
**Photograph 2:** View of excavation area.

The combined excavations measured approximately 1,640 square feet in area and were completed to depths ranging from 1 foot bgs to 2 feet bgs. A total of approximately 60 cubic yards of impacted soil were removed from the excavations. The impacted soil was transported and properly disposed of at the R360 Landfill located in Hobbs, New Mexico.

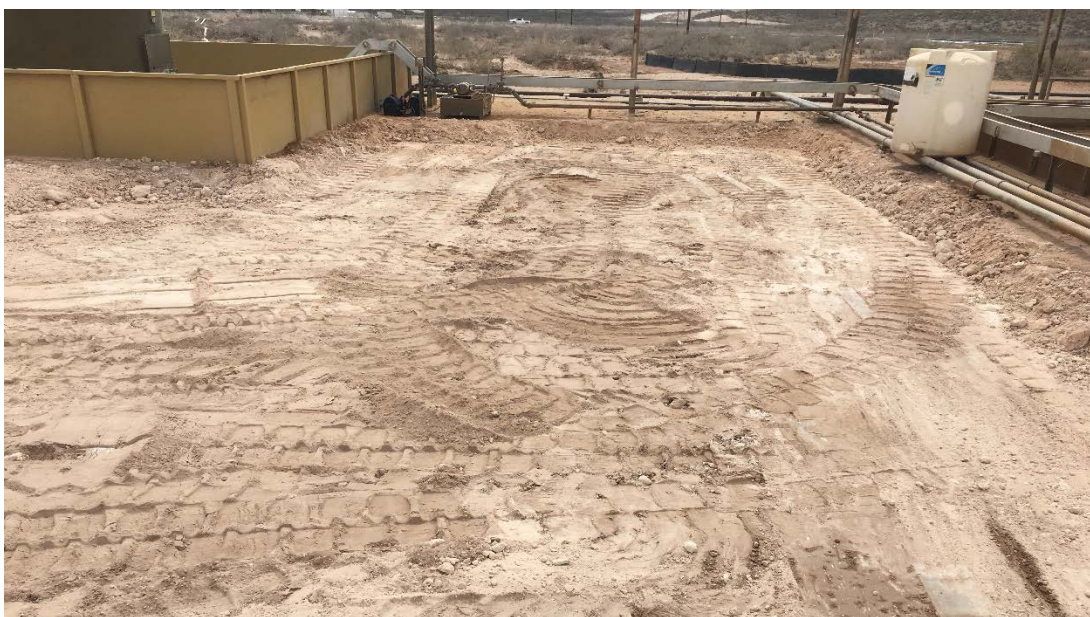
**Photograph 3:** View of excavation area.

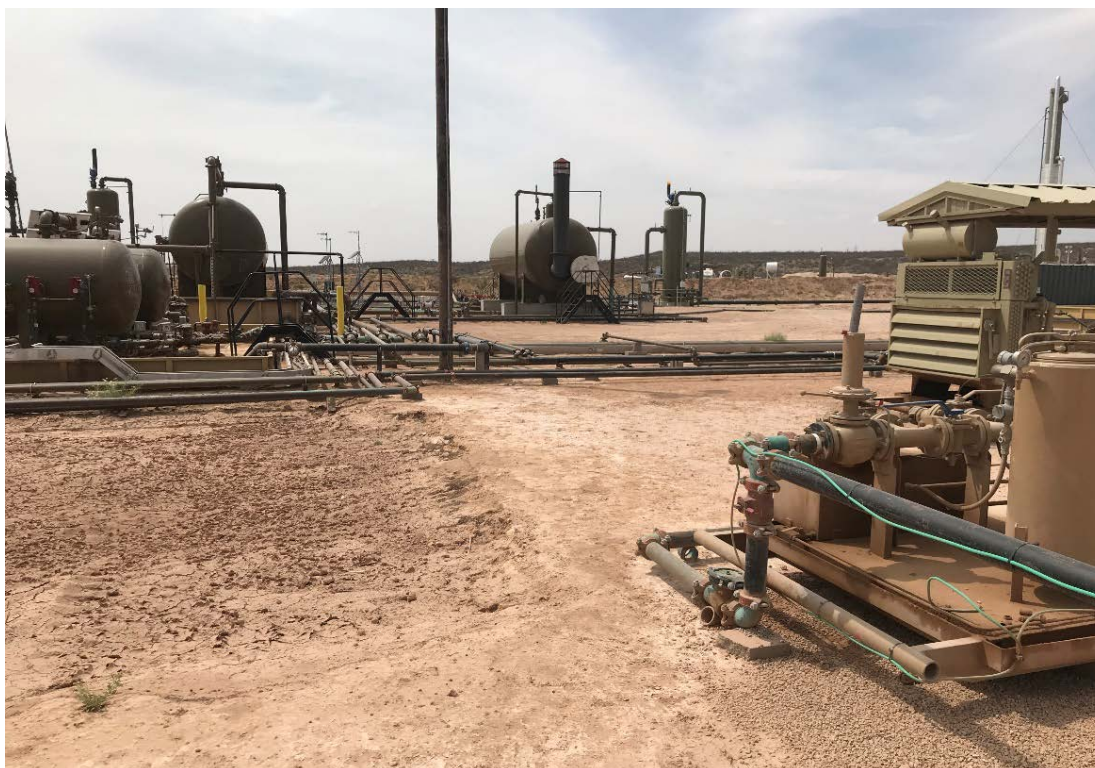
**Photograph 4:** View of excavation area.

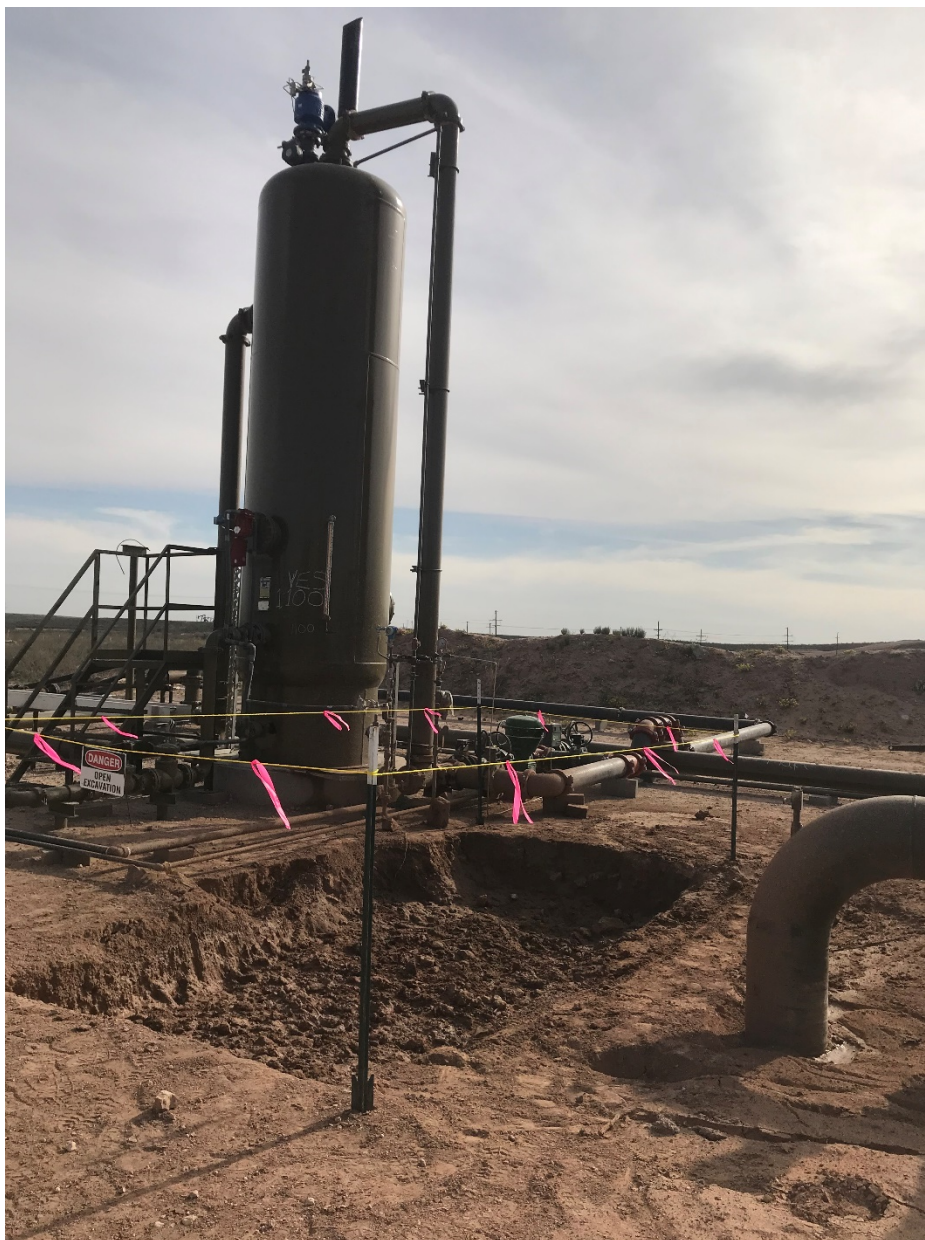
**Photograph 5:** View of excavation area.

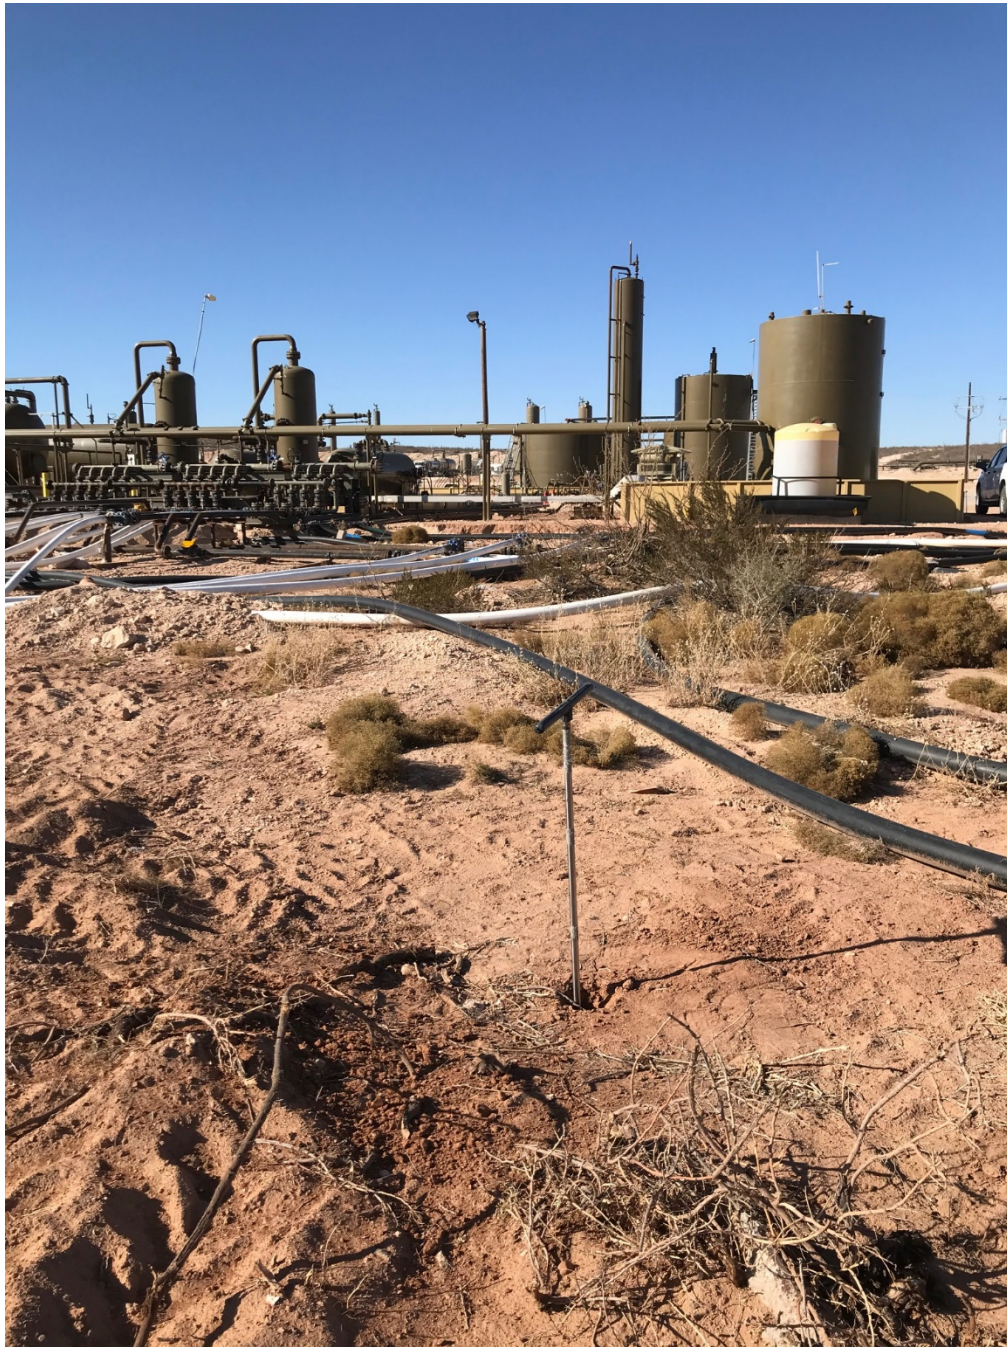
**Photograph 5:** North facing view of overspray area south of the pad, during assessment activities.

Potholes and boreholes were advanced via shovel or hand-auger at 9 locations on the well pad and pasture area south of the pad to assess for the presence or absence of additional impacted soil. Potholes PH01 through PH05 and boreholes BH01 through BH04 were advanced to depths ranging from 1 foot to 2 feet bgs. Two delineation soil samples were collected from each pothole and borehole from depths ranging from 0.5 feet to 2 feet bgs. Soil from the potholes and boreholes was field screened for volatile aromatic hydrocarbons and chloride utilizing a PID and Hach® chloride QuanTab® test strips, respectively. Field screening results and observations for
