## **Soil Assessment and Remediation Work Plan**

NB Tween State #1 \* 30-015-35915 \* 2RP-4115

Talon Project No. 700745.076.01

Subject:       **Soil Assessment and Remediation Work Plan**  
                  Apache Corporation  
                  NB Tween State #1 Battery  
                  API # 30-015-35915 2RP-4115

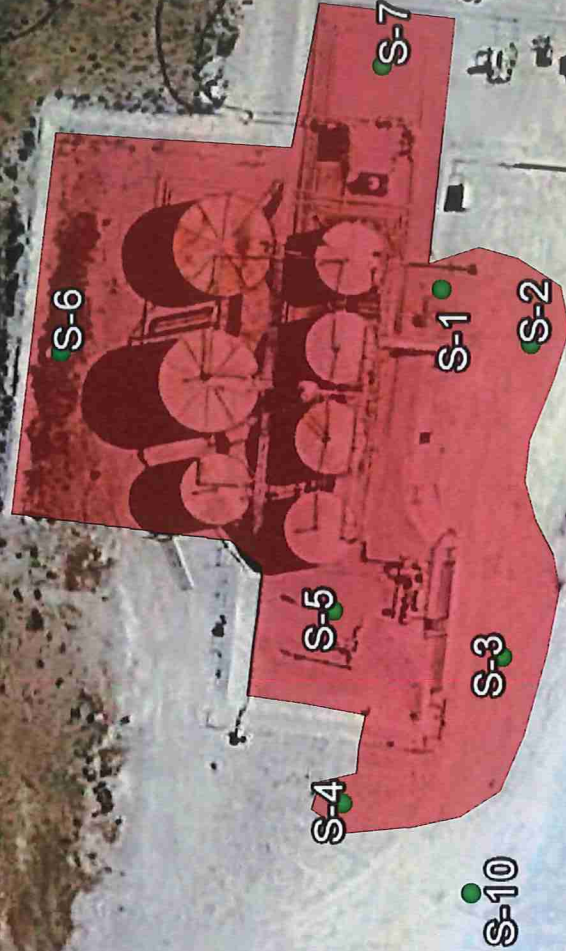
### **SITE MAP**

The gasket on the oil storage tank failed resulting in 40 barrels of oil to release in the unlined containment. The wells were shut in. A vac truck was immediately called to the location and recovered 35 barrels of oil. A site plan is presented in [Appendix I](#) which illustrates the impacted area.

- The impacted area in the vicinity of sample location S-1 and S-2 will be excavated to a depth of 1-foot deep on location. The impacted area at S-3 will be excavated to a depth of 0.5-feet deep.
- The impacted area at sample location S-5 is within Holly Frontier's pipeline right-of-way. S-5 will be hand excavated to a depth of 0.5-feet deep to the best extent reasonable, feasible and as safely as possible around the steel flow lines and with regard to the structural integrity of the equipment within the battery.
- The impacted area at sample location S-6 will be excavated to a depth of 2-feet deep with a confirmation sample obtained from the bottom of the excavation.

- The hydrocarbon impacted area in the battery at sample location S-7 and between the tanks will be excavated to the liner, which is approximately 0.5-feet deep, to the best extent reasonable, feasible and as safely as possible around the steel flow lines and with regard to the structural integrity of the equipment within the battery.
- All contaminated soil will be transported to a NMOCD approved disposal facility.
- Confirmation samples will be obtained and sent to the laboratory for analysis. Upon NMOCD approval of the confirmation samples in the battery, a bioremediation agent will then be applied to the area.
- The excavated area will be backfilled with new caliche. Once the backfill activities are complete the work area will be compacted.
- A final closure report documenting all remedial actions will be provided to the NMOCD Artesia Office along with a Final C-141 Form.
