**From:** Bratcher, Mike, EMNRD  
**Sent:** Monday, April 30, 2018 7:57 AM  
**To:** Raley, Jim; Tucker, Shelly  
**Cc:** Blaney, Karolina  
**Subject:** RE: Ross Draw Unit 14 - Final C-141

RE: RKI/WPX \* Ross Draw Ut 14 \* **2RP-2812** \* DOR: 2/11/15

RE: Ross Draw Unit 14 \*\* DOR 02.11.2015

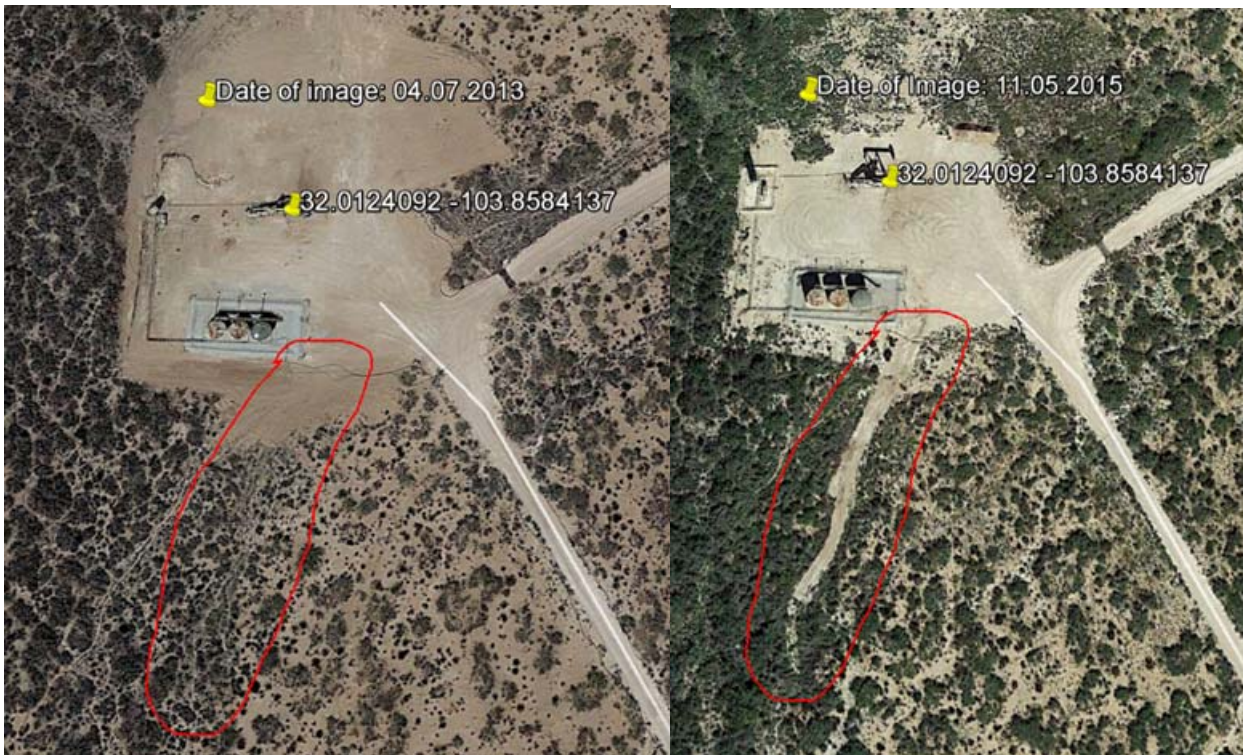
Lastly, looking at Google Earth shows surface disturbance, indicative of a release off site. According to BLM records, no authorization for off-site surface disturbance was authorized, nor were any releases reported to the BLM. Staining from the wellhead to off location is visible... Do you have knowledge of what has occurred?
