**Re: Closure Request Letter
Airbus Federal #001 (2RP-3828)
Unit Letter L, Section 12, Township 19S, Range 31E
Eddy County, NM**

COG Operating LLC is pleased to submit for your consideration the following Closure Request for the Airbus Federal #1 Tank Battery. This Closure Request Letter is in response to a crude oil release that occurred on August 9, 2016. Subsequent to the release a C-141 Initial report was submitted to the New Mexico Oil Conservation Division (NMOCD) and Bureau of Land Management (BLM) on August 12, 2016 (2RP-3828).

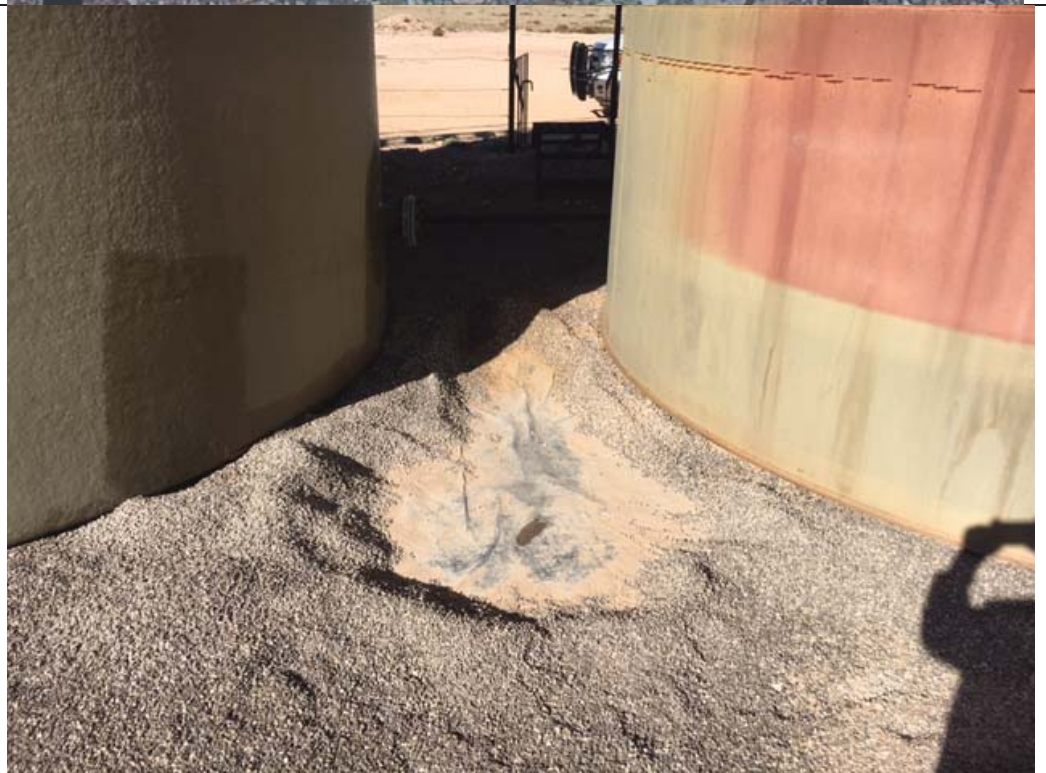
Photograph No. 2

Description:
View of Liner

The majority of the release remained within a lined facility; however a light spray impacted the pasture. A portion of the facility was a total loss. Concho sampled the adjacent pasture area impacted by a light overspray. Analytical results demonstrated chloride, TPH, benzene, and BTEX concentrations were below NMOCD standards. A final inspection has been conducted regarding the clean-up efforts. Free fluids were removed and if present the impacted gravel was removed from the liner and taken to a NMOCD approved disposal facility. The liner was inspected for damage and found to have liner integrity to contain free fluids.

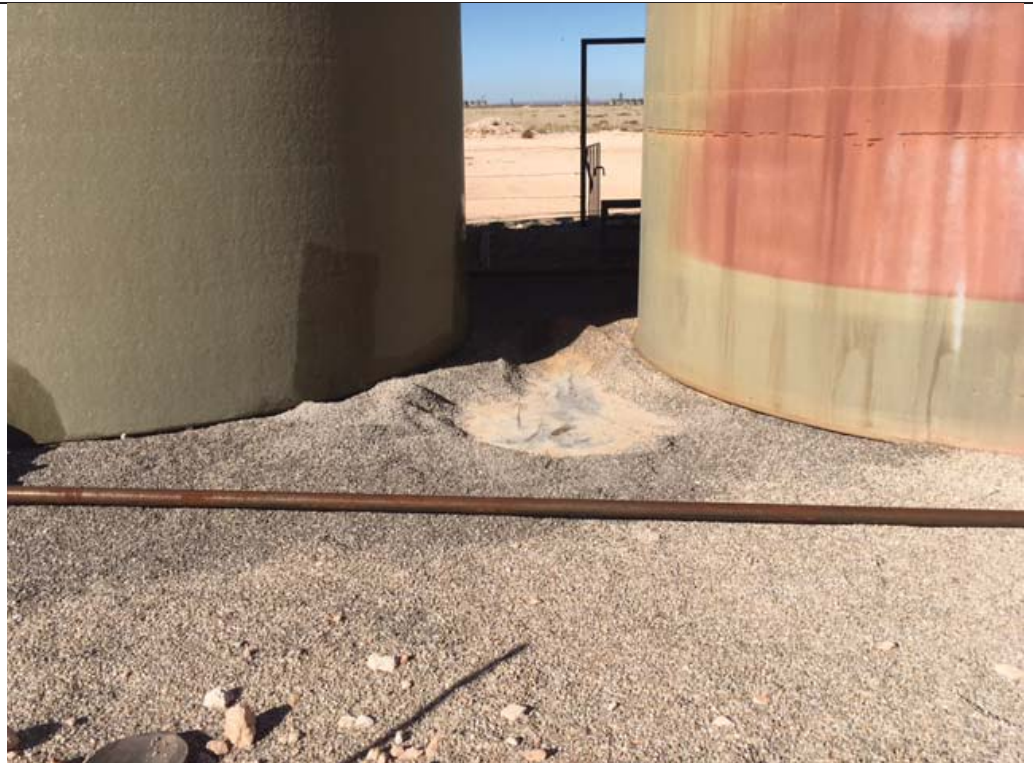
Photograph No. 3

Description:
View of the
Release Site
following the
removal of facility
equipment and
secondary
containment.
