**RE: Closure Request  
James Ranch Unit DI #2  
Remediation Permit Numbers 2RP-5194 and 2RP-5203  
Eddy County, New Mexico**

LT Environmental, Inc. (LTE), on behalf of XTO Energy, Inc. (XTO), presents the following report detailing site assessment, soil sampling, and excavation activities at the James Ranch Unit Drilling Island (DI) #2 (Site) in Unit K, Section 25, Township 22 South, Range 30 East, in Eddy County, New Mexico (Figure 1). The purpose of the site assessment, soil sampling, and excavation activities was to confirm the presence or absence of soil impacts following two separate releases of produced water and/or a mixture of fluids at the Site that occurred during frac operations. Based on the excavation activities and results of the soil sampling events, XTO is submitting this Closure Report and requesting no further action for Remediation Permit (RP) Numbers 2RP-5194 and 2RP-5203.

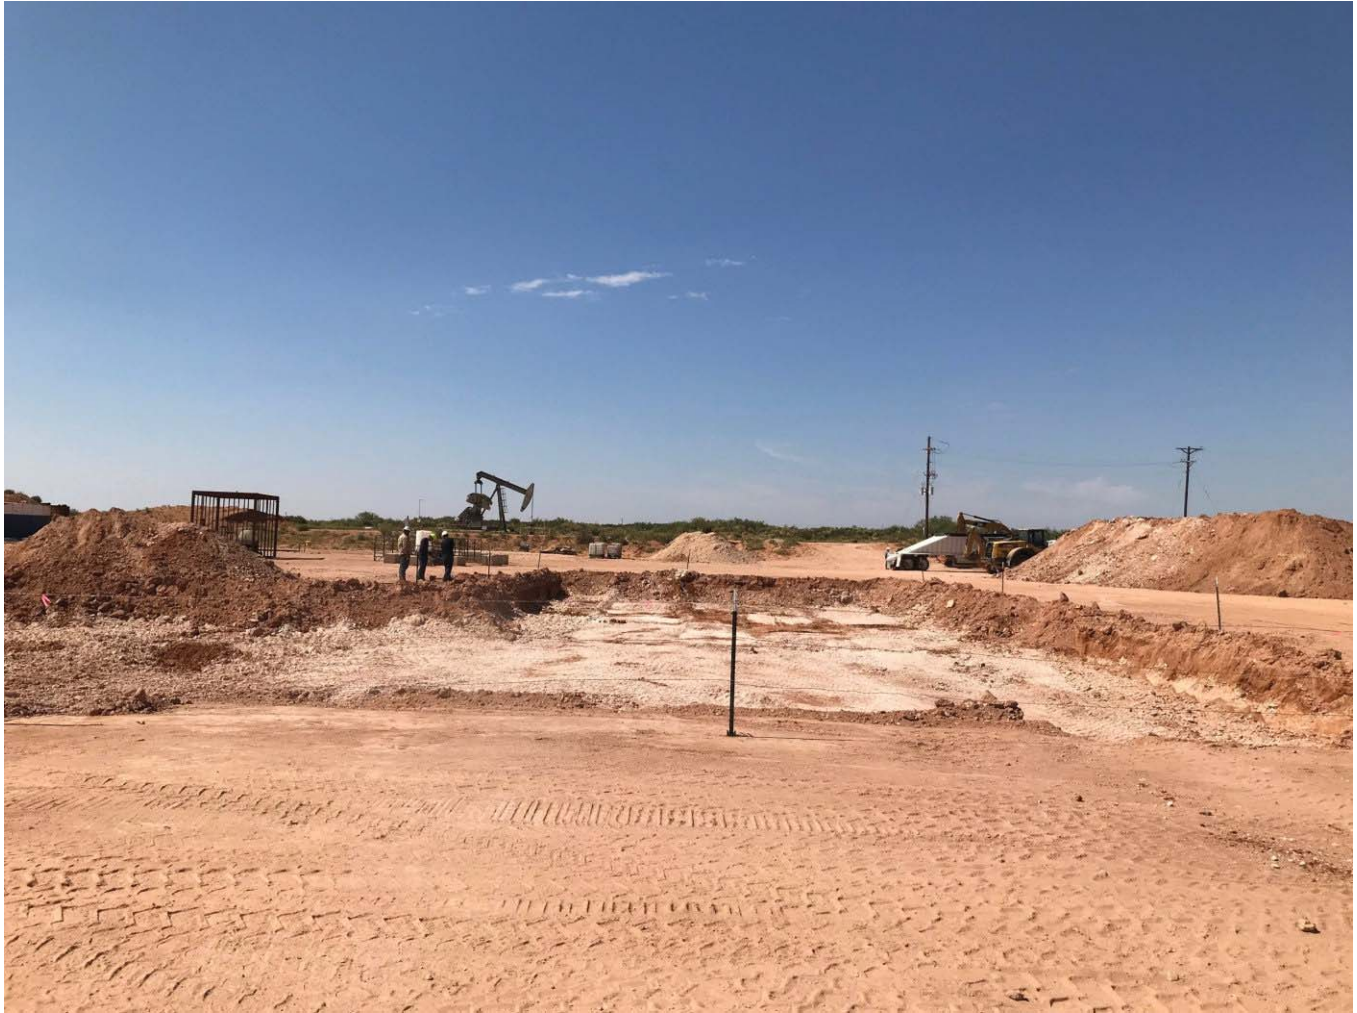
**Northern view of final excavation extent during confirmation soil sampling activities.**

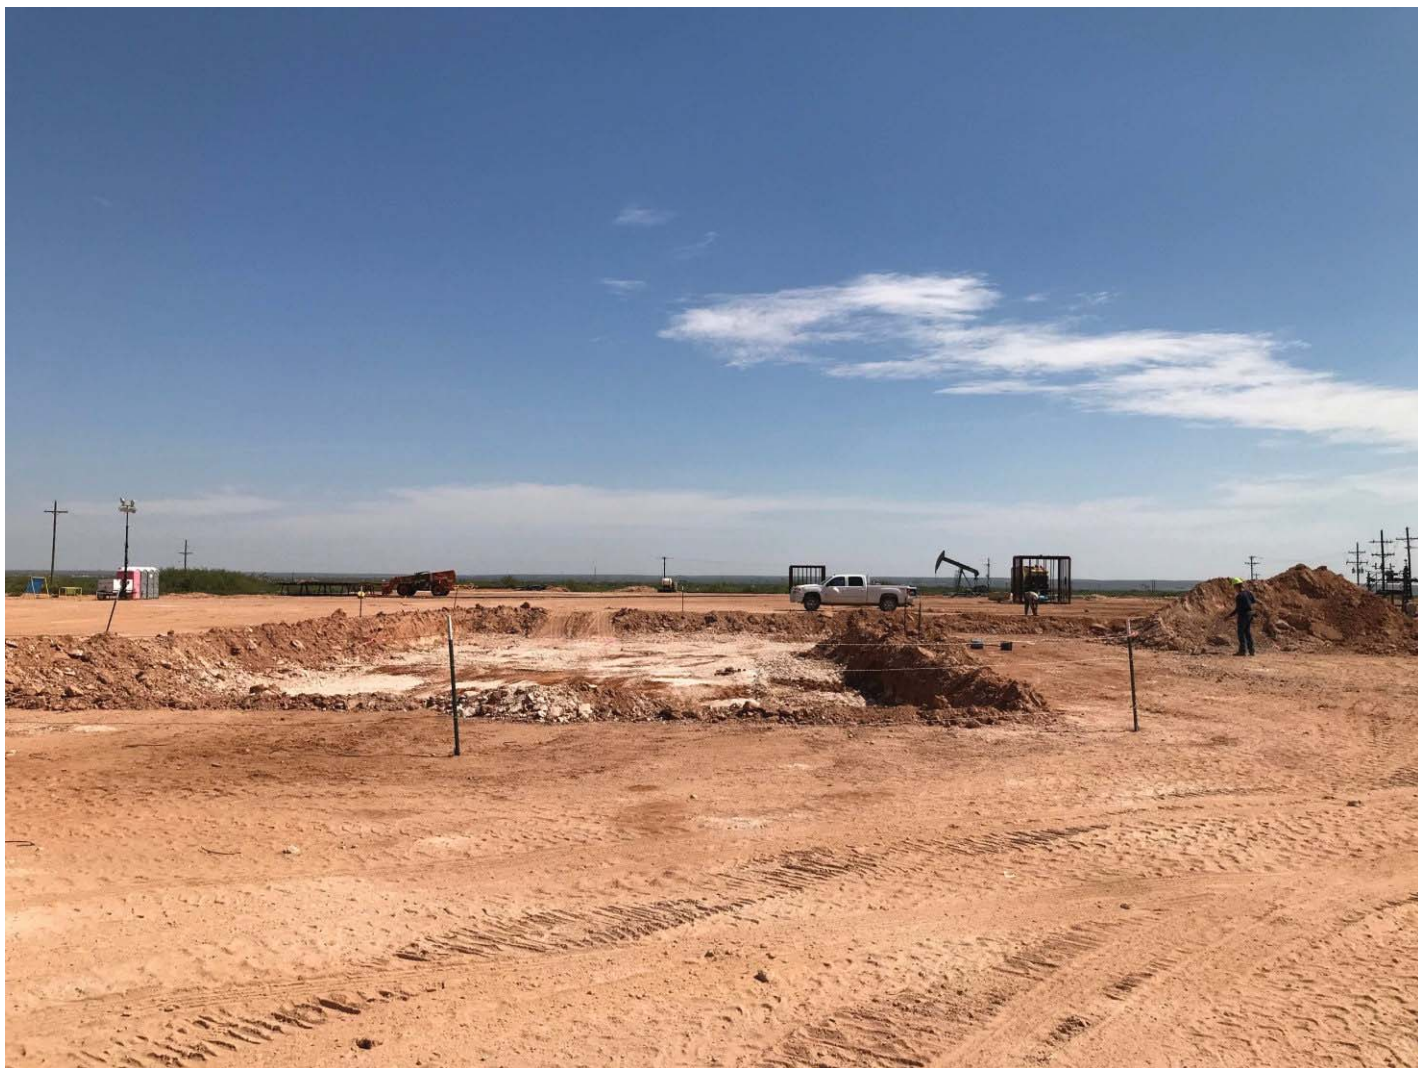
**Southern view of final excavation extent during confirmation soil sampling activities.**
