| Site Name Remuda 25 Observation Well #001 | Site Type Observation Well |

On February 28, 2019, on-site drilling crews encountered a subsurface pressure kick during the installation of an observation well. Crews secured the drilling rig, switched off engines and ignition points, and safely evacuated the area. The well flowed for approximately three hours before depleting the pressurized zone. Approximately 915 barrels (bbls) of crude oil and 2,746 bbls of produced water were released onto the caliche well pad and into the pasture area following the north-trending lease road and pipeline right-of-way (ROW). In addition, overspray was observed to the west of the well pad in a pasture area. Vacuum trucks were dispatched to the Site to recover free-standing fluids; approximately 199 bbls of crude oil and 596 bbls of produced water were recovered. XTO reported the release to the New Mexico Oil Conservation Division (NMOCD) on a Release Notification and Corrective Action Form C-141 (Form C-141) on March 13, 2019 and was assigned RP Number 2RP-5309 (Attachment 1).

Attachment 1 Initial/Final NMOCD Form C-141 (2RP-5309)  
Attachment 2 Photographic Log  
Attachment 3 Lithologic/Soil Sampl

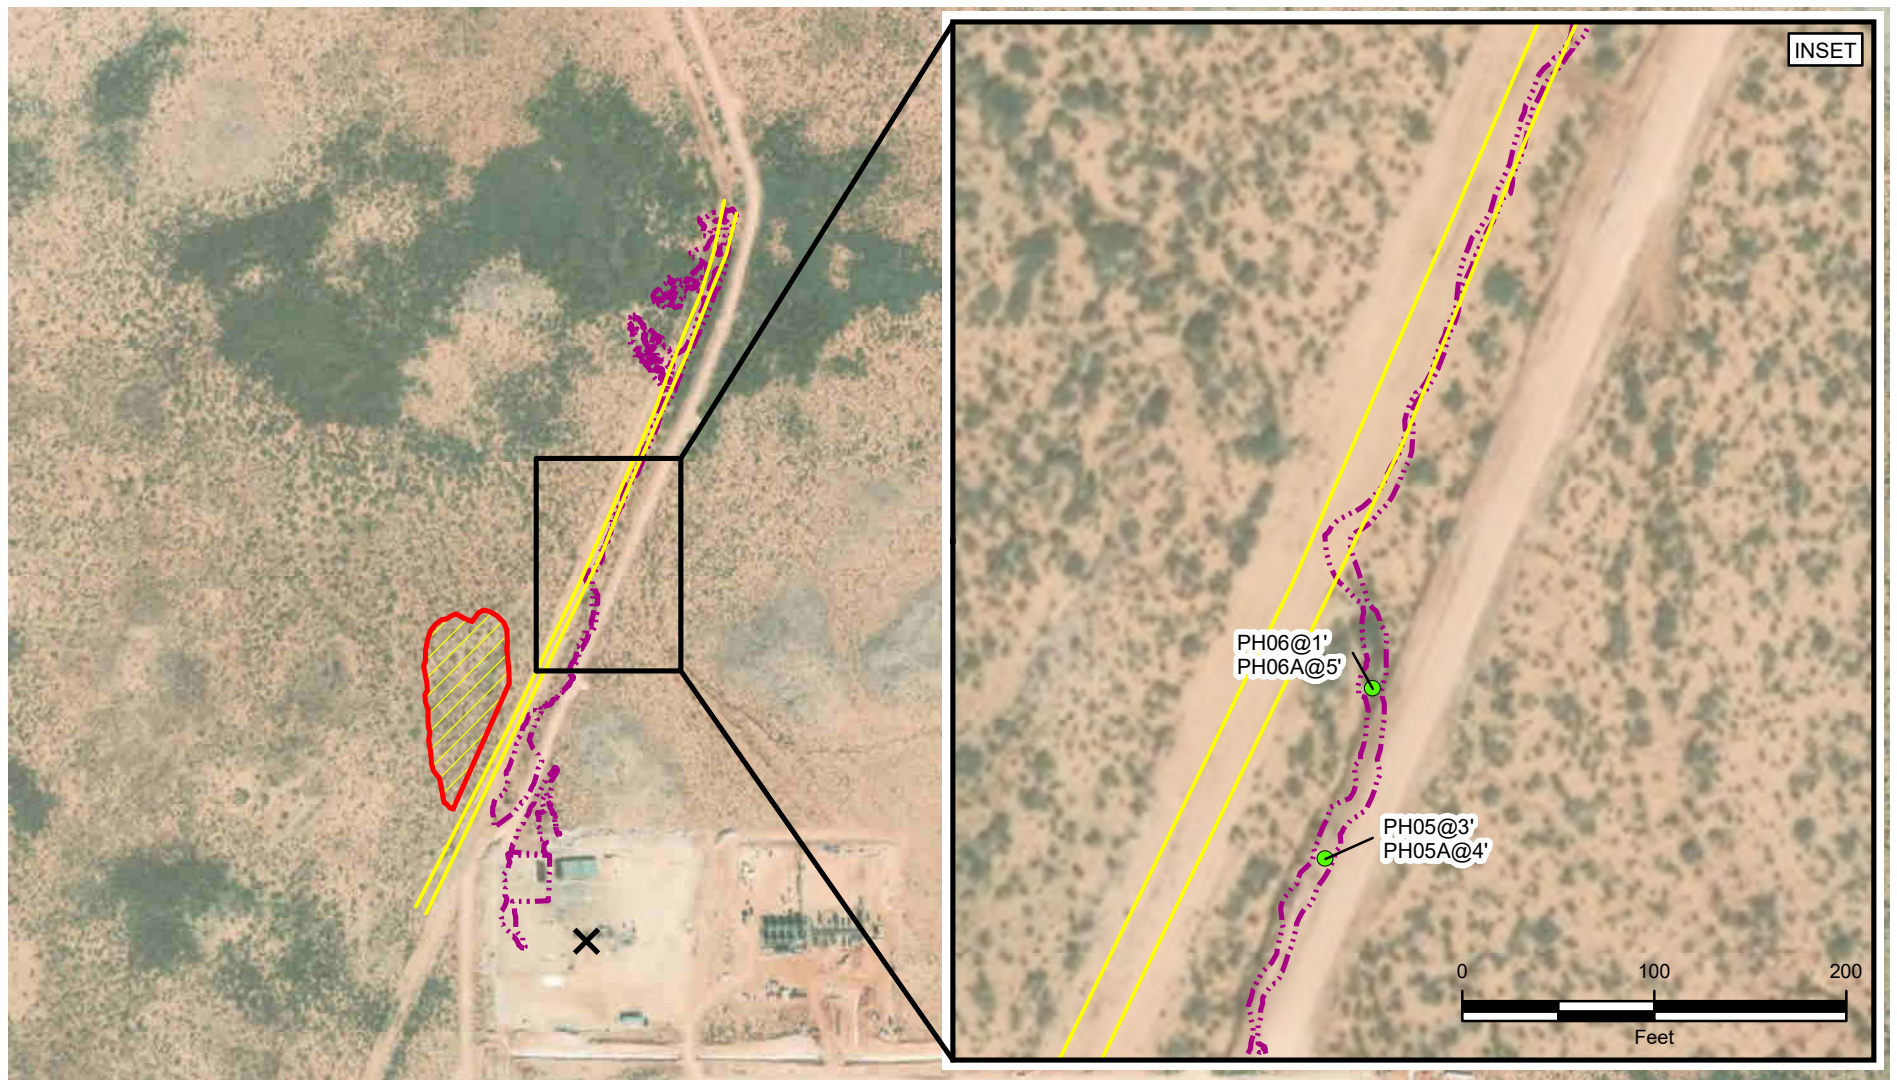
**FIGURE 3B**  
**DELINEATION SOIL SAMPLE LOCATIONS**  
**REMUDA 25 OBSERVATION WELL #1**  
**UNIT D SEC 25 T23S R29E**  
**EDDY COUNTY, NEW MEXICO**  
**XTO ENERGY, INC.**

- X RELEASE LOCATION
- DELINEATION SOIL SAMPLE IN COMPLIANCE WITH APPLICABLE CLOSURE CRITERIA
- GAS LINE
- OVERSPRAY
- RELEASE EXTENT
