SUNDRY NOTICES AND REPORTS ON WELLS

8. Well Name and No.
 CONOCO "8" FEDERAL #1

CONOCO #8 FEDERAL #1

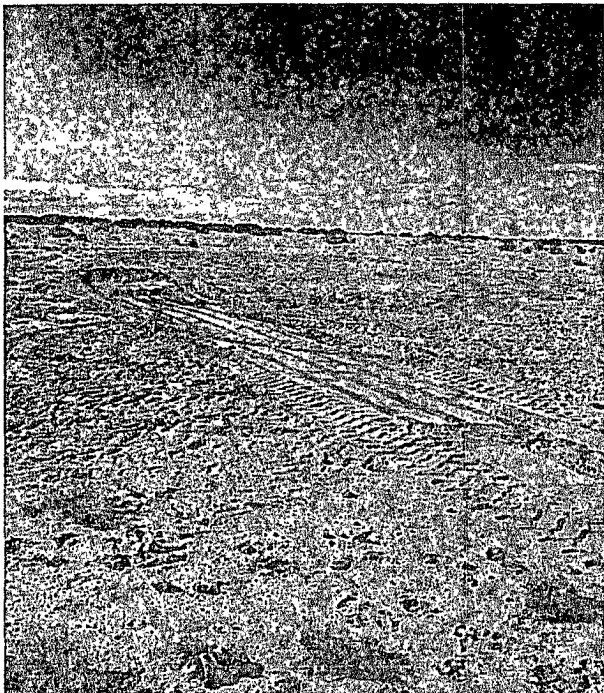
November 14, 2011 Initial Excavation Activities

Based upon the findings of the preliminary excavation activities approximately eighteen inches of soil was removed from the entire area of the pit. This equates to about 900 cubic yards of materials being removed from the pit. The materials removed from the pit were transported to the Gandy Marley, Inc. Commercial Surface Waste Facility in Chaves County New Mexico. The pit contents removed include soil, thread protectors, plastic liner, and concrete rubble. All excavated soils were similar reddish brown, mostly fine grain and moist below about eighteen inches. There was no evidence of hydrocarbon staining in the excavation.

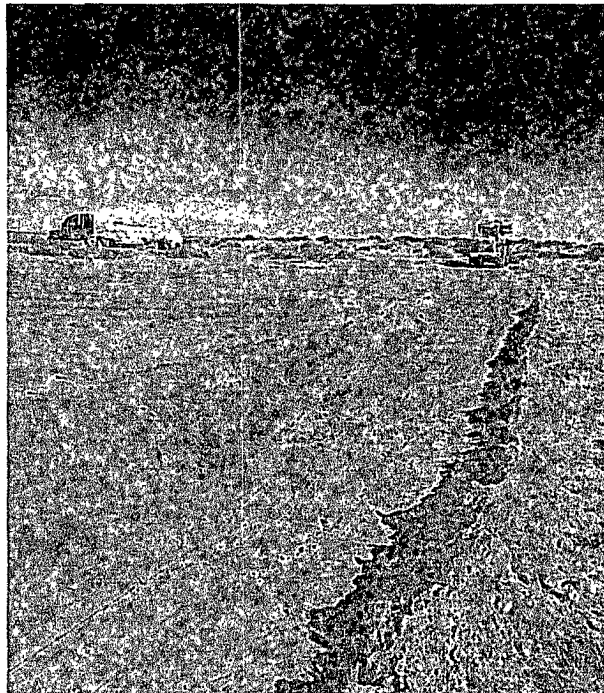
November 14, 2011 Pit Excavation

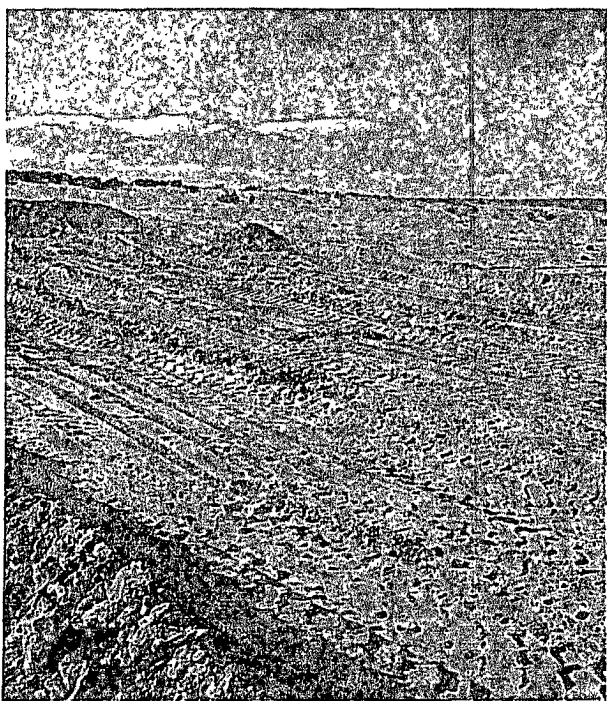
November 14, 2011 Pit Excavation

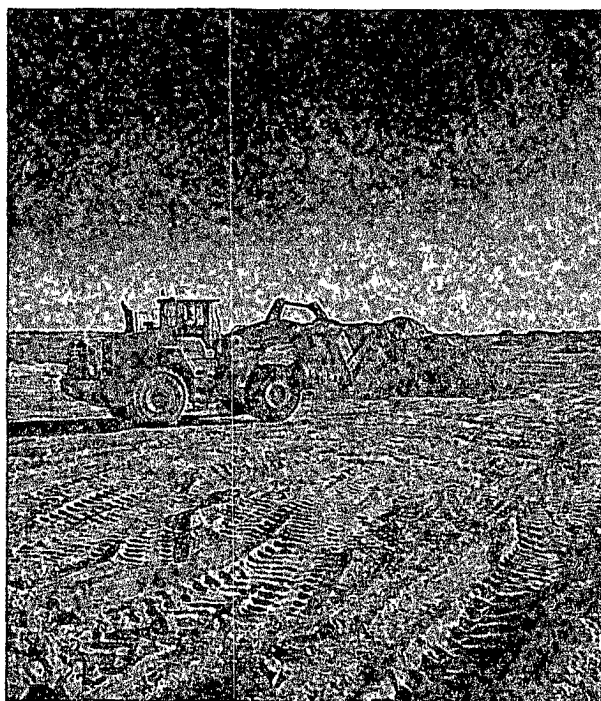
November 14, 2011 Pit Excavation

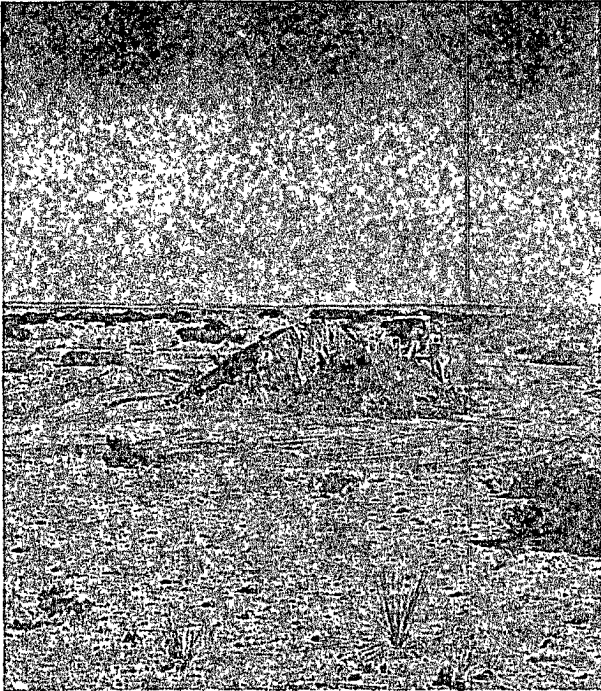
November 15, 2011 Pit Excavation

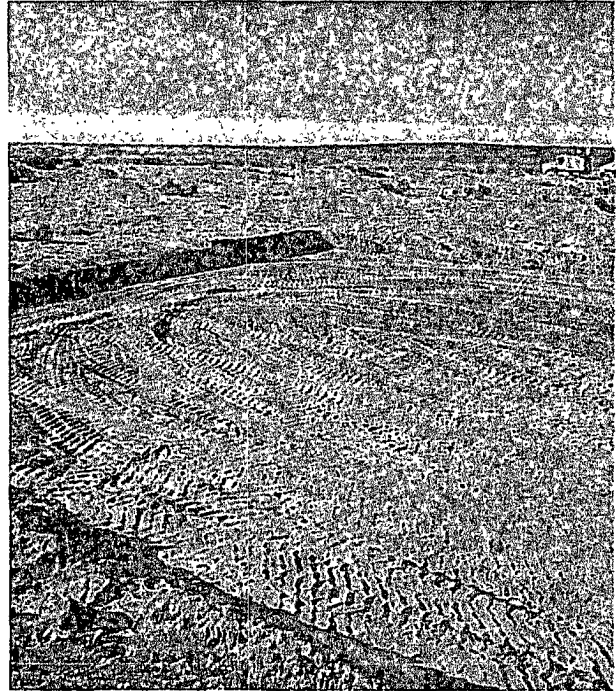
November 15, 2011 Pit Excavation

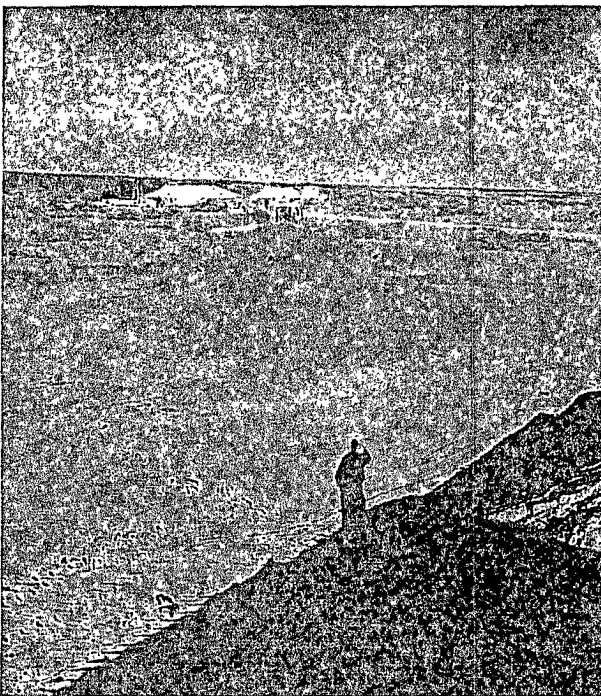
November 15, 2011 Pit Excavation

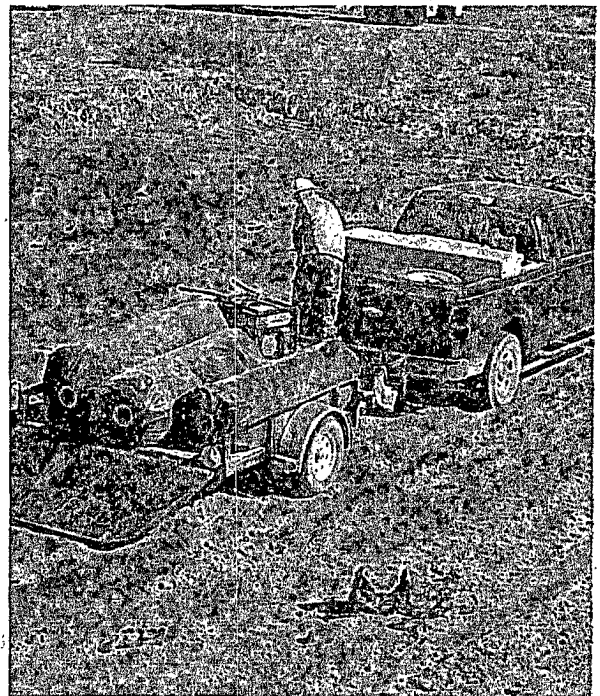
November 16, 2011 Preparing for Liner Installation

A 20 mil liner was then installed by sewing together three 60 feet by 100 feet rolls of liner materials. The liner was keyed in with a one foot deep trench along the edges of the pit to assure its placement. Approximately 24 inches of clean soil or (1,188 cubic yards) were placed on the liner to return the pit area to the adjacent grade. The clean soil placed in the pit area is conducive to promoting vegetative growth.

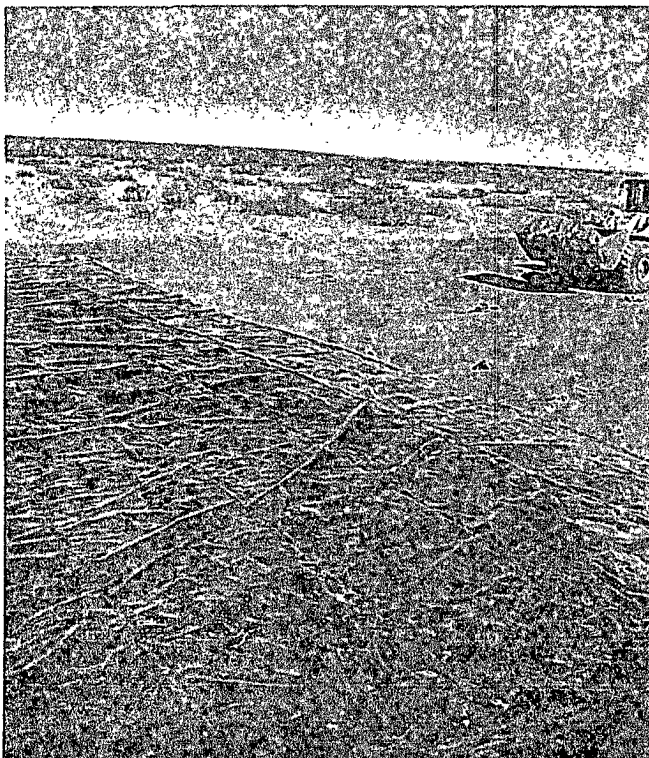
November 16, 2011 Liner Installation

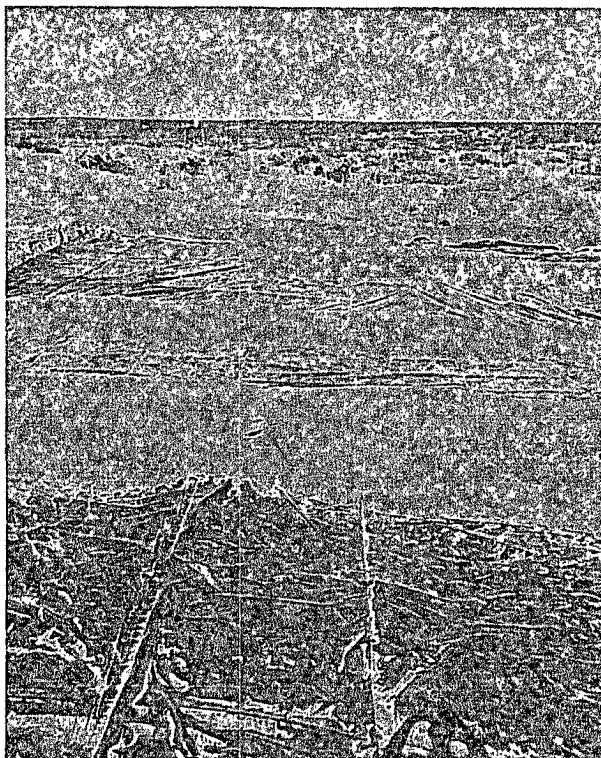
November 16, 2011 Liner Installation

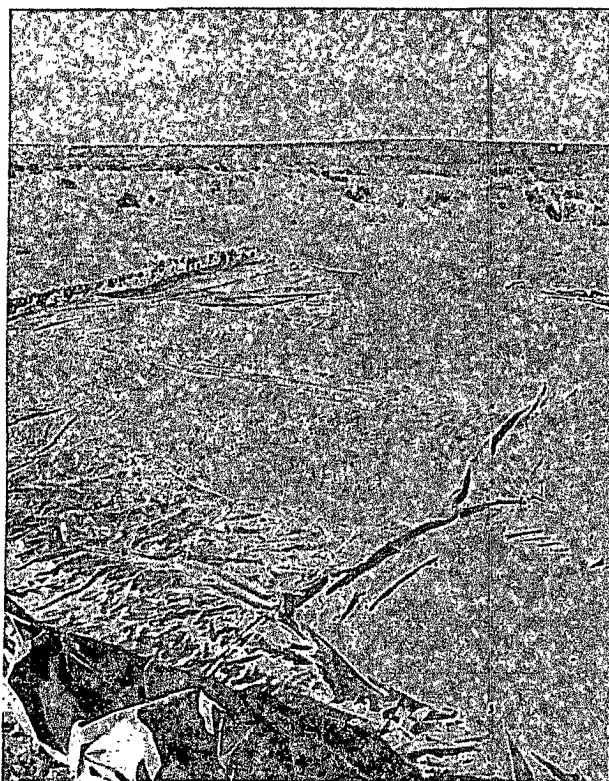
November 16, 2011 Liner Installation

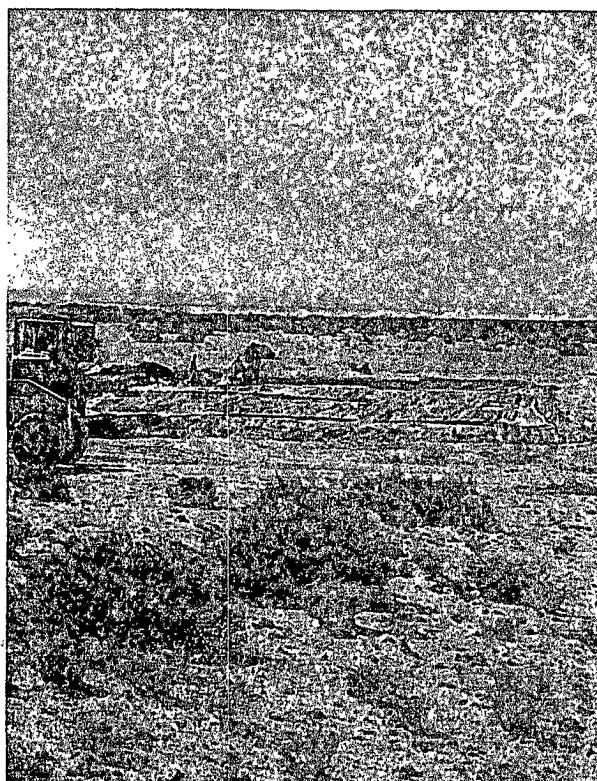
November 16, 2011 Liner Installation

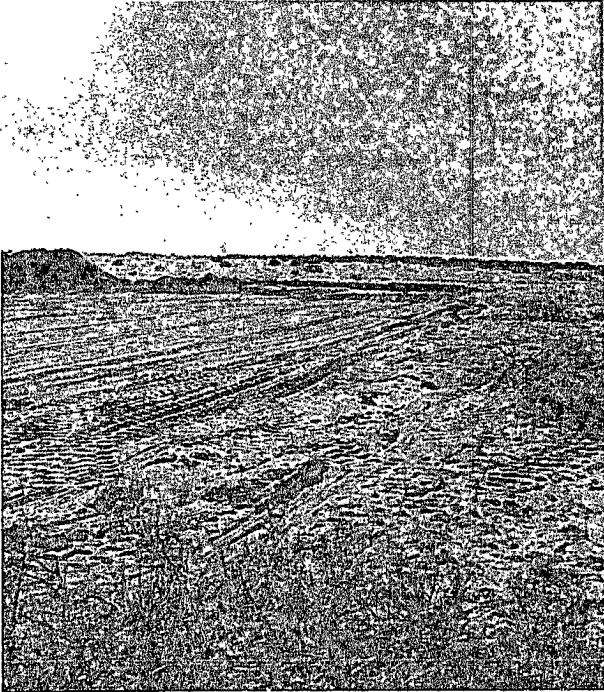
November 16, 2011 Liner being covered with clean soil

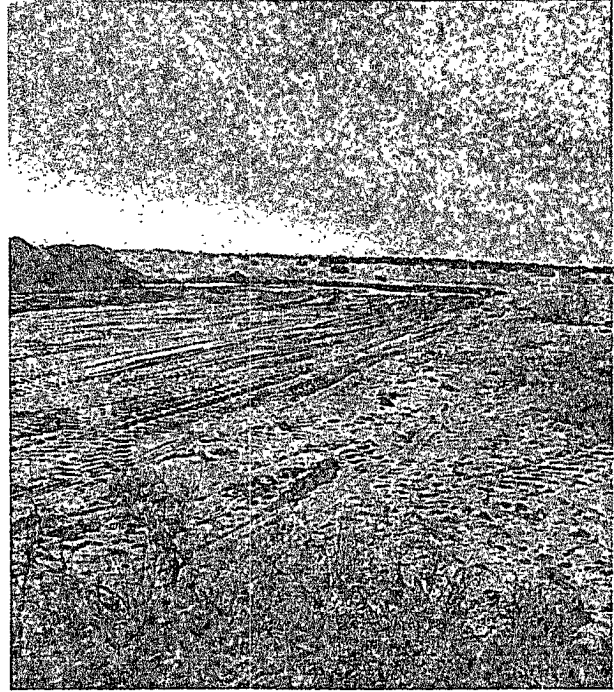
November 16, 2011 Liner being covered with clean soil

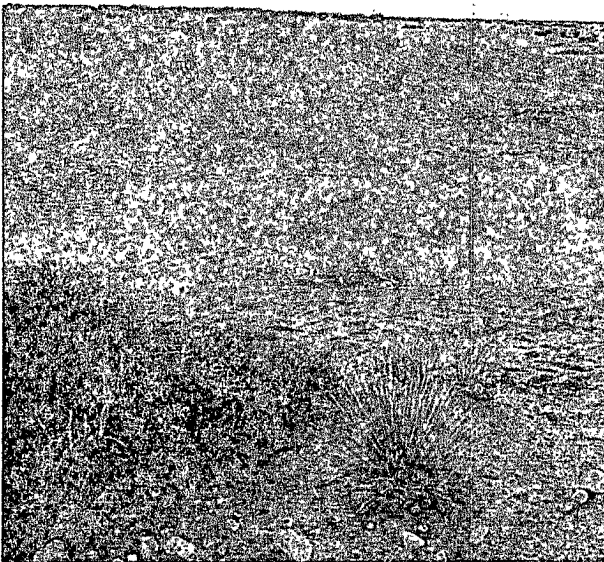
November 16, 2011 Final Cap

Per the request of the Rancher the caliche road that provided access to the pit area will not be removed. The pit area will be seeded with the proper seed mixture for that area, which is prescribed in the letter from BLM. This will be done in the Spring of 2012 at the beginning of the growing season. Attached pictures during the re-cap activities.
