## Release Notification

| Site Name | Trunk S Pipeline | Site Type | Natural Gas Pipeline |

**TOPOGRAPHIC SITE LOCATION MAP**  
HARVEST MIDSTREAM  
TRUNK S RELEASE LOCATION  
NE¼ SE¼, SEC. 7, T25N, R3W  
RIO ARriba COUNTY, NEW MEXICO  
N36.41180, -107.18085

NMOCD Site Assessment/Characterization, Remediation & Closure

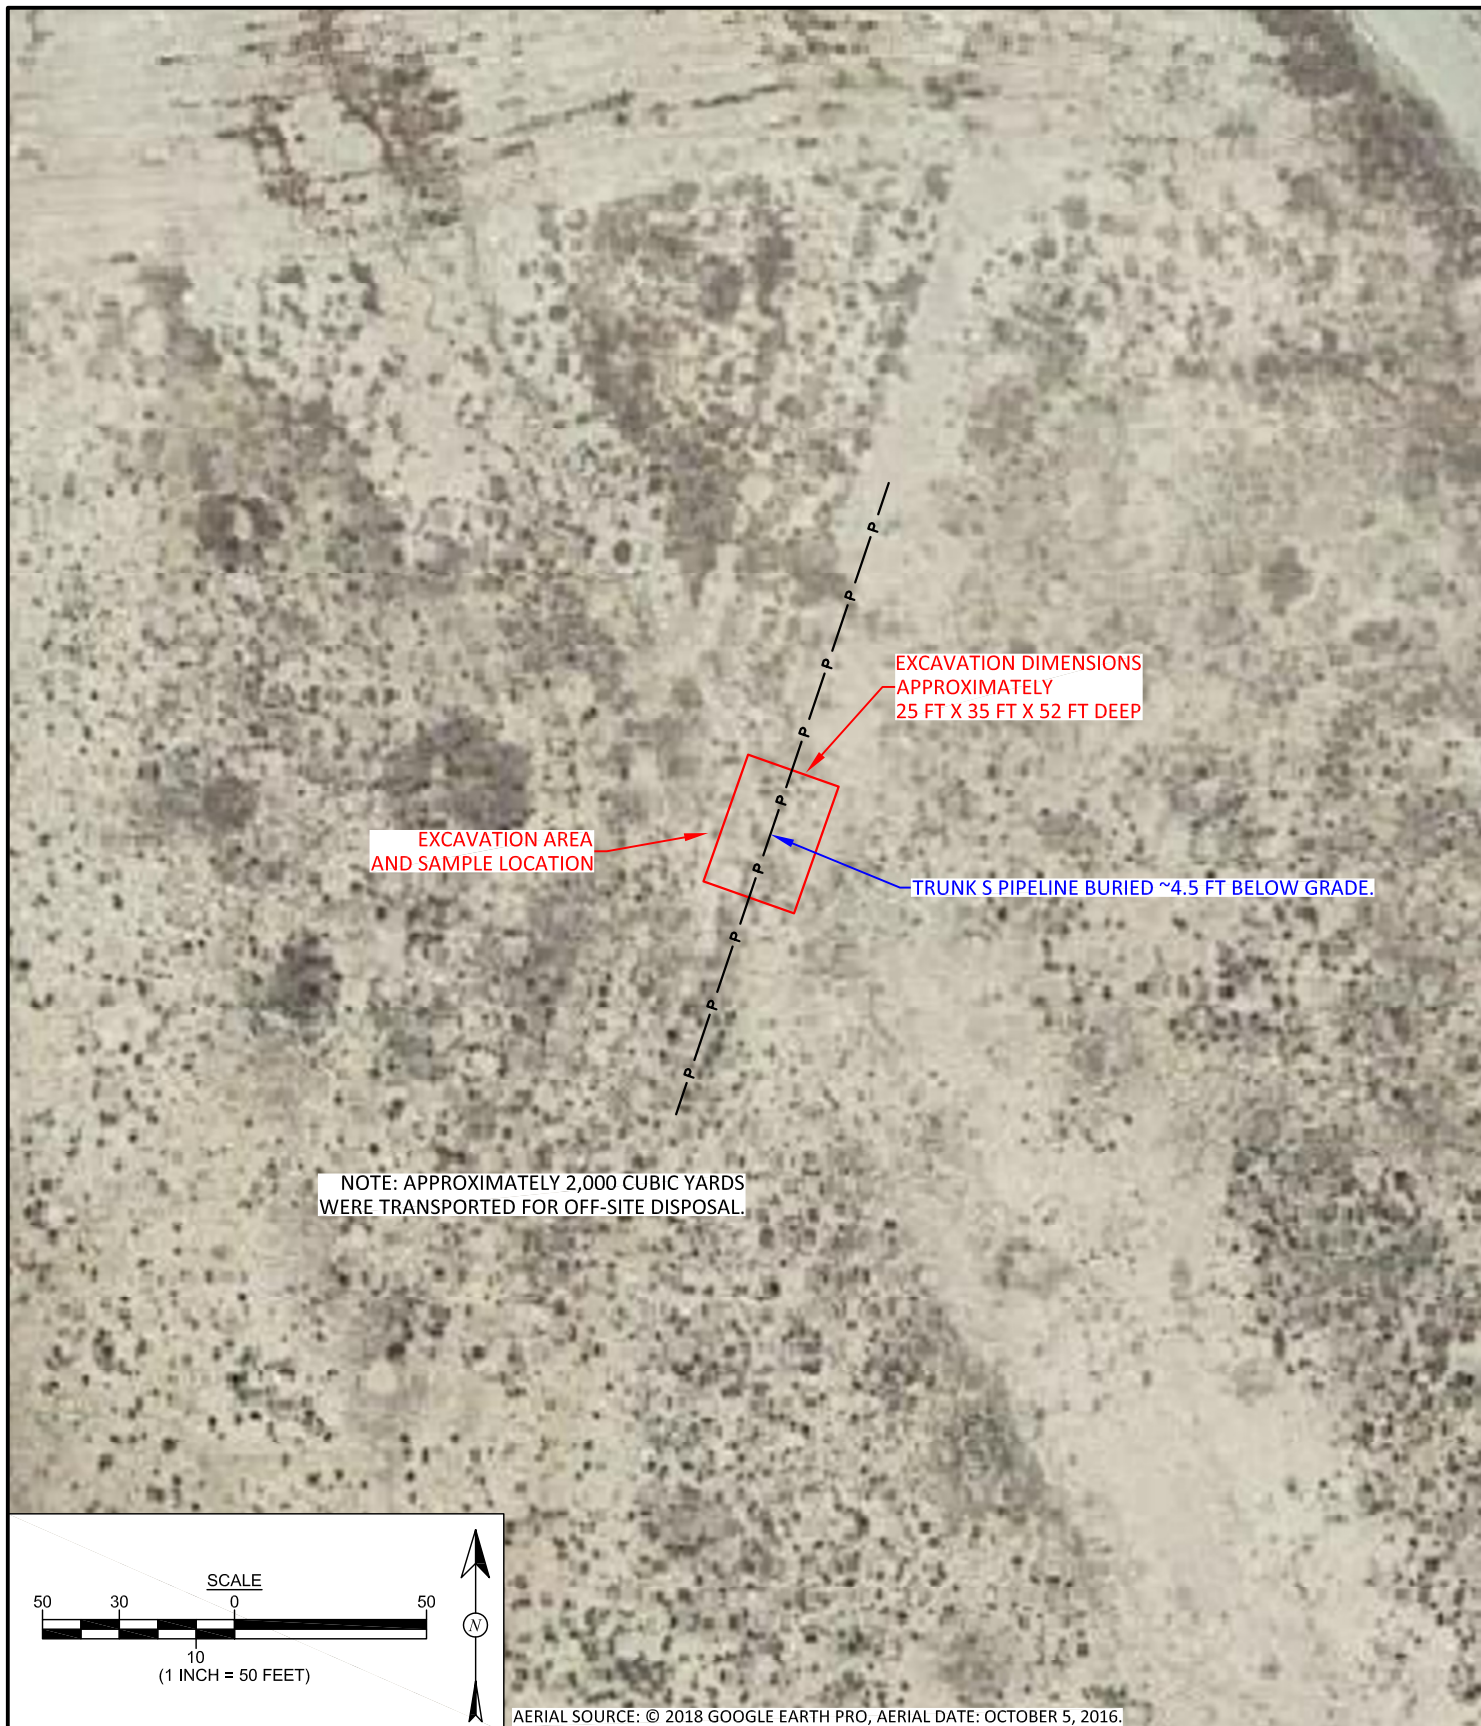
## FIGURE 3

**EXCAVATION DETAILS**  
HARVEST MIDSTREAM  
TRUNK S RELEASE LOCATION  
NE $\frac{1}{4}$  SE $\frac{1}{4}$ , SEC. 7, T25N, R3W  
RIO ARriba COUNTY, NEW MEXICO  
N36.41180, -107.18085
