Pit, Closed-Loop System, Below-Grade Tank, or pCS2009758598
Proposed Alternative Method Permit or Closure Plan Application

BELOW-GRADE TANK CLOSURE PLAN

Cedar Hill Gathering Pipeline – Tank ID: A

APP #: BPPK063110

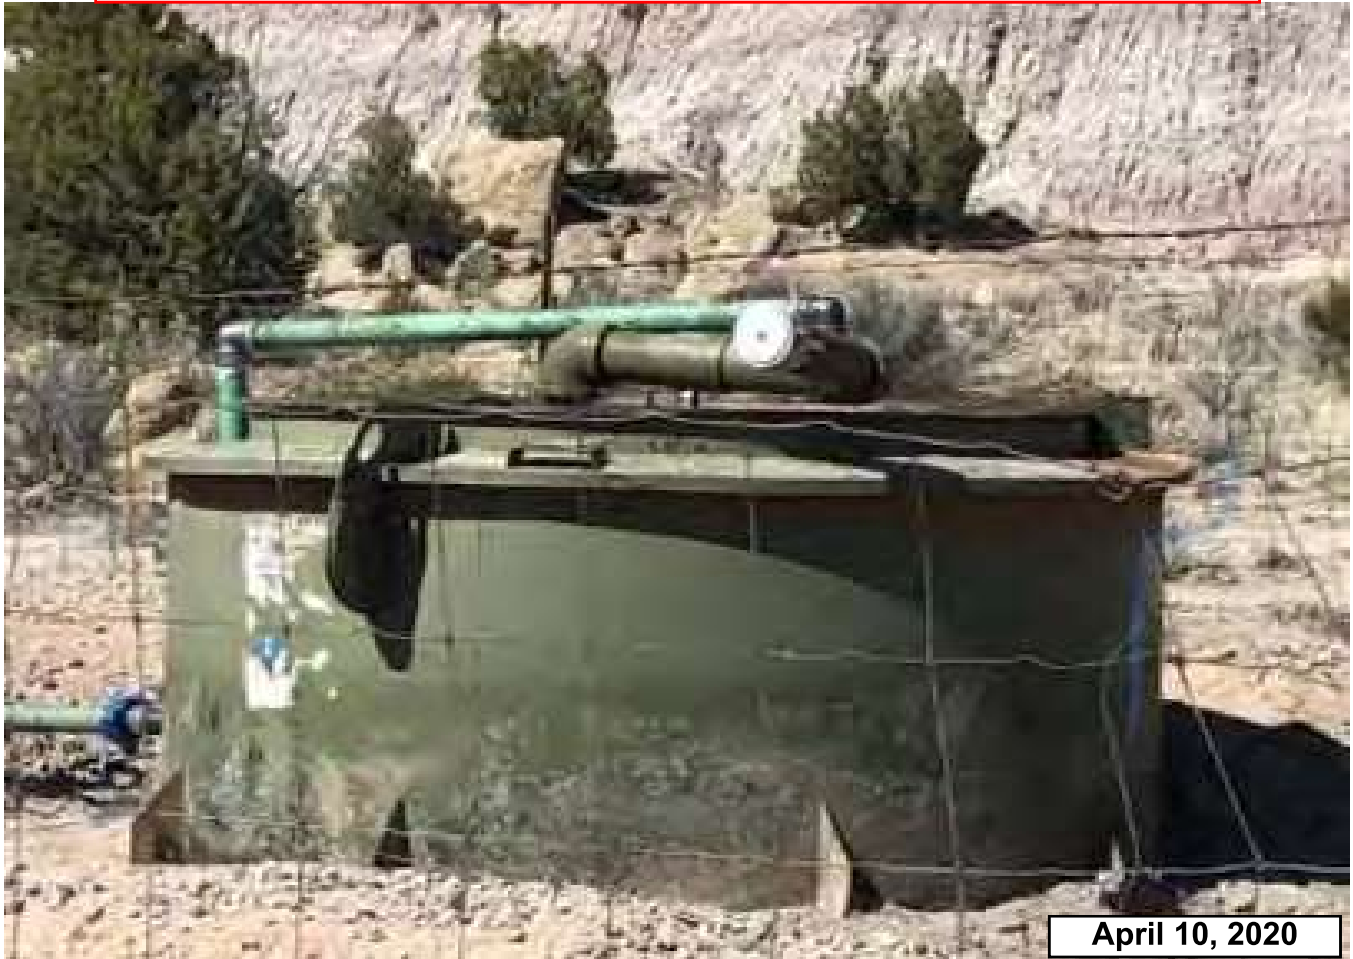
April 10, 2020

10 bbl Above-grade Tank Set Atop 21 bbl BGT Position

Sampling results reveal no evidence of a release had occurred. BGT area has been backfilled with clean, earthen material after remedial activity has been completed.
