# BURLINGTON RESOURCES

Re: San Juan 30-6 Unit #71  
CTP0223253  
NM-012293  
30-039-07862  
1730'FNL, 1050'FEL, Section 13-30-7

# SAN JUAN 30-6 UNIT 71

## WellView - Schematic

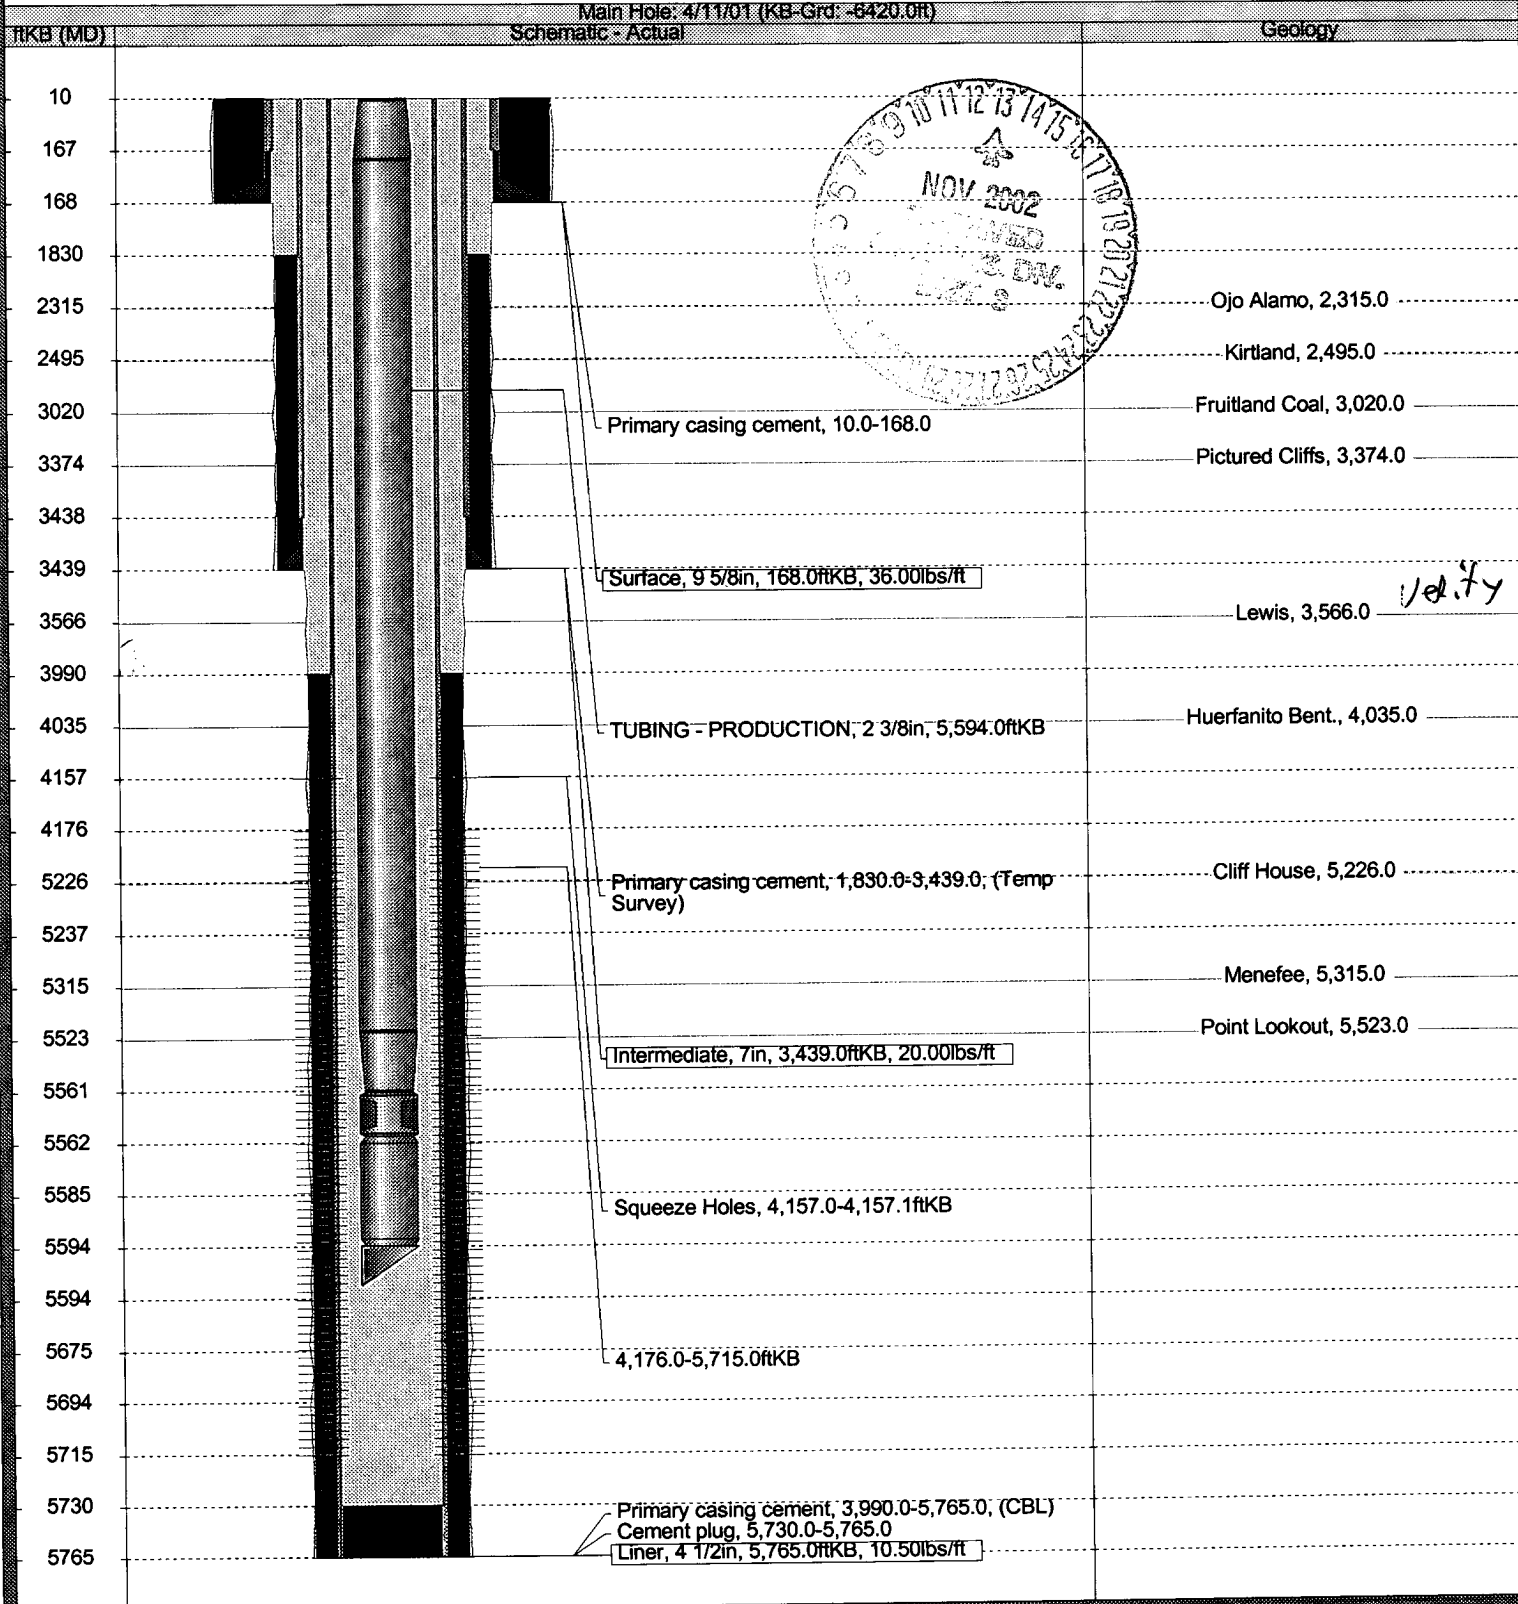
### Schematic

The San Juan 30-6 Unit #71 has pressure on the intermediate but not on the bradenhead. The intermediate casing string is landed into the Lewis and the top of cement on the production string covers the Huerfanito Bentonite. See the attached wellbore schematic and bradenhead test for more detail.
