## PIT REMEDIATION AND CLOSURE REPORT

30-039-07675

Operator: ConocoPhillips (Phillips Petroleum) Telephone: (505) 599-3400

Facility Or: San Juan 29-6 # 19

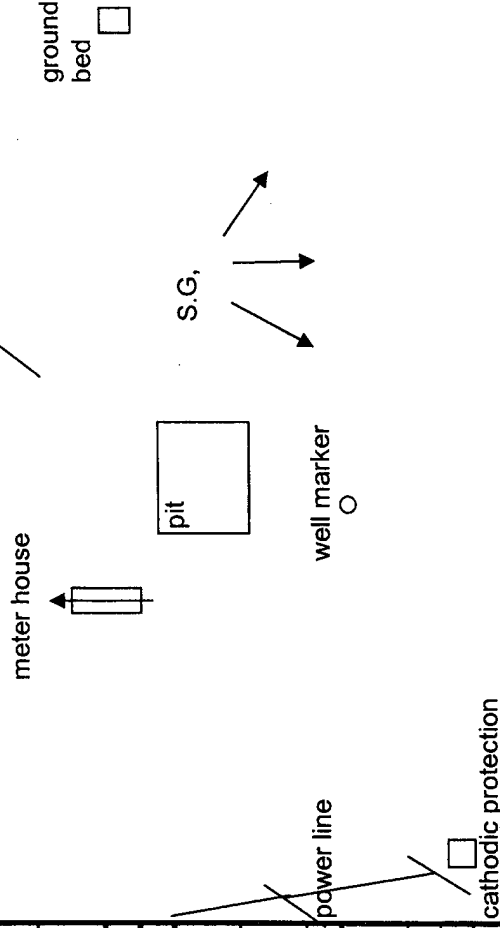
Site Diagram:

| 50' north 10 degrees W | |
| Initial size: | 15' x 15' x 3' deep |

**Comments:**  
 Topography is mesa top. Soil is brown clay loam.  
 No hydrocarbon staining or odor was noticed. Sample was  
 extracted from 6 ft below surface (3 ft below pit bottom).  
 Sample from 6-ft was sent to IML for GRO/DRO analysis.
