**PIT REMEDIATION AND CLOSURE REPORT**

Operator: ConocoPhillips Telephone: 505-599-3400

Facility Or: SJ 29-5 # 60

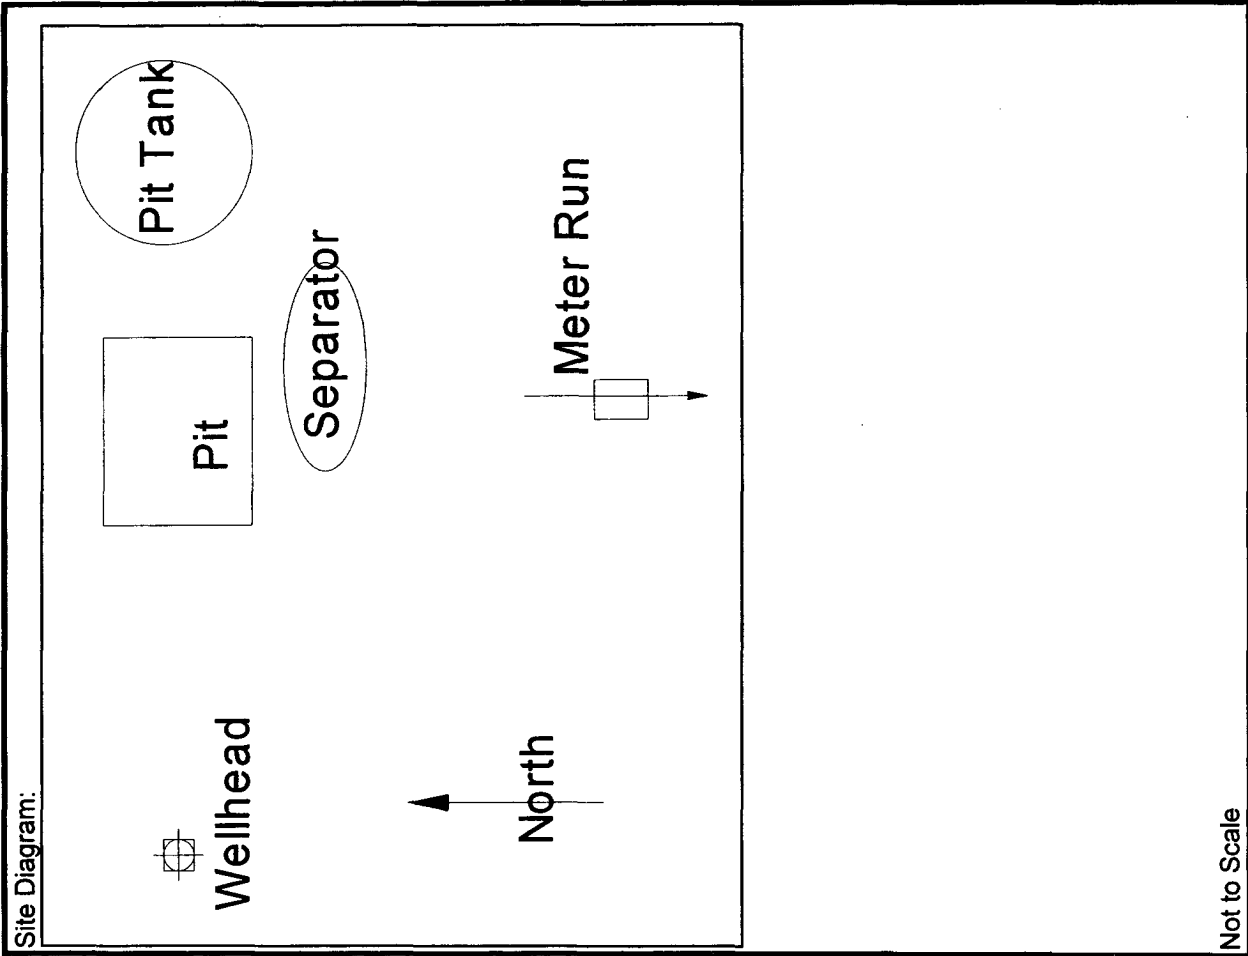
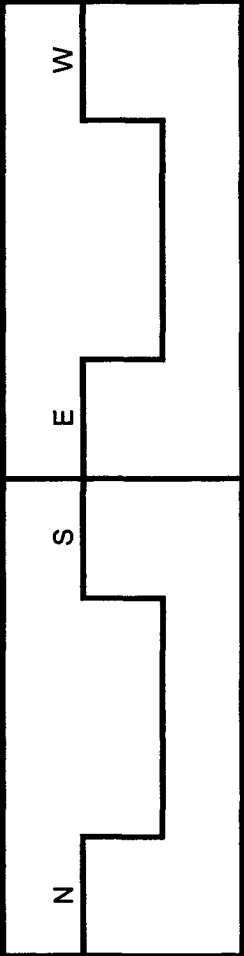
Final Pit: Sample location Soil sample collected from center of pit with hand probe

Sample depth 3-feet below pit bottom
