Pit, Below-Grade Tank, or
Proposed Alternative Method Permit or Closure Plan Application

Facility or well name: SAN JUAN 28-7 UNIT 154

ConocoPhillips Company
San Juan Basin: New Mexico Assets
Below Grade Tank Closure Report

Lease Name: San Juan 28-7 Unit 154

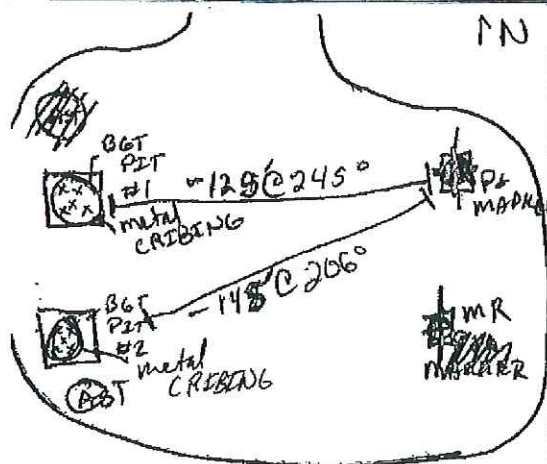
PROFILE

SAMPLE ID	READING	CALC. (mg/kg)
Spt Comp #1	0.0	< 33
Spt Comp #2	0.0	< 33

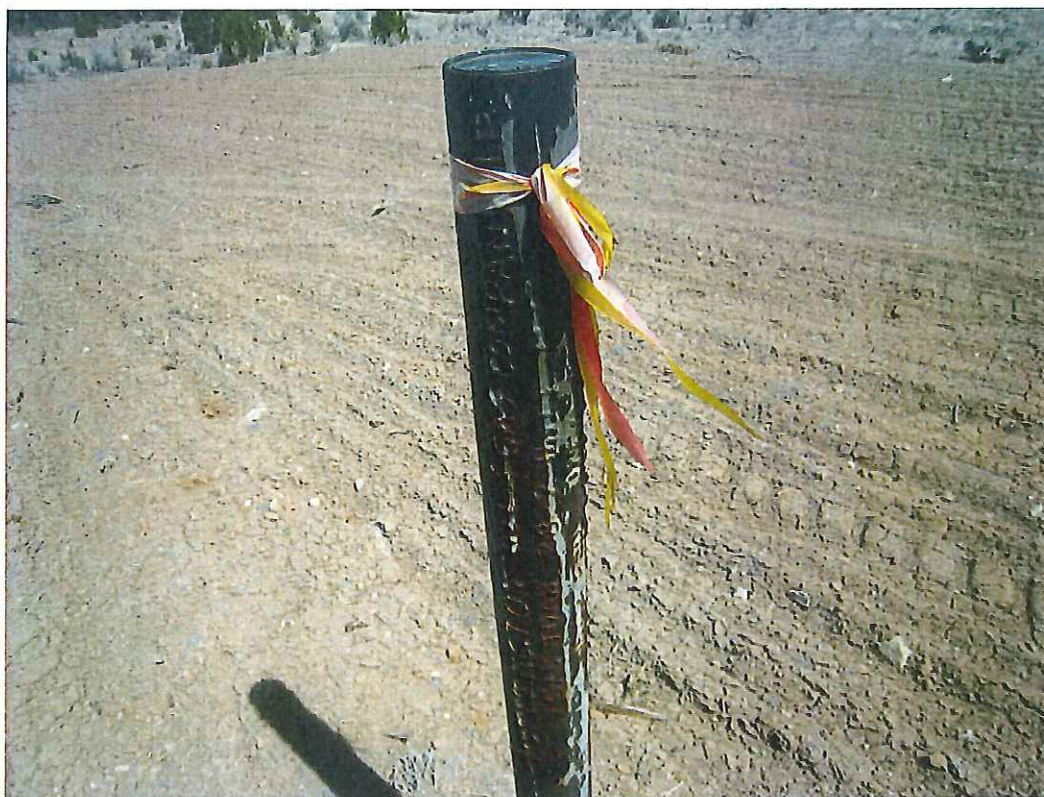
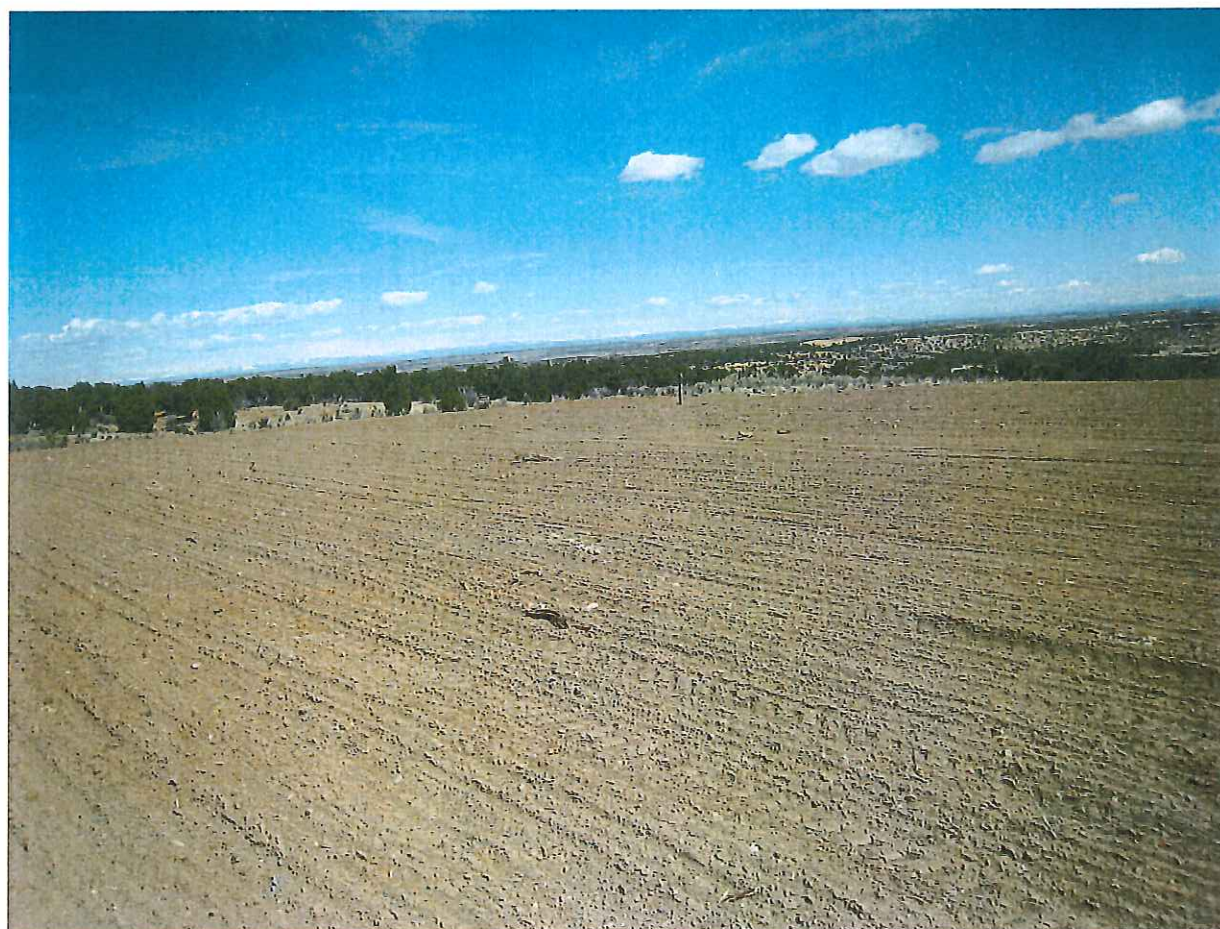
SAN JUAN 28-7 UNIT 154

The former BGT area is not required for production activities and reseeding was completed on 11/14/2012 per the procedure noted above.
