Pit, Closed-Loop System, Below-Grade Tank, or Proposed Alternative Method Permit or Closure Plan Application

BPX ENERGY
(formally BP America Production Company)
SAN JUAN BASIN, NORTHWEST NEW MEXICO

BELOW-GRADE TANK CLOSURE PLAN

API #: 3004526799

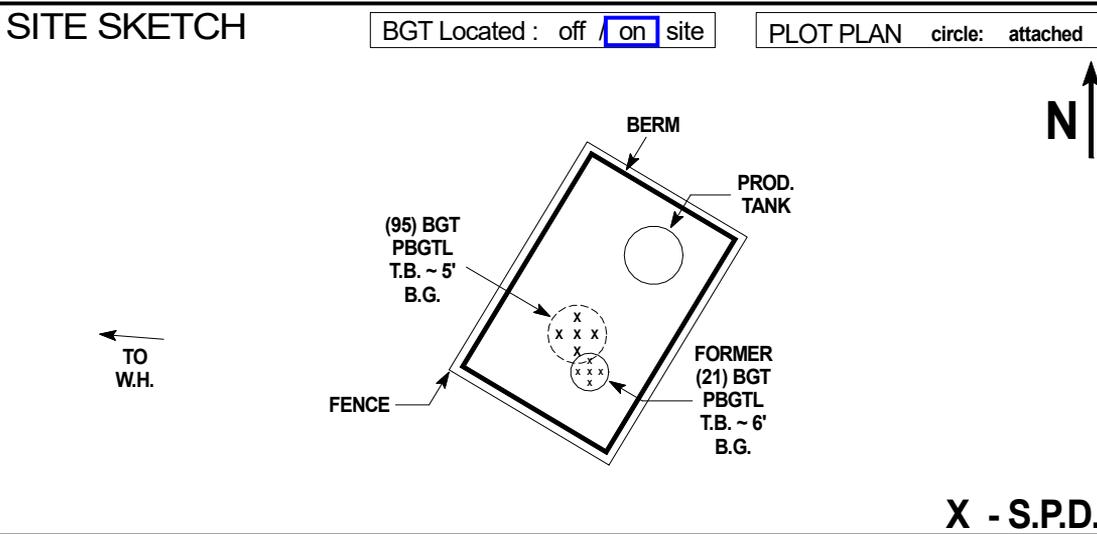
SOIL DESCRIPTION: SOIL TYPE: **SAND** / **SILTY SAND** / SILT / SILTY CLAY / CLAY / GRAVEL / OTHER
SOIL COLOR: **DARK YELLOWISH BROWN**
PLASTICITY (CLAYS): NON PLASTIC / SLIGHTLY PLASTIC / COHESIVE / MEDIUM PLASTIC / HIGHLY PLASTIC
COHESION (ALL OTHERS): **NON COHESIVE** / SLIGHTLY COHESIVE / COHESIVE / HIGHLY COHESIVE
DENSITY (COHESIVE CLAYS & SILTS): SOFT / FIRM / STIFF / VERY STIFF / HARD
CONSISTENCY (NON COHESIVE SOILS): LOOSE / **FIRM** / DENSE / VERY DENSE
HC ODOR DETECTED: YES **NO** EXPLANATION -
MOISTURE: DRY / **SLIGHTLY MOIST** / MOIST / WET / SATURATED / SUPER SATURATED
SAMPLE TYPE: GRAB / **COMPOSITE** # OF PTS. **5**
ANY AREAS DISPLAYING WETNESS: YES **NO** EXPLANATION -
DISCOLORATION/STAINING OBSERVED: YES **NO** EXPLANATION -

SITE OBSERVATIONS: LOST INTEGRITY OF EQUIPMENT: YES **NO** EXPLANATION -
APPARENT EVIDENCE OF A RELEASE OBSERVED AND/OR OCCURRED: YES **NO** EXPLANATION:
EQUIPMENT SET OVER RECLAIMED AREA: YES **NO** EXPLANATION -
OTHER: **NMOC D OR BLM REPS. NOT PRESENT TO WITNESS CONFIRMATION SAMPLING. 95 DOUBLE WALLED/DOUBLE BOTTOM BGT REPLACED 21 BGT SOMETIME AFTER MARCH 2015. 21 BGT HAD WOODEN RETAINING WALL.**
EXCAVATION DIMENSION ESTIMATION: **NA** ft. X **NA** ft. X **NA** ft. EXCAVATION ESTIMATION (Cubic Yards): **NA**
DEPTH TO GROUNDWATER: **50' < x < 100'** NEAREST WATER SOURCE: **>1,000'** NEAREST SURFACE WATER: **300' < x < 1,000'** NMOC D TPH CLOSURE STD: **2,500** ppm
