Pit, Closed-Loop System, Below-Grade Tank, or Proposed Alternative Method Permit or Closure Plan Application

ConocoPhillips Company San Juan Basin Closure Report

Lease Name: STATE COM R 14B

API No.: 30-045-35039

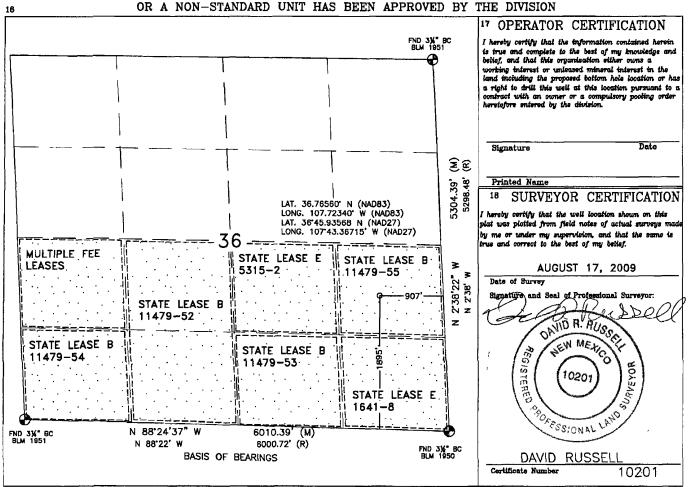
WELL LOCATION AND ACREAGE DEDICATION PLAT

CONOCOPHILLIPS COMPANY **WELL FLAG** STATE COM R #14 B LATITUDE: 36 76560° N 1895' FSL & 907' FEL LONGITUDE: 107.72340° W LOCATED IN THE NE/4 SE/4 OF SECTION 36. **CENTER OF PIT** T30N, R9W, N M.P.M., LATITUDE: 36.76571° N SAN JUAN COUNTY, NEW MEXICO ONGITUDE: 107.72324° W 30' **GROUND ELEVATION: 5851'. NAVD 88** ELEVATION: 5838.9' FINISHED PAD ELEVATION: 5850.9', NAVD 88 SCALE = 60' DATUM: NAD83 & NAVD88 1.) BASIS OF BEARING BETWEEN FOUND MONUMENTS AT THE SOUTHEAST CORNER AND THE SOUTHEAST CORNER OF SECTION 36, TOWNSHIP 30 NORTH, RANGE 9 WEST, N.M.P.M. SAN JUAN COUNTY, NEW MEXICO LINE BEARS: N. 882437 W A DISTANCE OF 6010.39 FEET AS MEASURED BY G.P.S. C'F+12.3 B'F+7.4 A'_®/ F+6.1 2.) LATITUDE, LONGITUDE AND ELLIPSOIDAL HEIGHT BASED ON AZTEC CORS LI PHASE CENTER. DISTANCES SHOWN ARE GROUND DISTANCES USING A TRAVERSE MERCATOR PROJECTION FROM A WOSB4 ELLIPSOID, CONVERTED TO MADBS ANDOBE ELEVATIONS AS PREDICTED BY GEOIDOS 2:1 Slopes Reserve Pit Positive drain e, DEED CENTER OF PIT 쥬 ᆵ 10' Deep 12' Deep 3.) LOCATION OF UNDERGROUND UTILITIES DEPICTED ARE APPROXIMATE. PRIOR TO EXCAVATION UNDERGROUND UTILITIES SHOULD BE FIELD VERIFIED. ALL DH-DELHI STATE COM #1 0 LONG. 107 72340° W SHOULD BE FIELD VERNIED ALL CONSTRUCTION ACTIVITIES SHOULD BE FIELD VERIFIED WITH NEW MEXICO ONE—CALL AUTHORITIES AT LEAST 48 HOURS PRIOR TO CONSTRUCTION RIG ANCHOR (NAD 83) RIG ANCHOR REAR Wellhead to back Wellhead to front LAYDOWN 0 5 00°00′00″ W 200' **©** 140' S 11°15′55" E 160 C-0.5 C-0.5 EXISTING ACCESS 9 GATE TO BE 0 O Wellhead INSTALLED RIG ANCHOR RIG ANCHOR 38 EXISTING WELL PAD C-3.8 C-14.8 ② C-11.2 B

TOTAL PERMITTED AREA 330' x 400' = 3.03 ACRES

RESERVE PIT DIKE: TO BE 8' ABOVE DEEP SIDE (OVERFLOW - 3' WIDE AND 1' ABOVE SHALLOW SIDE). RUSSELL SURVEYING, INC. IS NOT LIABLE FOR UNDERGROUND UTILITIES OR PIPELINES. CONTRACTOR SHOULD CALL ONE-CALL FOR LOCATION OF ANY MARKED OR UNMARKED, BURIED PIPELINES OR CABLES ON WELL PAD, IN CONSTRUCTION ZONE AND/OR ACCESS ROAD AT LEAST TWO (2) WORKING DAYS PRIOR TO CONSTRUCTION.

SLOPES TO BE CONSTRUCTED TO MATCH THE ORIGINAL CONTOURS AS CLOSE AS POSSIBLE.
