Form C-144 July 21, 2008

## Burlington Resources Oil Gas Company, LP San Juan Basin Closure Report

Lease Name: SAN JUAN 27-5 UNIT 100N

API No.: 30-039-30798

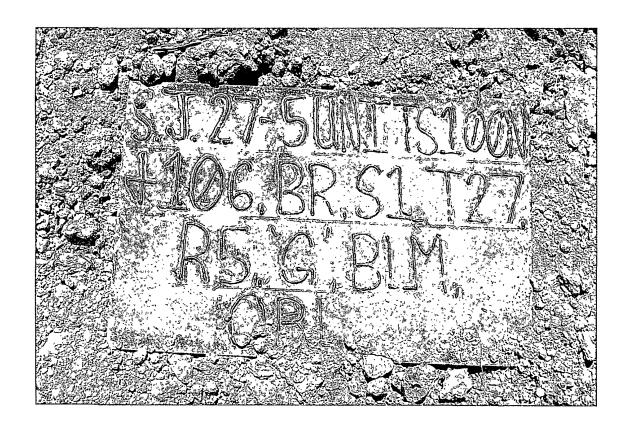
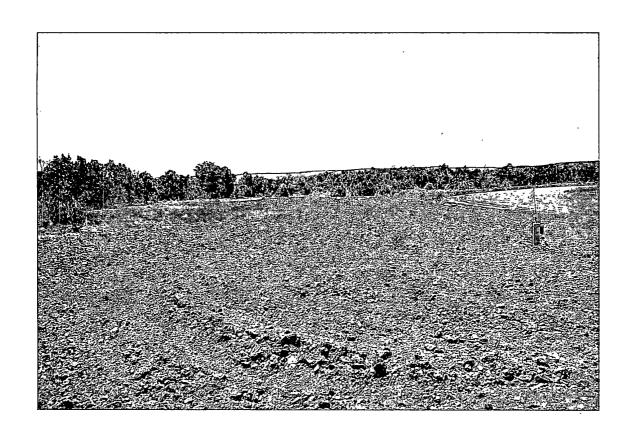
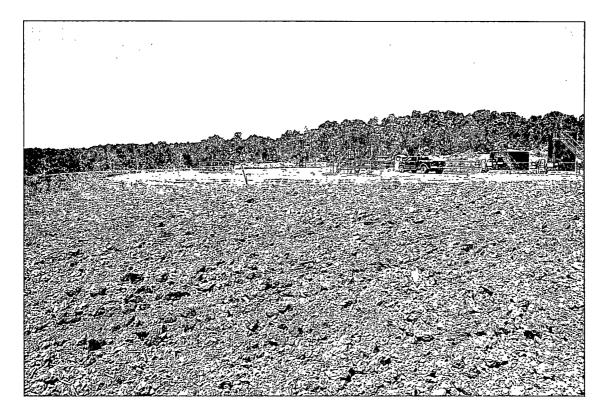
Reclamation Form:
Date: 5/25/11
Well Name: San Juan 27-5 100N
Footages: 1705 FNL, 1585 FEL Unit Letter: G
Section: 1, T-27-N, R-5-W, County: R.A State: NM
Reclamation Contractor: 3. D. Ritter
Reclamation Date: 5/9/2011
Road Completion Date: 5/13/2011
Seeding Date: <u>5/18/2011</u>
**PIT MARKER STATUS (When Required): Picture of Marker set needed  MARKER PLACED: 5/10/2011 (DATE)  LATATUDE: 36, 258
MARKER PLACED: 5/10/2011 (DATE)
MARKER PLACED: 5/10/2011 (DATE)  LATATUDE: 36, 36,258  LONGITUDE: /07 /8.333  Pit Manifold removed 5/5/2011 (DATE)
MARKER PLACED: 5/10/2011 (DATE)  LATATUDE: 36, 258  LONGITUDE: 107 18.333

SAN JUAN 27-5 UNIT #100N
LATITUDE 36° 36 MIN 16 SEC N (NAD83)
LONGITUDE 107° 18 MIN 21 SEC W (NAD 83)
UNIT G SEC 01 T27N R05W
BH: NW/SE SEC 01 T27N R05W
1705' FNL 1585' FEL / API#30-039-30798
LEASE# SF-079491 ELEV. 7387'
RIO ARRIBA COUNTY, NEW MEXICO
EMERGENCY CONTACT: 1-505-324-5170

Provision 15 was accomplished by installing a steel marker in the temporary pit, no less than four inches in diameter, cemented in a hole three feet deep in the center of the onsite burial. The marker is flush with the ground to allow access of the active well pad and for safety concerns. The top of the marker contains a welded steel 12" square plate that indicates the onsite burial of the temporary pit. The plate contains the following: Operator Name, Lease Name, Well Name and number, Unit Number, Section, Township, Range and an indicator that the marker is an onsite burial location.

The plate will be easily removable and a four foot tall riser will be threaded into the top of the collar marker and welded around the base with the following operator's information at the time of all wells on the pad are abandoned. The riser will be labeled: BR, BLM, SAN JUAN 27-5 UNIT 100N, UL-G, Sec. 1, T 27N, R 5W, API # 30-039-30798
