Pit, Closed-Loop System, Below-Grade Tank, or Proposed Alternative Method Permit or Closure Plan Application Type of action: Permit of a pit, closed-loop system, below-grade tank, or proposed alternative method Closure of a pit, closed-loop system, below-grade tank, or proposed alternative method Modification to an existing permit Closure plan only submitted for an existing permitted or non-permitted pit, closed-loop system, below-grade tank, or proposed alternative method

Burlington Resources Oil Gas Company, LP San Juan Basin Closure Report

Lease Name: REESE MESA 7H

API No.: 30-045-35135

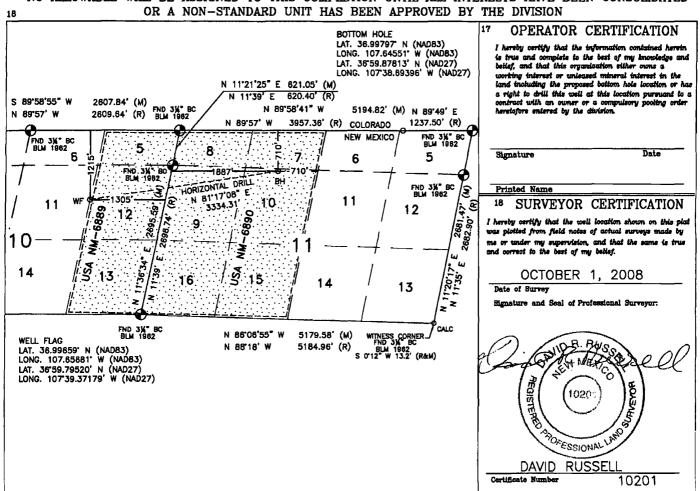
WELL FLAG

LATITUDE: 36.99659°N LONGITUDE: 107.65681°W

CENTER OF PIT

LATITUDE: 36.99659° N LONGITUDE: 107.65651° W ELEVATION: 6989.9' DATUM: NAD83 & NAVD88

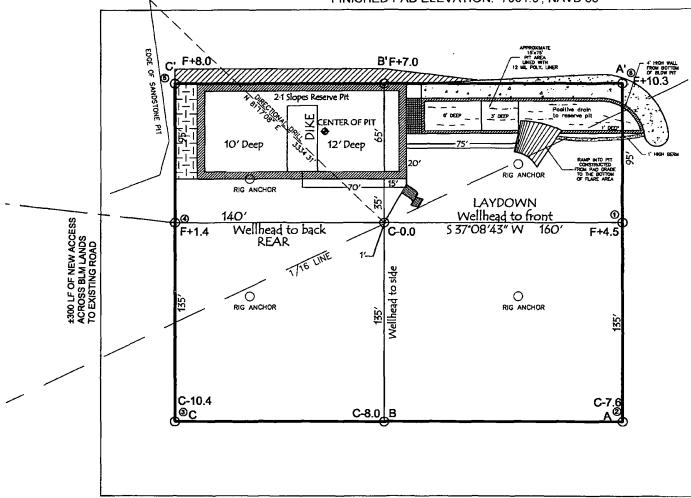
REESE MESA #7 S 1215' FNL & 1305' FEL LOCATED IN THE NW/4 SE/4 OF SECTION 10, T32N, R8W, N.M.P.M.,

SLOPES TO BE CONSTRUCTED TO MATCH THE ORIGINAL CONTOURS AS CLOSE AS POSSIBLE.

NOTE: 330' x 400' = 3.03 ACRES OF DISTURBANCE RESERVE PIT DIKE: TO BE 8' ABOVE DEEP SIDE (OVERFLOW - 3' WIDE AND 1' ABOVE SHALLOW SIDE). SCALE: 1" = 60' RUSSELL SURVEYING, INC. IS NOT LIABLE FOR UNDERGROUND UTILITIES OR PIPELINES. CONTRACTOR SHOULD CALL ONE-CALL FOR LOCATION OF ANY MARKED OR UNMARKED, BURIED PIPELINES OR CABLES ON WELL PAD. IN CONSTRUCTION ZONE AND/OR ACCESS ROAD AT LEAST TWO (2) WORKING DAYS PRIOR TO CONSTRUCTION.
