Pit, Closed-Loop System, Below-Grade Tank, or Proposed Alternative Method Permit or Closure Plan Application

Burlington Resources Oil Gas Company, LP San Juan Basin Closure Report

Lease Name: SAN JUAN 28-6 UNIT 126N

API No.: 30-039-30711

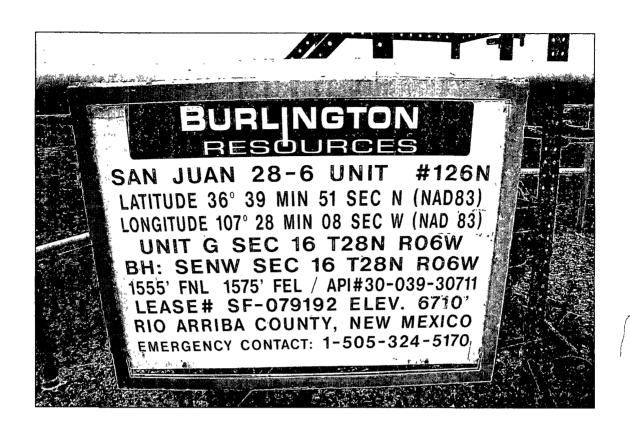
Reclamation Form:
Date: 10/25/2011
Well Name: <u>55 28-6 126ル</u>
Footages: 1555 FNL, 1575 FEL Unit Letter: G
Section: 16, T-28-N, R-6 -W, County: R.A. State: NM
Reclamation Contractor: Riffer
Reclamation Date: 7/11/2011
Road Completion Date: 7/26/2011
Seeding Date: 9/29/2011
O.S. P. P.
**PIT MARKER STATUS (When Required): Picture of Marker set needed
MARKER PLACED: 7/14/2011 (DATE)
LATATUDE:
LONGITUDE:
Pit Manifold removed(DATE)
onstruction Inspector: Norman Faver Date: 10/25/2011
nspector Signature: 11 man fave
fice Use Only: ubtask SM older ctures evised 11/4/10

The pit material passed solidification and testing standards. The pit area was then backfilled with compacted, non-waste containing, earthen material. More than four feet of cover was achieved and the cover included one foot of suitable material to establish vegetation at the site.

The pit area was re-contoured to match fit, shape, line, form and texture of the surrounding area. Reshaping included drainage control, to prevent ponding and erosion. Natural drainages were unimpeded and water bars and/or silt traps were placed in areas where needed to prevent erosion on a large scale. Final recontour has a uniform appearance with smooth surface, fitting the natural landscape.

Provision 15 was accomplished by installing a steel marker in the temporary pit, no less than four inches in diameter, cemented in a hole three feet deep in the center of the onsite burial. The marker is flush with the ground to allow access of the active well pad and for safety concerns. The top of the marker contains a welded steel 12" square plate that indicates the onsite burial of the temporary pit. The plate contains the following: Operator Name, Lease Name, Well Name and number, Unit Number, Section, Township, Range and an indicator that the marker is an onsite burial location.
