Burlington Resources Oil Gas Company, LP San Juan Basin Closure Report

Lease Name: CANYON LARGO UNIT 292F

API No.: 30-039-30952

CANYON LARGO UNIT #292F, 1830' FSL & 1560' FEL SECTION 10, T-25-N, R-6-W, NMPM, RIO ARRIBA COUNTY, NM GROUND ELEVATION: 6712', DATE: MAY 13, 2010

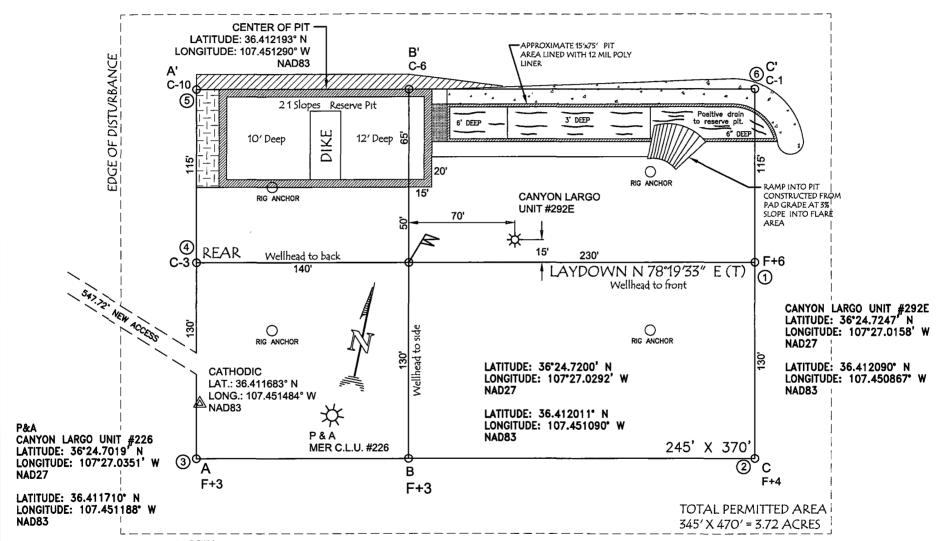
- VECTOR SURVEYS IS NOT LIABLE FOR UNDERGROUND UTILITIES OR PIPELINES. CONTRACTOR SHOULD CALL ONE-CALL FOR LOCATION OF ANY MARKED OR UNMARKED BURIED PIPELINES OR CABLES ON WELL PAD AND OR ACCESS ROAD AT LEAST TWO (2) WORKING DAYS PRIOR TO CONSTRUCTION.
- RESERVE PIT DIKE: TO BE 8' ABOVE DEEP SIDE (OVERFLOW 3' WIDE AND 1' ABOVE SHALLOW SIDE).
