RE: BELOW-GRADE TANK CLOSURE DOCUMENTATION FOR THE RINCON #128M WELL SITE, RIO ARRIBA COUNTY, NEW MEXICO

BELOW GRADE TANK (BGT) CLOSURE PLAN

RINCON #128M WELL SITE
UNIT LETTER P, SECTION 28, TOWNSHIP 27N, RANGE 6W
RIO ARRIBA COUNTY, NEW MEXICO
LATITUDE: N36.5414768° LONGITUDE: W107.4680004°

Site Photography Chevron North America Rincon #128M Well Site Below Grade Tank Closure Project No. 92270-0872 October 3, 2011

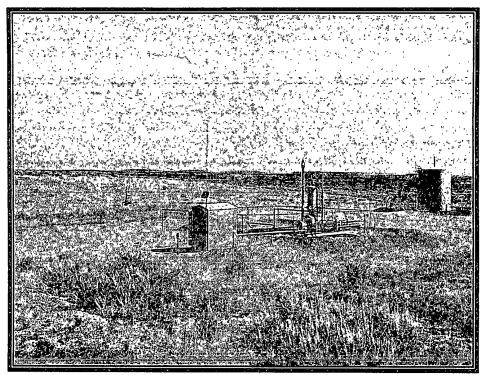
Picture 1: Former Below Grade Tank

- a. <u>Chevron has removed the BGT and associated equipment that will not be reused on-site; see attached Site Photography.</u>

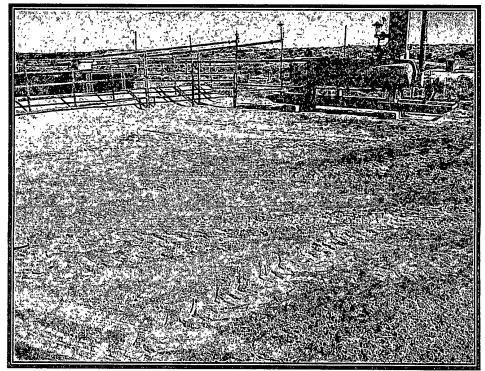
Picture 2: Backfilled Below Grade Tank Pit

- 1. BGT pit was backfilled with clean earthen material in accordance with 19.15.17.13 Subsection E Paragraph (6) NMAC.
 - ii. Upon decommissioning of the well site Chevron North America or a contractor acting on behalf of Chevron will construct a divisonprescribed soil cover, substantially restore, recontour and re-vegetate the site, in accordance with 19.15.17.13 Subsections G, H, and I NMAC.
