Pit, Closed-Loop System, Below-Grade Tank, or Proposed Alternative Method Permit or Closure Plan Application

BP AMERICA PRODUCTION COMPANY
SAN JUAN BASIN, NORTHWEST NEW MEXICO

BELOW-GRADE TANK CLOSURE PLAN

Gallegos Canyon Unit 522
API No. 3004529044
Unit Letter C, Section 22, T29N, R12W

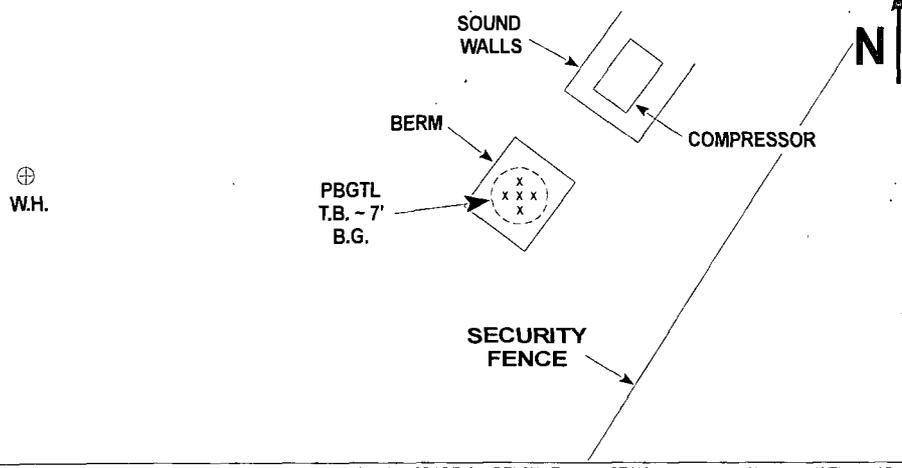
SITE SKETCH	BGT Located: off <input checked="" type="checkbox"/> on site	PLOT PLAN circle: <input checked="" type="checkbox"/> attached	OVM CALIB. READ. = 101.0 ppm	RF = 1.00
			OVM CALIB. GAS = 100 ppm	
			TIME: 3:25 am/pm DATE: 01/21/14

SITE OBSERVATIONS:	LOST INTEGRITY OF EQUIPMENT: YES <input checked="" type="checkbox"/> NO <input type="checkbox"/> EXPLANATION -
APPARENT EVIDENCE OF A RELEASE OBSERVED AND/OR OCCURRED: YES <input checked="" type="checkbox"/> NO <input type="checkbox"/> EXPLANATION:	
EQUIPMENT SET OVER RECLAIMED AREA: <input checked="" type="checkbox"/> YES <input type="checkbox"/> NO EXPLANATION -	95 BBL LP AGT TO BE SET A TOP BGT LOCATION.
OTHER:

SOIL IMPACT DIMENSION ESTIMATION: NA ft. X NA ft. X NA ft.	EXCAVATION ESTIMATION (Cubic Yards): NA
DEPTH TO GROUNDWATER: <50'	NEAREST WATER SOURCE: >1,000' NEAREST SURFACE WATER: <1,000' NMOCD TPH CLOSURE STD: 100 ppm
