Pit, Closed-Loop System, Below-Grade Tank, or
Proposed Alternative Method Permit or Closure Plan Application

BP AMERICA PRODUCTION COMPANY
SAN JUAN BASIN, NORTHWEST NEW MEXICO

BELOW-GRADE TANK CLOSURE PLAN

Lawson LS 1A

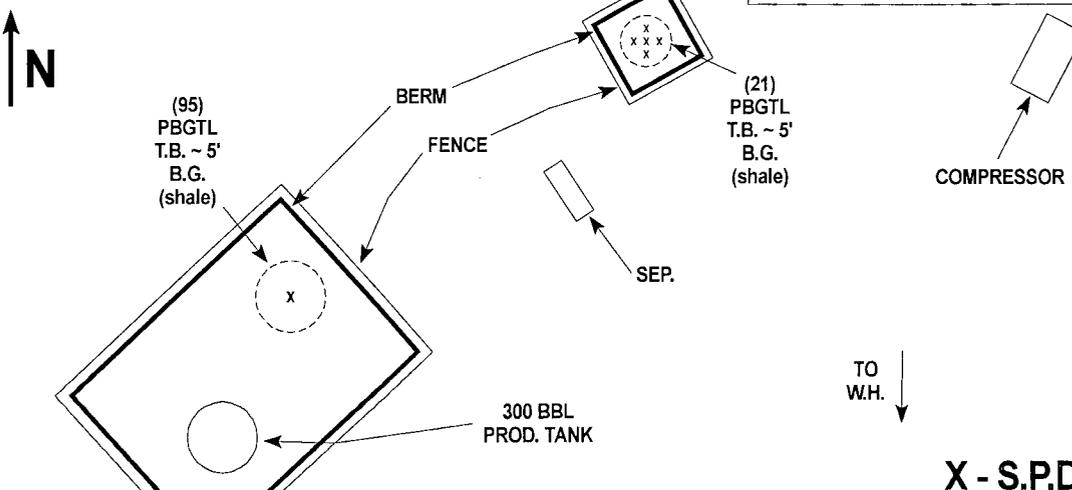
SITE SKETCH

ADDITIONAL COMMENTS: **GRAB SAMPLE COLLECTED FROM BENEATH 95 BBL BGT. 95 BBL BGT SW/DB BEING REPLACED WITH 95 BBL BGT DW/DB.**
