BP AMERICA PRODUCTION COMPANY  
SAN JUAN BASIN, NORTHWEST NEW MEXICO

BELOW-GRADE TANK CLOSURE PLAN

**Moore 11 – Tank B (95 bbl)**  
**API No. 3004526666**  
**Unit Letter E, Section 35, T32N, R11W**

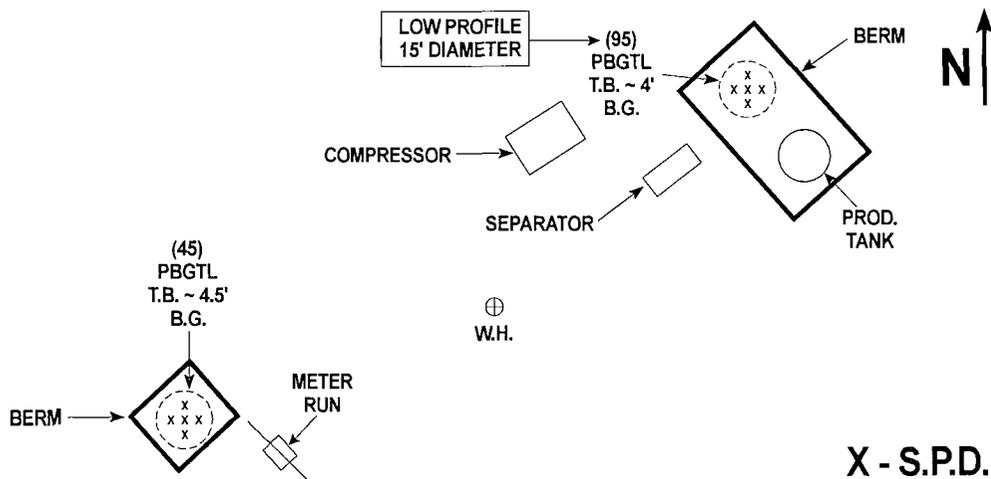
**SITE SKETCH** BGT Located: off  **on** site PLOT PLAN circle:  **attached** OVM CALIB. READ. = **NA** ppm RF = 0.52  
OVM CALIB. GAS = **NA** ppm  
TIME: **NA** am/pm DATE: **NA**

**SOIL DESCRIPTION:** SOIL TYPE: SAND  **SILTY SAND** / SILT  **SILTY CLAY / CLAY** / GRAVEL  **OTHER** /  **BEDROCK (SANDSTONE/SILTSTONE)**  
SOIL COLOR: **MODERATE BROWN TO VERY PALE ORANGE** PLASTICITY (CLAYS): NON PLASTIC / SLIGHTLY PLASTIC  **COHESIVE / MEDIUM PLASTIC** / HIGHLY PLASTIC  
COHESION (ALL OTHERS):  **NON COHESIVE** / SLIGHTLY COHESIVE / COHESIVE / HIGHLY COHESIVE DENSITY (COHESIVE CLAYS & SILTS):  **SOFT / FIRM** / STIFF / VERY STIFF / HARD  
CONSISTENCY (NON COHESIVE SOILS):  **LOOSE / FIRM** / DENSE /  **VERY DENSE** HC ODOR DETECTED: YES  **NO** EXPLANATION -  
MOISTURE: DRY  **SLIGHTLY MOIST** / MOIST  **WET** / SATURATED / SUPER SATURATED  
SAMPLE TYPE: GRAB  **COMPOSITE** # OF PTS. **5** ANY AREAS DISPLAYING WETNESS:  **YES** / NO EXPLANATION - **95 BGT BOTTOM FROM PRECIPITATION.**  
DISCOLORATION/STAINING OBSERVED: YES  **NO** EXPLANATION -

**SITE OBSERVATIONS:** LOST INTEGRITY OF EQUIPMENT: YES  **NO** EXPLANATION -  
APPARENT EVIDENCE OF A RELEASE OBSERVED AND/OR OCCURRED: YES  **NO** EXPLANATION:  
EQUIPMENT SET OVER RECLAIMED AREA:  **YES** / NO EXPLANATION - **LIFT TO BE SET ATOP 95 BGT ONLY.**  
OTHER: **BEDROCK ENCOUNTERED ~ 6 INCHES BENEATH 95 BGT (VERY PALE ORANGE). SOIL COVER SILTY CLAY TO CLAY & WET. SAMPLE COLLECTED FROM BEDROCK SURFACE.**  
SOIL IMPACT DIMENSION ESTIMATION: **NA** ft. X **NA** ft. X **NA** ft. EXCAVATION ESTIMATION (Cubic Yards): **NA**  
DEPTH TO GROUNDWATER: **<100'** NEAREST WATER SOURCE: **>1,000'** NEAREST SURFACE WATER: **<1,000'** NMOCD TPH CLOSURE STD: **100** ppm

**The area under the BGT was backfilled with clean soil. The area over the BGT is covered by the raised compressor pad and is still within the active well area.**
