Pit, Below-Grade Tank, or
Proposed Alternative Method Permit or Closure Plan Application

BELOW-GRADE TANK CLOSURE PLAN

Wallace Gas Com 1A

API No. 3004510168

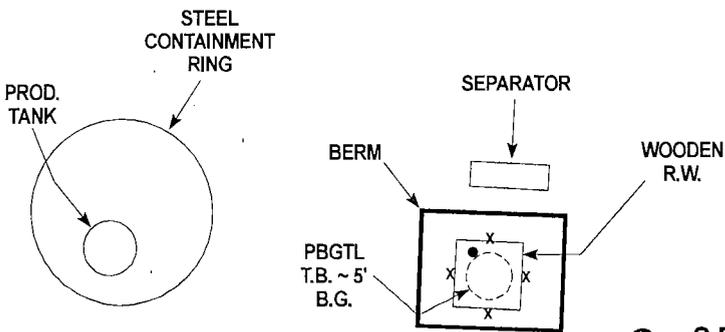
OTHER: **GROUNDWATER OBSERVED MOST LIKELY RESULTED FROM UP AND SIDE GRADIENT IRRIGATION ACTIVITY.**

OVM CALIB. READ. = NA ppm	RF = 0.52
OVM CALIB. GAS = NA ppm	
TIME: NA am/pm	DATE: NA
