Pit, Below-Grade Tank, or
Proposed Alternative Method Permit or Closure Plan Application

BELOW-GRADE TANK CLOSURE PLAN

Jacques 2A

API No. 3004522287

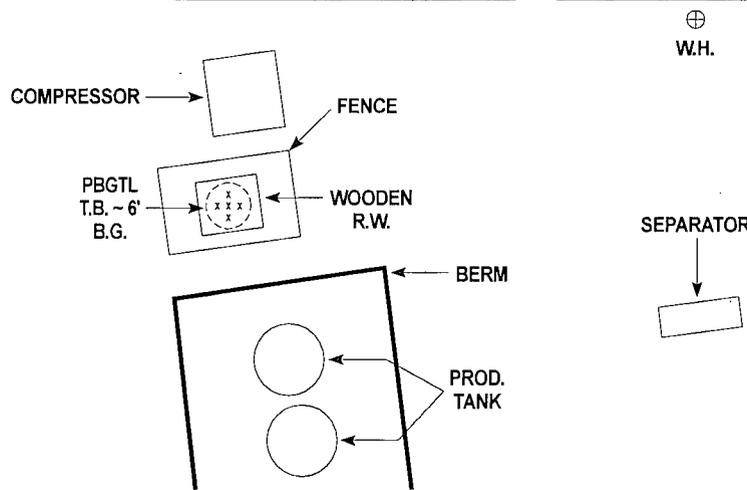
SITE SKETCH	BGT Located: off <input checked="" type="checkbox"/> on site	PLOT PLAN circle: <input checked="" type="checkbox"/> attached	OVM CALIB. READ. = NA ppm RF=0.52
			OVM CALIB. GAS = NA ppm
			TIME: NA am/pm DATE: NA

SITE OBSERVATIONS:	LOST INTEGRITY OF EQUIPMENT: YES <input checked="" type="checkbox"/> NO EXPLANATION -
APPARENT EVIDENCE OF A RELEASE OBSERVED AND/OR OCCURRED: YES <input checked="" type="checkbox"/> NO EXPLANATION:	
EQUIPMENT SET OVER RECLAIMED AREA: <input checked="" type="checkbox"/> YES <input type="checkbox"/> NO EXPLANATION - T-BLOCK LIFT TO BE SET PARTIALLY ATOP BGT POSITION.	
OTHER:

SOIL IMPACT DIMENSION ESTIMATION: NA ft. X NA ft. X NA ft.	EXCAVATION ESTIMATION (Cubic Yards): NA
DEPTH TO GROUNDWATER: <50' NEAREST WATER SOURCE: <1,000' NEAREST SURFACE WATER: <1,000'	NMOCD TPH CLOSURE STD: 100 ppm
