BP AMERICA PRODUCTION COMPANY  
SAN JUAN BASIN, NORTHWEST NEW MEXICO

BELOW-GRADE TANK CLOSURE PLAN

Archuleta Gas Com A 1A  
API No. 3004522297  
Unit Letter J, Section 5, T29N, R9W

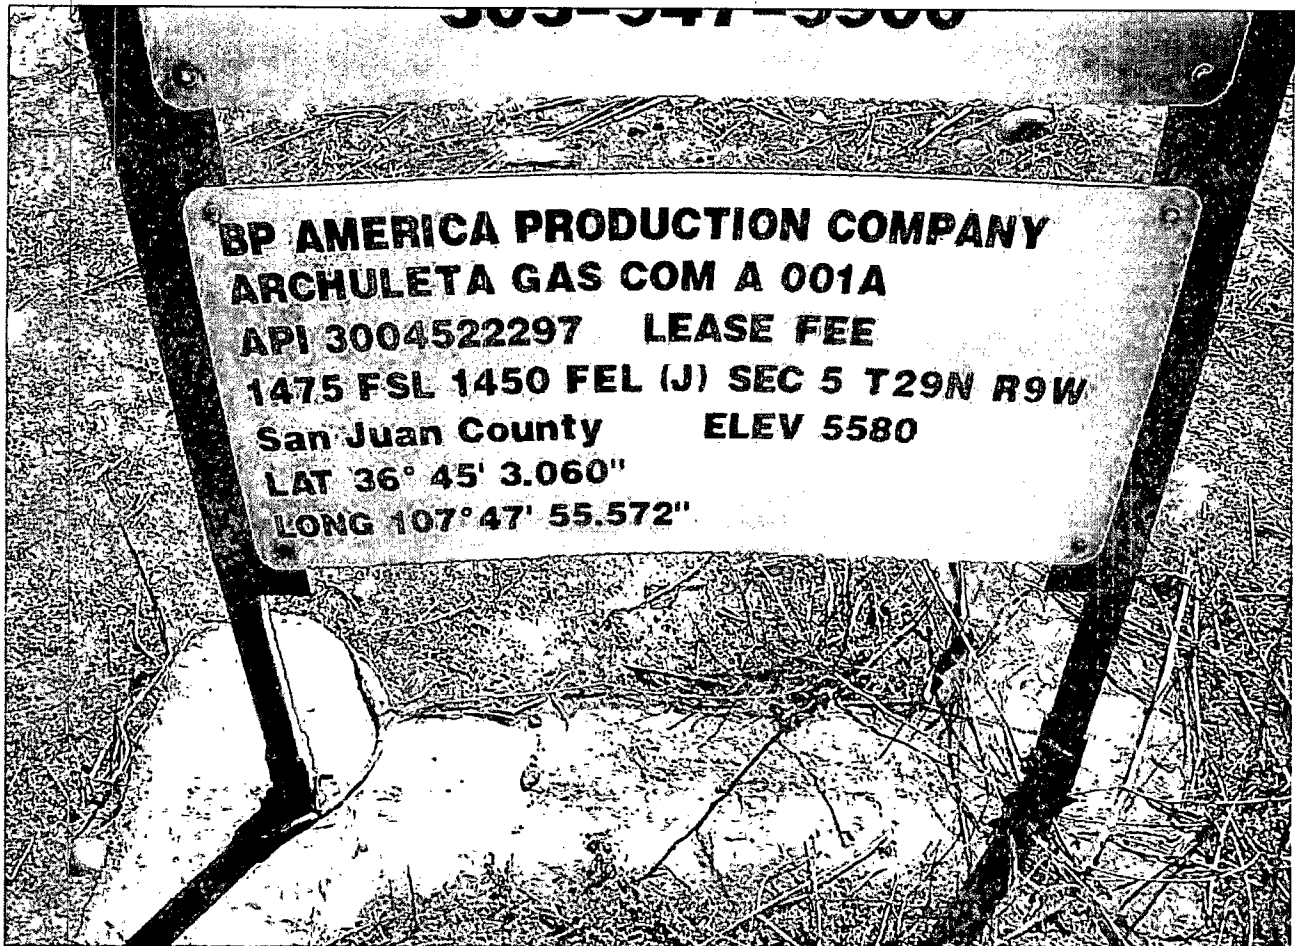
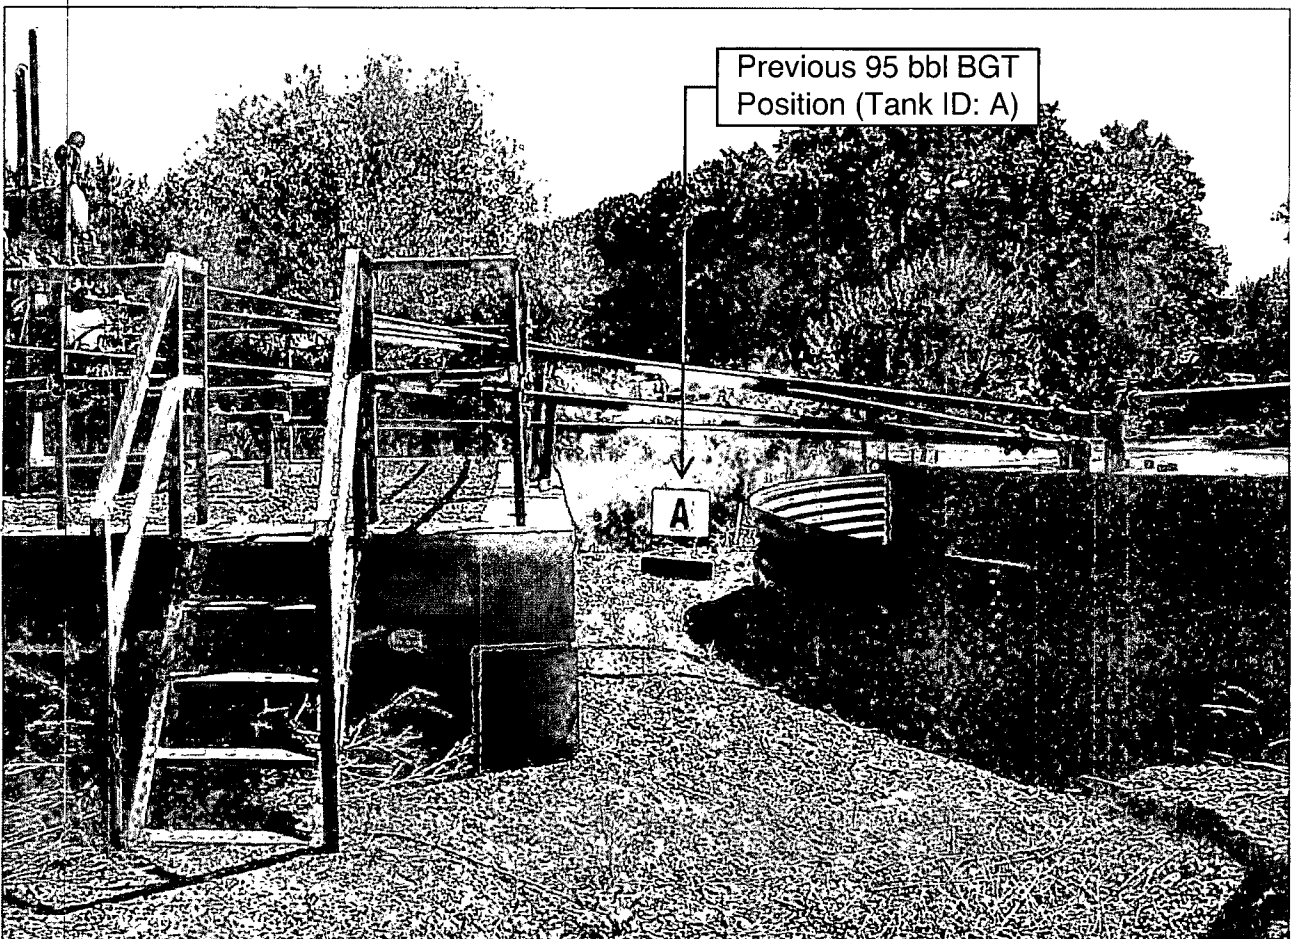
**The area under the BGT was backfilled with clean soil and is still within the active well area.**
10. BP shall reclaim the BGT location and all areas associated with the BGT including associated access roads to a safe and stable condition that blends with the surrounding undisturbed area. BP shall substantially restore the impacted surface area to the condition that existed prior to oil and gas operations by placement of the soil cover as provided in Subsection H of 19.15.17.13 NMAC, re-contour the location and associated areas to a contour that approximates the original contour and blends with the surrounding topography and re-vegetate according to Subsection I of 19.15.17.13 NMAC.

**The area over the BGT is still within the active well area. This area will be reclaimed when the well is plugged and abandoned as part of final reclamation.**
