12403 Proposed Alternative Method Permit or Closure Plan Application **OIL CONS. DIV DIST. 3**

BP AMERICA PRODUCTION COMPANY
SAN JUAN BASIN, NORTHWEST NEW MEXICO

BELOW-GRADE TANK CLOSURE PLAN

Mudge LS 23

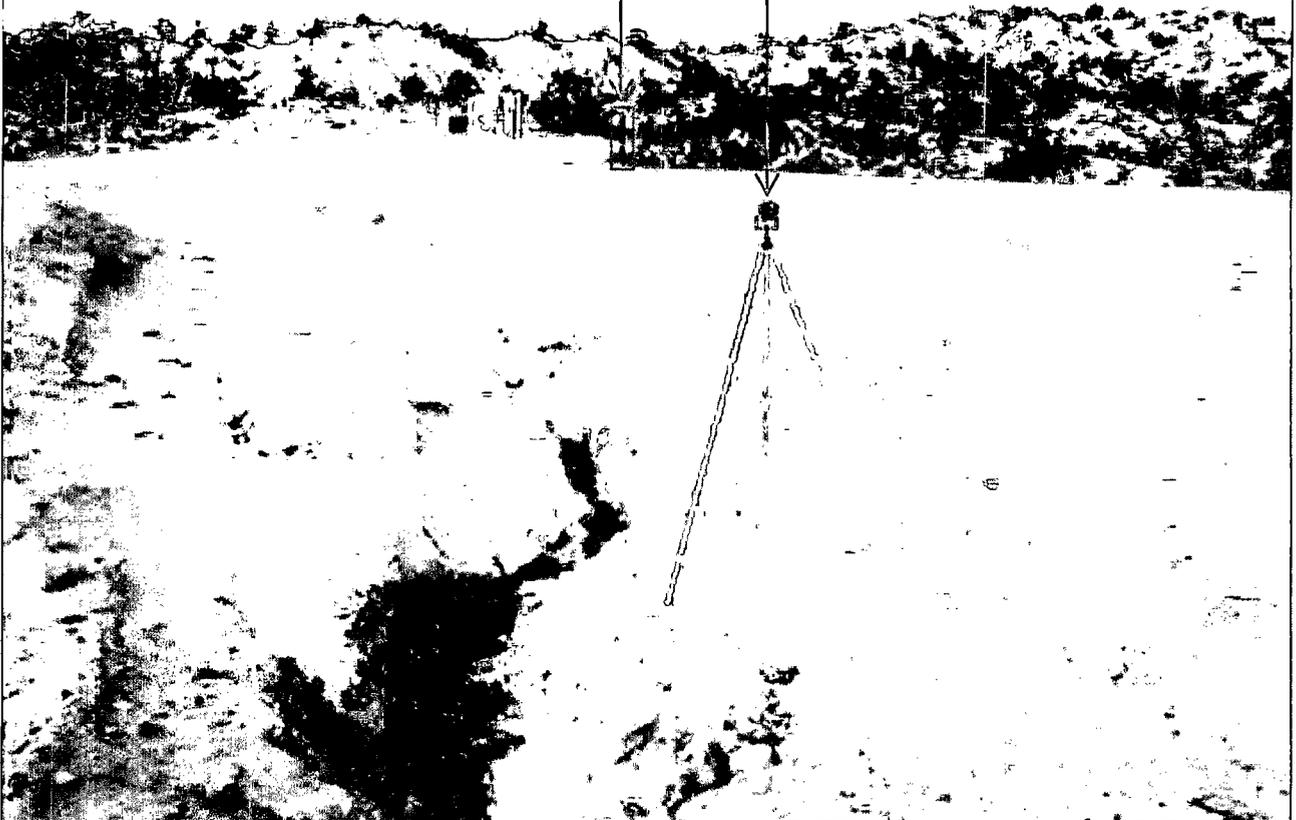
Previous 21 bbl BGT
Position (Tank ID: A)

The BGT was transported to a storage area for sale and re-use.

Soil under the BGT was sampled and TPH, BTEX and chloride levels were below the stated limits. Sampling data is attached.
