Form C-144  
Revised June 6, 2013

BELOW-GRADE TANK CLOSURE PLAN

Canepa Gas Com C 1, BGT Tank A (95 bbl)

API No. 3004520984

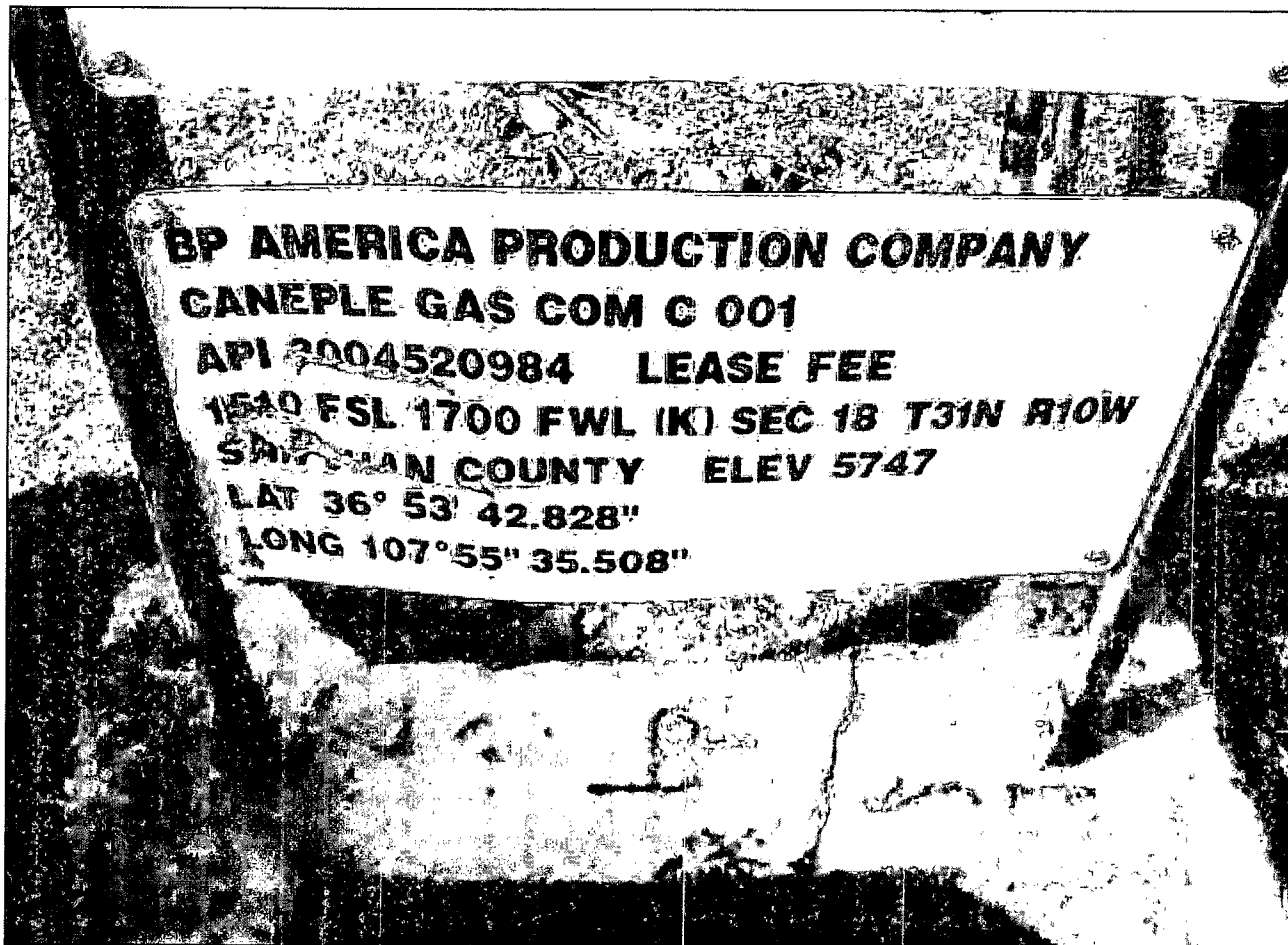
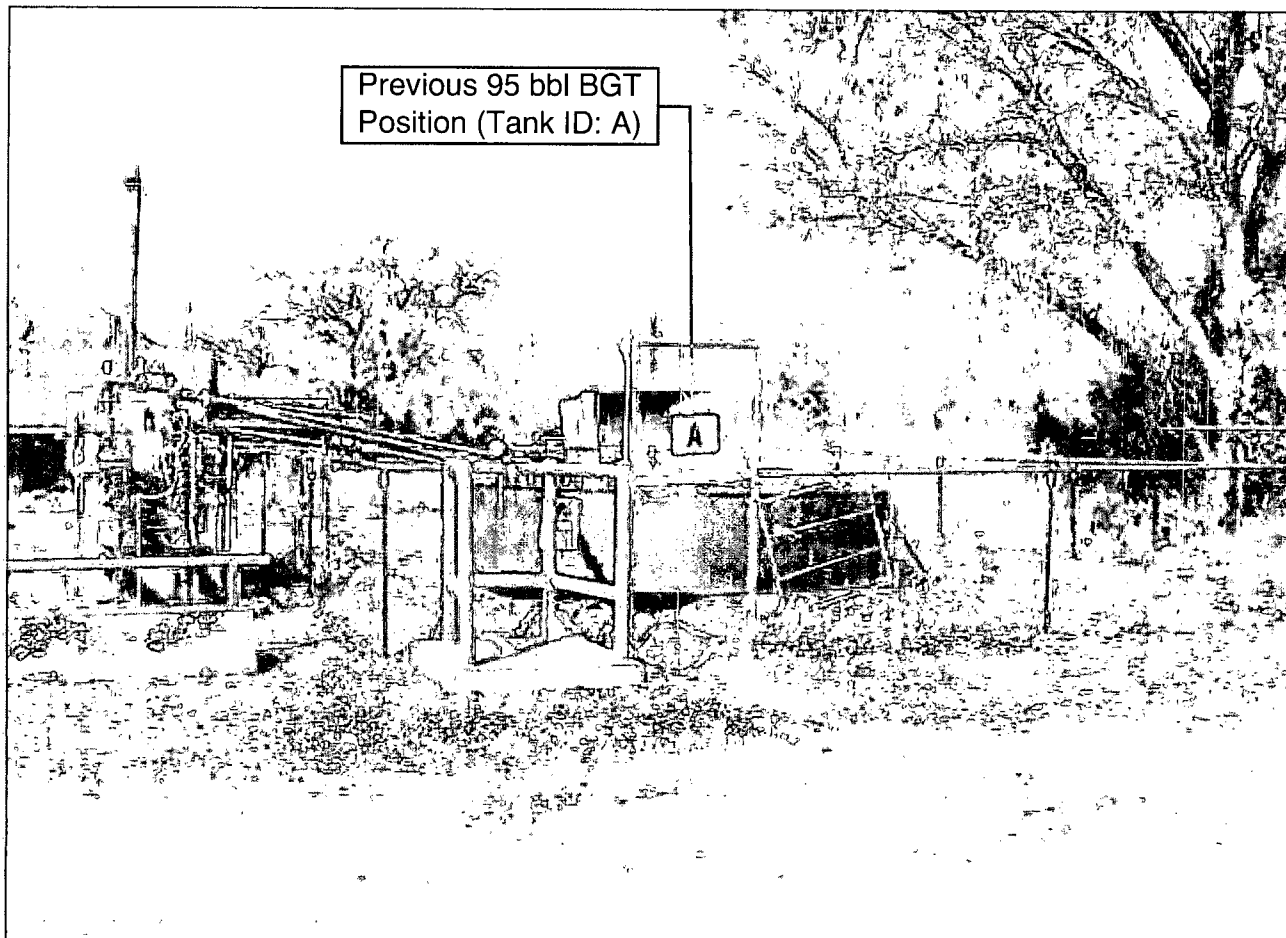
☒ Proof of Closure Notice (surface owner and division)  
☐ Proof of Deed Notice (required for on-site closure for private land only)  
☐ Plot Plan (for on-site closures and temporary pits)  
☒ Confirmation Sampling Analytical Results (if applicable)  
☐ Waste Material Sampling Analytical Results (required for on-site closure)  
☒ Disposal Facility Name and Permit Number  
☒ Soil Backfilling and Cover Installation  
☐ Re-vegetation Application Rates and Seeding Technique  
☒ Site Reclamation (Photo Documentation)

10. BP shall reclaim the BGT location and all areas associated with the BGT including associated access roads to a safe and stable condition that blends with the surrounding undisturbed area. BP shall substantially restore the impacted surface area to the condition that existed prior to oil and gas operations by placement of the soil cover as provided in Subsection H of 19.15.17.13 NMAC, re-contour the location and associated areas to a contour that approximates the original contour and blends with the surrounding topography and re-vegetate according to Subsection I of 19.15.17.13 NMAC.
