BELOW-GRADE TANK CLOSURE PLAN

Gallegos Canyon Unit 124, BGT Tank A (95 bbl)

API No. 3004513076

Unit Letter D, Section 35, T28N, R12W

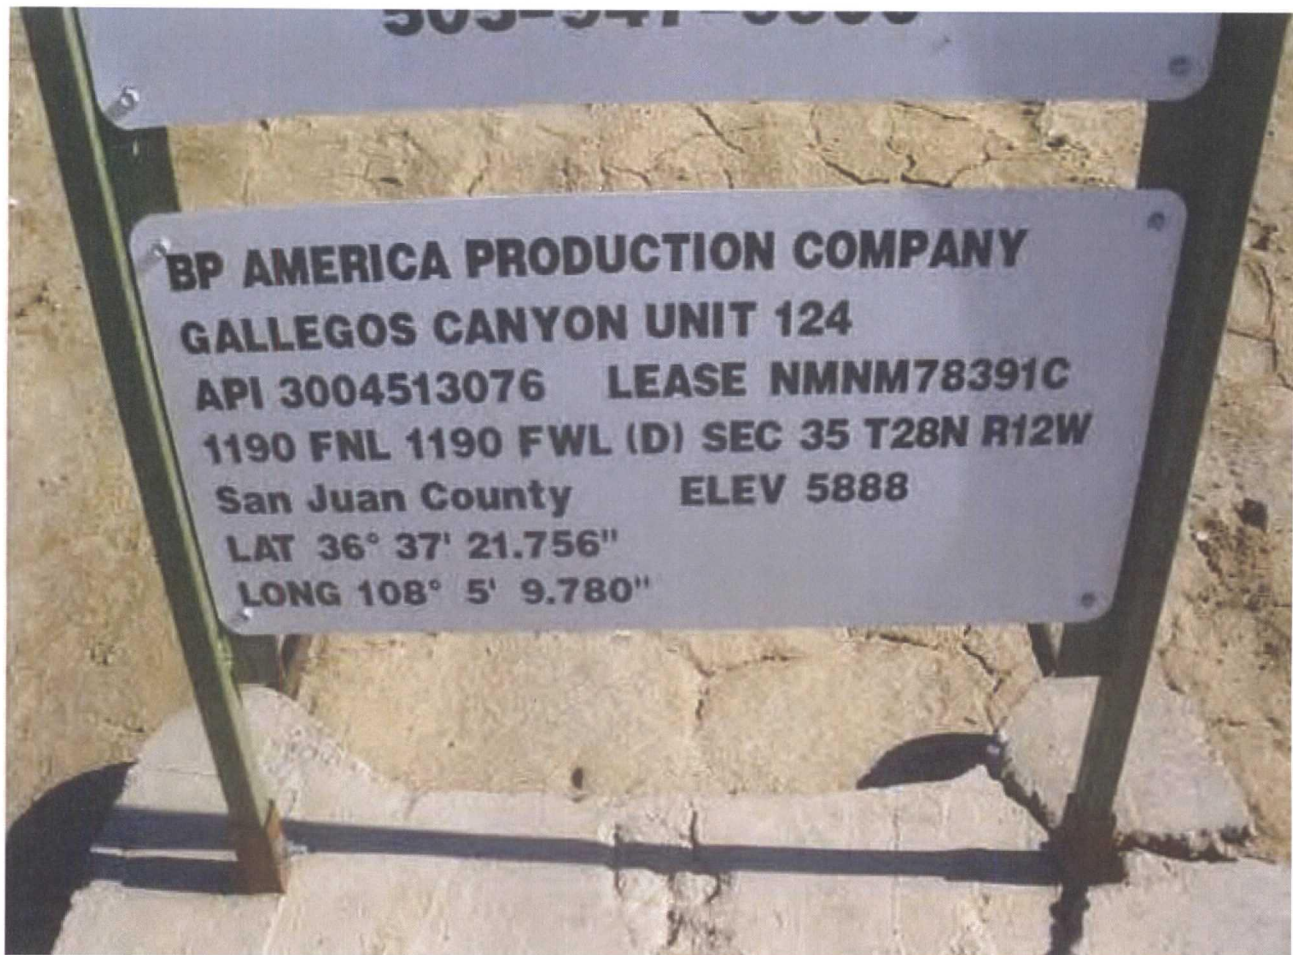
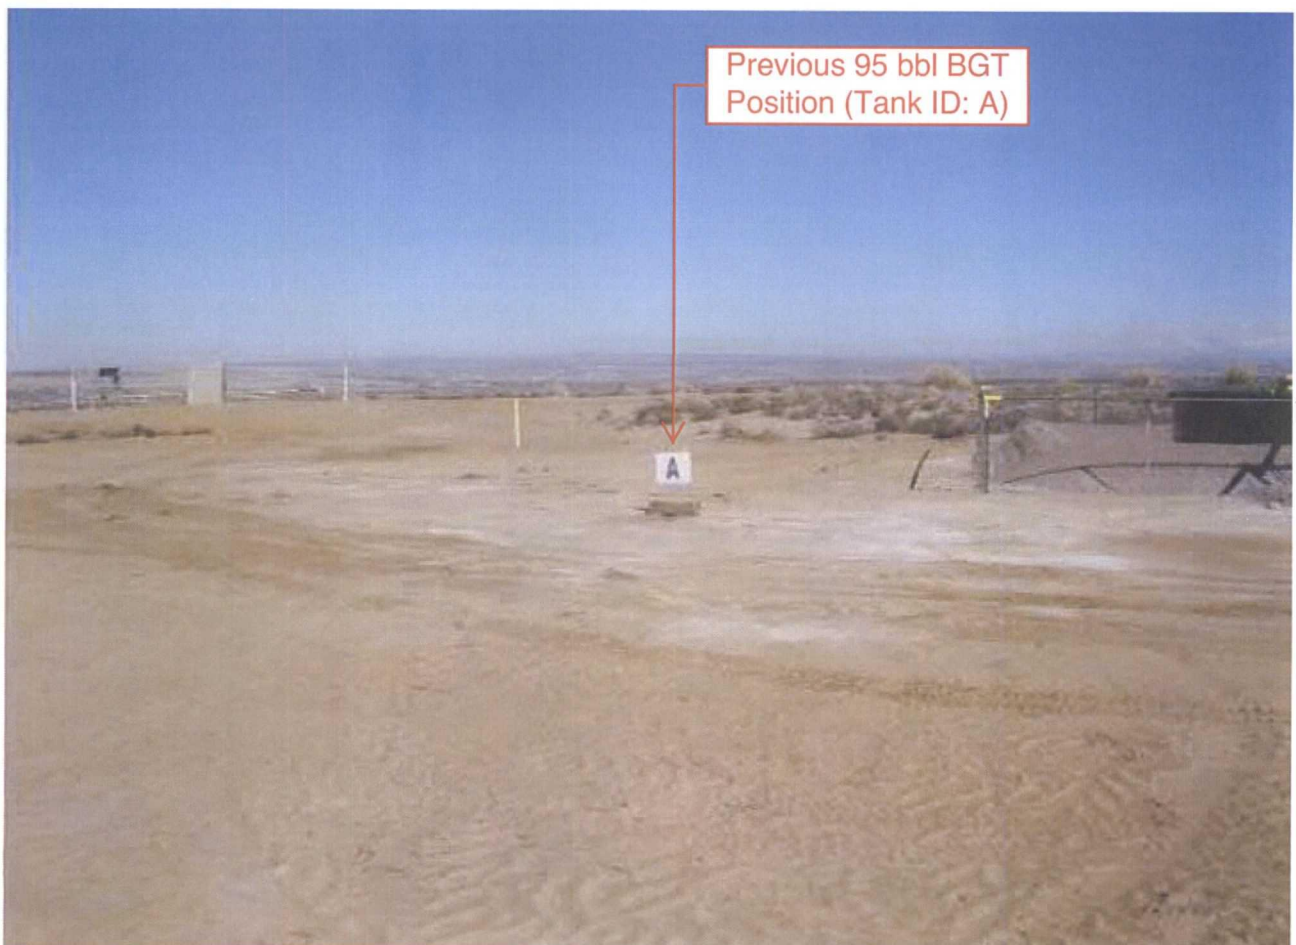
☒ Proof of Closure Notice (surface owner and division)
☐ Proof of Deed Notice (required for on-site closure for private land only)
☐ Plot Plan (for on-site closures and temporary pits)
☒ Confirmation Sampling Analytical Results (if applicable)
☐ Waste Material Sampling Analytical Results (required for on-site closure)
☒ Disposal Facility Name and Permit Number
☒ Soil Backfilling and Cover Installation
☐ Re-vegetation Application Rates and Seeding Technique
☒ Site Reclamation (Photo Documentation)

9. If the sampling demonstrates that a release has not occurred or that any release does not exceed the concentrations specified above, then BP shall backfill the excavation, with compacted, non-waste containing, earthen material; construct a division-prescribed soil cover, re-contour and re-vegetate the location. The location will be reclaimed if it is not within the active process area
The area under the BGT was backfilled with clean soil and is still within the active well area.
