12901 Proposed Alternative Method Permit or Closure Plan Application

BELOW-GRADE TANK CLOSURE PLAN

Gallegos Canyon Unit 326

API No. 3004524616

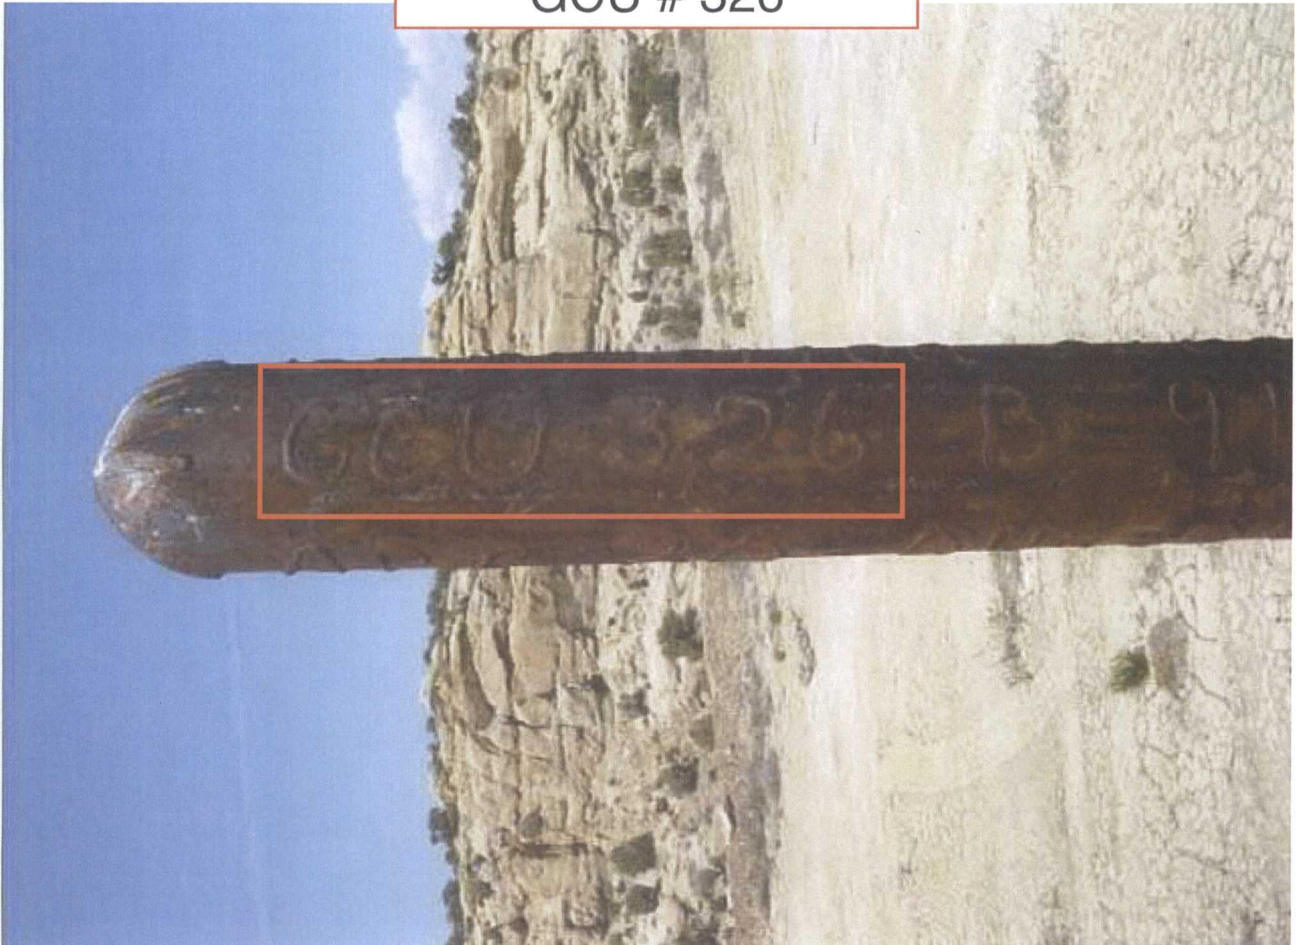
GCU # 326

Plugged &  
Abandoned Marker

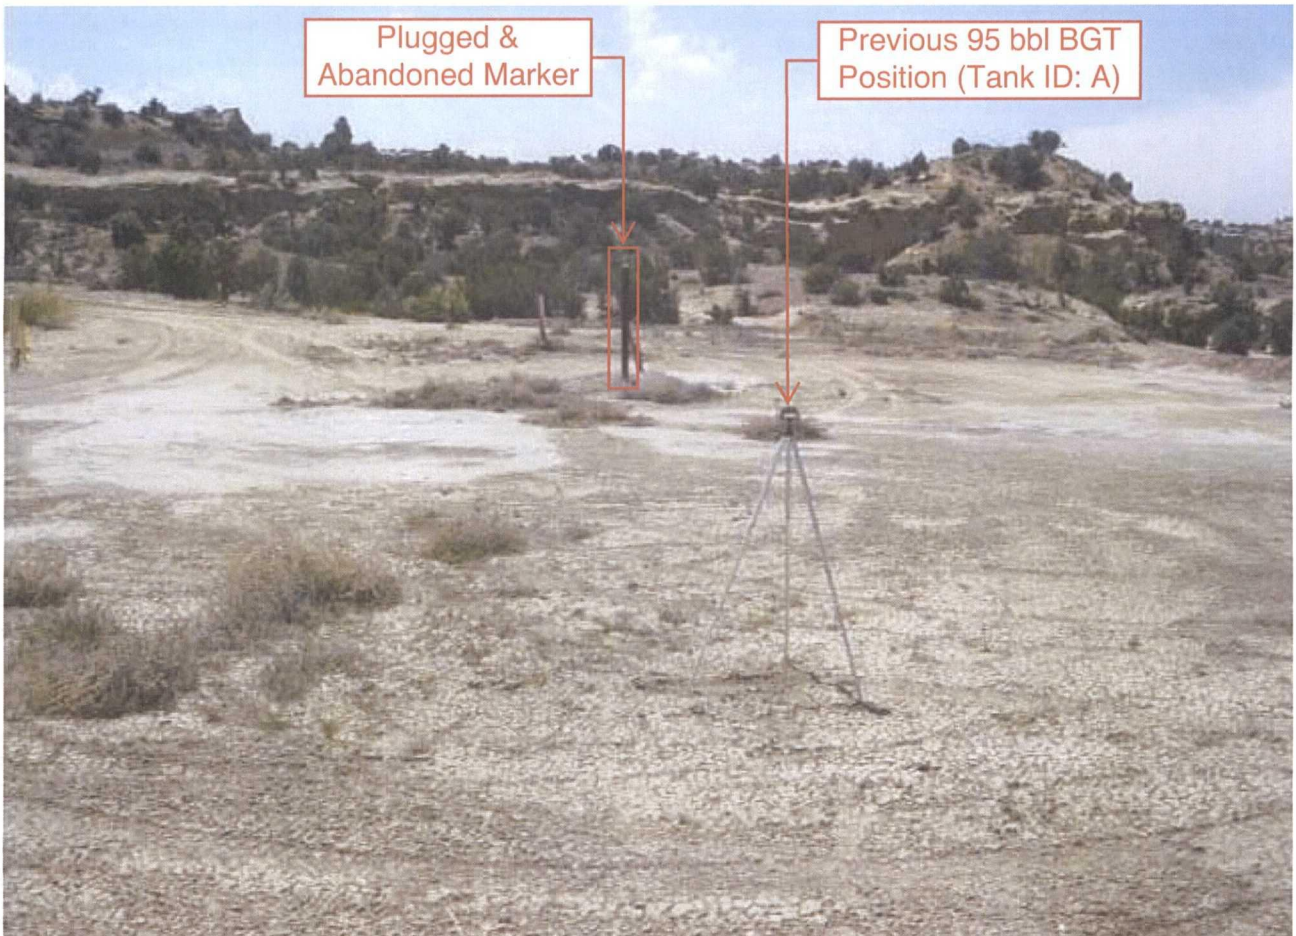
Previous 95 bbl BGT  
Position (Tank ID: A)

**The area under the BGT was backfilled with clean soil and will be reclaimed with the rest of the site since the well has been plugged and abandoned.**
