Proposed Alternative Method Permit or Closure Plan Application

ConocoPhillips Company
San Juan Basin
Below Grade Tank Closure Report

Lease Name: San Juan 29-5 Unit 49A

API No.: 30-039-26542

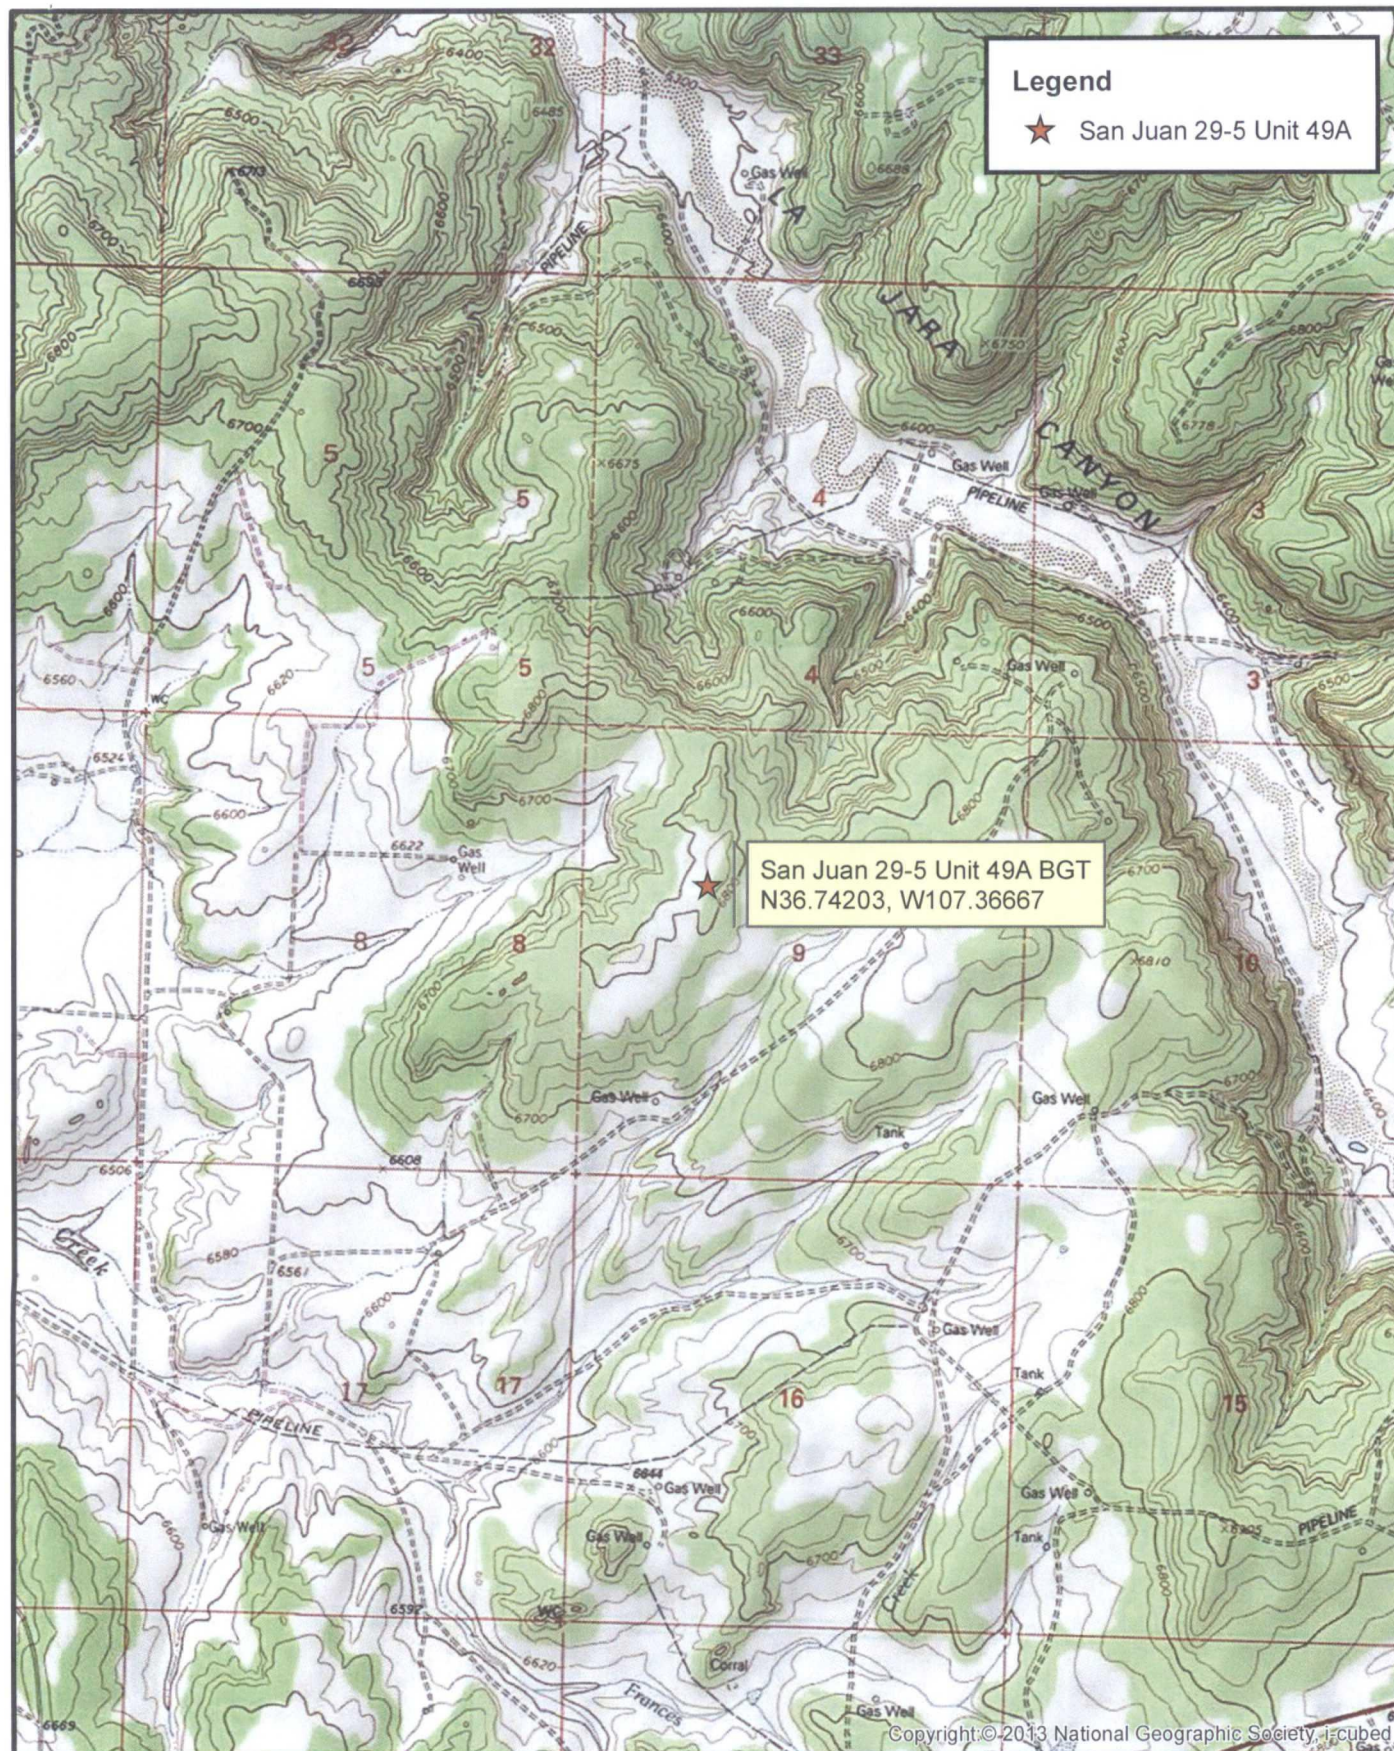
Date: 7/16/2015 File: 150716 San Juan 29-5 Unit 49A Topographic Map Figure: 1

Topographic Map
ConocoPhillips
San Juan 29-5 Unit 49A
API: 30-039-26542

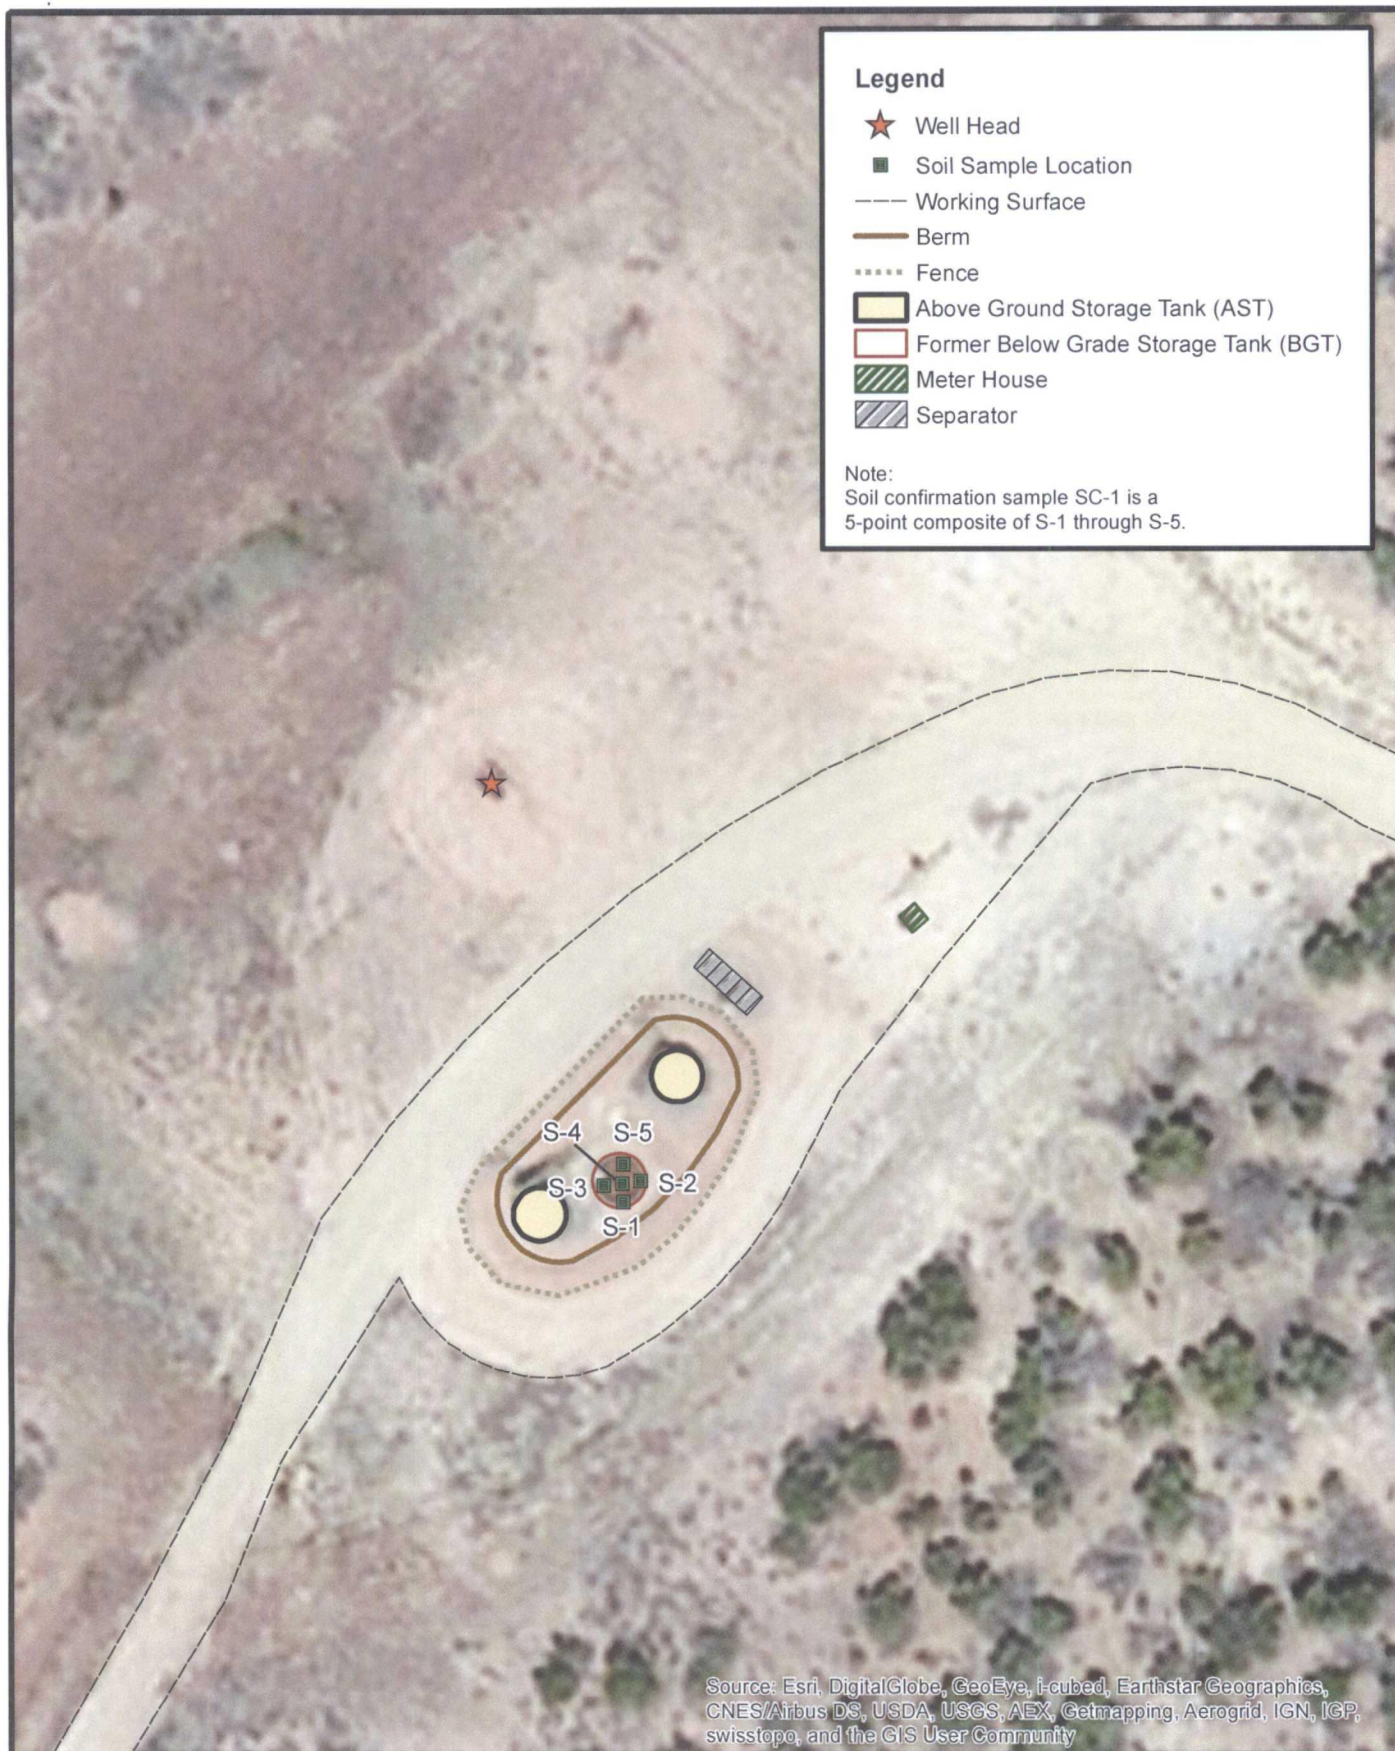
On June 30, 2015, following removal of the BGT tank and gravel, Rule personnel conducted a visual inspection for surface/subsurface indications of a release. No evidence of a release was observed. Rule personnel then collected five soil samples (S-1 through S-5) from 0.5 feet beneath the BGT liner. Figure 2 provides

Observations: No staining or indication of a release. A little damp below tank on NE side.

SC-1 is a 5-point composite of S-1 through S-5, collected 0.5 ft below tank liner.

On June 30, 2015, BGT closure sampling activities were conducted at the ConocoPhillips San Juan 29-5 Unit 49A. Field and laboratory results for sample SC-1 were reported below the BGT closure standards for benzene, total BTEX, TPH, and chlorides as outlined in 19.15.17.13.NMAC. Based on field sampling and laboratory analytical results, no release occurred from the BGT and no further work is recommended.
