Proposed Alternative Method Permit or Closure Plan Application

1.
Operator: BP America Production Company OGRID #: 778
Address: 200 Energy Court, Farmington, NM 87401
Facility or well name: Florance Gas Com K 3
API Number: 3004527882 OCD Permit Number: _____
U/L or Qtr/Qtr B Section 22 Township 30N Range 9W County: San Juan
Center of Proposed Design: Latitude 36.80064 Longitude -107.76506 NAD: 1927 1983
Surface Owner: Federal State Private Tribal Trust or Indian Allotment

Closure Report (required within 60 days of closure completion): 19.15.17.13 NMAC

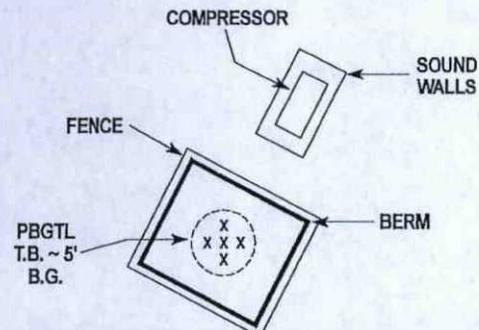
SITE SKETCH	BGT Located : off / <input checked="" type="checkbox"/> on site	PLOT PLAN circle: <input checked="" type="checkbox"/> attached	OVM CALIB. READ. = NA ppm RF=0.52
			OVM CALIB. GAS = NA ppm
			TIME: NA am/pm DATE: NA

X - S.P.D.

Describe Cause of Problem and Remedial Action Taken. *Sampling of the soil beneath the BGT was performed during removal to ensure no soil impacts from the BGT. Soil analysis resulted in TPH, BTEX and chloride concentrations below soil remediation guidelines. Analytical results are attached. Note this is a subsequent report including an extended range of organic compounds not included in the previous submission.

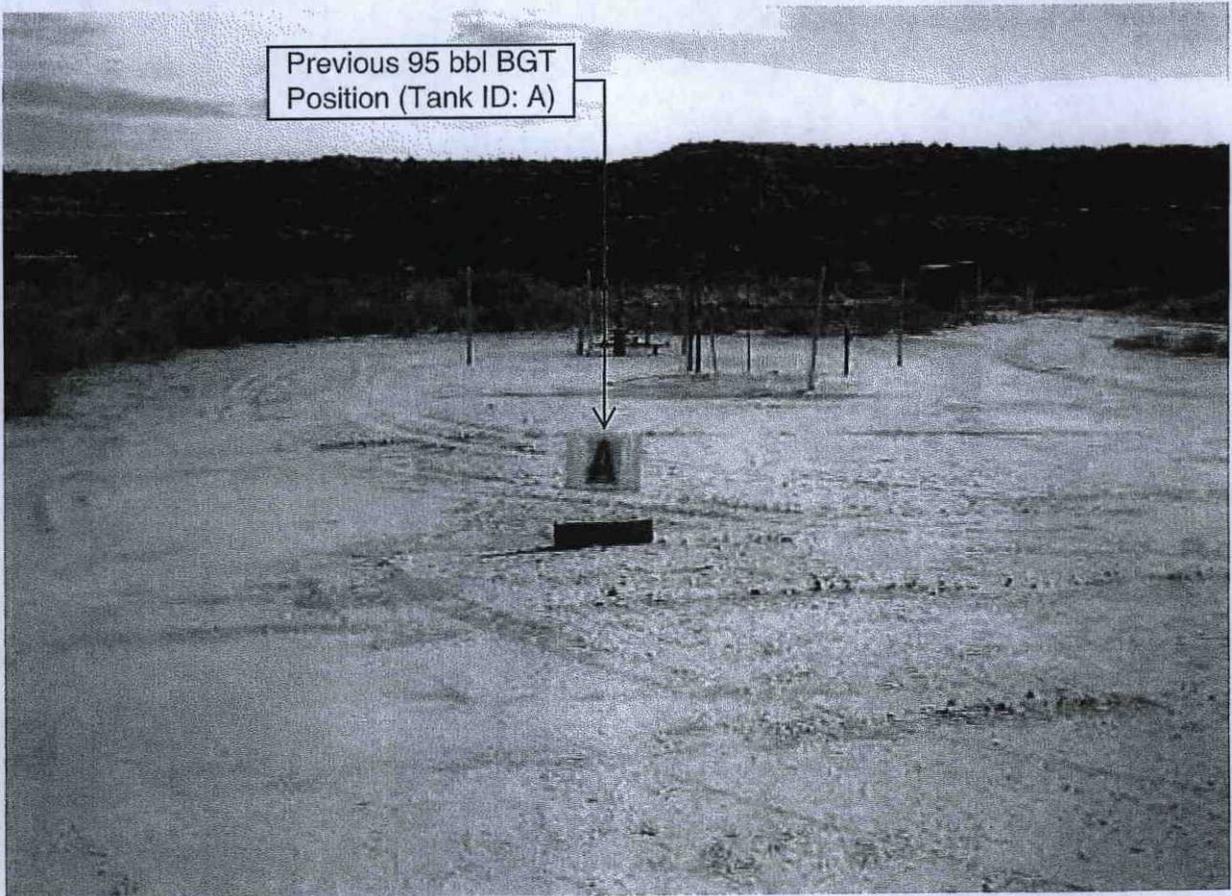
LAT 36° 48' 2.850"

LONG 107° 45' 53.757"

Previous 95 bbl BGT
Position (Tank ID: A)
