BP AMERICA PRODUCTION COMPANY  
SAN JUAN BASIN, NORTHWEST NEW MEXICO

BELOW-GRADE TANK CLOSURE PLAN

Gallegos Canyon Unit #034

API No. 3004507144

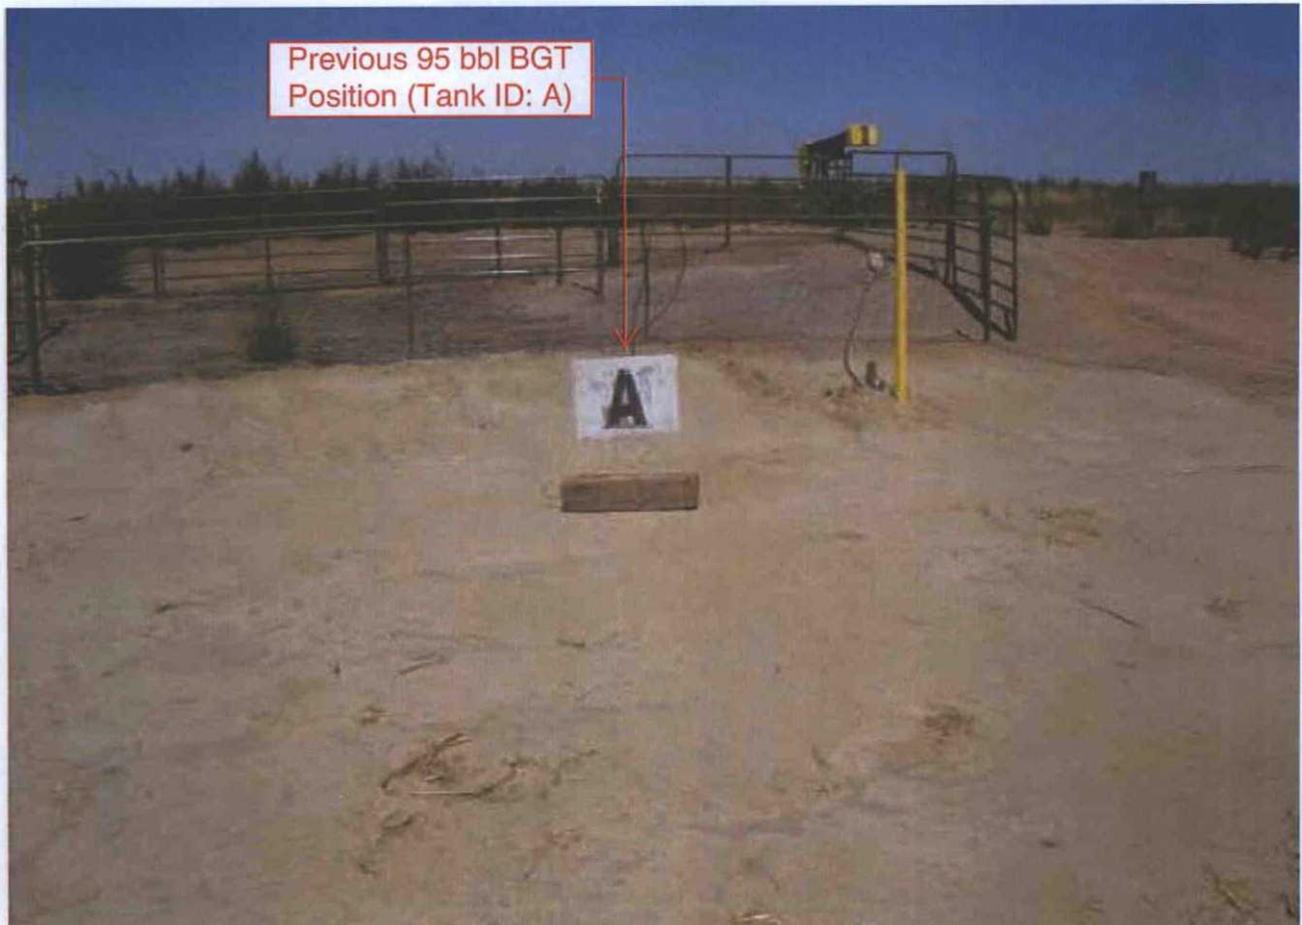
Previous 95 bbl BGT  
Position (Tank ID: A)
