14206 Proposed Alternative Method Permit or Closure Plan Application

BELOW-GRADE TANK CLOSURE PLAN

Gallegos Canyon Unit #233E

API No. 3004526210

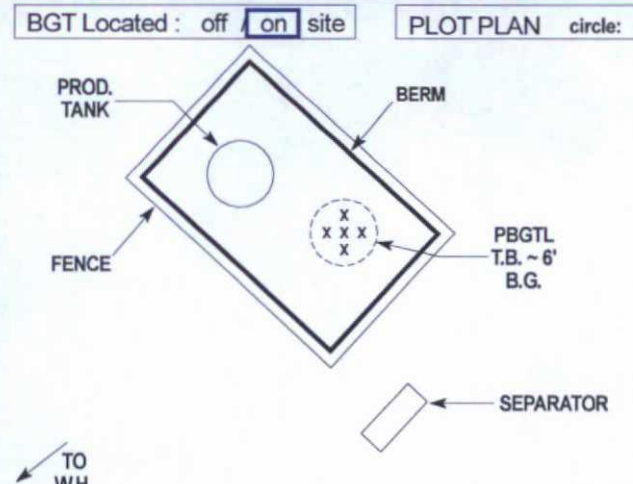
REFERENCE POINT: WELL HEAD (W.H.) GPS COORD.: <b>36.63111 X 108.09647</b> GL ELEV.: <b>5,778'</b> 1) <b>95 BGT (DW/DB)</b> GPS COORD.: <b>36.63136 X 108.09604</b> DISTANCE/BEARING FROM W.H.: <b>153', N53E</b> 2) _____ GPS COORD.: _____ DISTANCE/BEARING FROM W.H.: _____ 3) _____ GPS COORD.: _____ DISTANCE/BEARING FROM W.H.: _____ 4) _____ GPS COORD.: _____ DISTANCE/BEARING FROM W.H.: _____		
SAMPLING DATA: CHAIN OF CUSTODY RECORD(S) # OR LAB USED: <b>HALL</b> 1) SAMPLE ID: <b>5PC - TB @ 5' (95)</b> SAMPLE DATE: <b>01/15/16</b> SAMPLE TIME: <b>0910</b> LAB ANALYSIS: <b>8015B/8021B/300.0 (CI)</b> 2) SAMPLE ID: _____ SAMPLE DATE: _____ SAMPLE TIME: _____ LAB ANALYSIS: _____ 3) SAMPLE ID: _____ SAMPLE DATE: _____ SAMPLE TIME: _____ LAB ANALYSIS: _____ 4) SAMPLE ID: _____ SAMPLE DATE: _____ SAMPLE TIME: _____ LAB ANALYSIS: _____		OVM READING (ppm)  <b>NA</b>
SOIL DESCRIPTION: SOIL TYPE: <input checked="" type="checkbox"/> SAND / <input checked="" type="checkbox"/> SILTY SAND / <input type="checkbox"/> SILT / <input type="checkbox"/> SILTY CLAY / <input type="checkbox"/> CLAY / <input type="checkbox"/> GRAVEL / <input type="checkbox"/> OTHER _____ SOIL COLOR: <b>DARK YELLOWISH ORANGE</b> COHESION (ALL OTHERS): <input checked="" type="checkbox"/> NON COHESIVE / <input type="checkbox"/> SLIGHTLY COHESIVE / <input type="checkbox"/> COHESIVE / <input type="checkbox"/> HIGHLY COHESIVE CONSISTENCY (NON COHESIVE SOILS): <input checked="" type="checkbox"/> LOOSE / <input checked="" type="checkbox"/> FIRM / <input type="checkbox"/> DENSE / <input type="checkbox"/> VERY DENSE MOISTURE: DRY / <input checked="" type="checkbox"/> SLIGHTLY MOIST / <input type="checkbox"/> MOIST / <input type="checkbox"/> WET / <input type="checkbox"/> SATURATED / <input type="checkbox"/> SUPER SATURATED SAMPLE TYPE: GRAB / <input checked="" type="checkbox"/> COMPOSITE # OF PTS. <b>5</b> DISCOLORATION/STAINING OBSERVED: YES <input checked="" type="checkbox"/> NO <input type="checkbox"/> EXPLANATION - _____ PLASTICITY (CLAYS): NON PLASTIC / SLIGHTLY PLASTIC / COHESIVE / MEDIUM PLASTIC / HIGHLY PLASTIC DENSITY (COHESIVE CLAYS & SILTS): SOFT / FIRM / STIFF / VERY STIFF / HARD HC ODOR DETECTED: YES <input checked="" type="checkbox"/> NO <input type="checkbox"/> EXPLANATION - _____ ANY AREAS DISPLAYING WETNESS: YES <input checked="" type="checkbox"/> NO <input type="checkbox"/> EXPLANATION - _____

SITE OBSERVATIONS: LOST INTEGRITY OF EQUIPMENT: YES <input checked="" type="checkbox"/> NO <input type="checkbox"/> EXPLANATION - _____ APPARENT EVIDENCE OF A RELEASE OBSERVED AND/OR OCCURRED: YES <input checked="" type="checkbox"/> NO <input type="checkbox"/> EXPLANATION: _____ EQUIPMENT SET OVER RECLAIMED AREA: YES <input checked="" type="checkbox"/> NO <input type="checkbox"/> EXPLANATION - _____ OTHER: _____		
SOIL IMPACT DIMENSION ESTIMATION: <b>NA</b> ft. X <b>NA</b> ft. X <b>NA</b> ft. EXCAVATION ESTIMATION (Cubic Yards): <b>NA</b> DEPTH TO GROUNDWATER: <b>&lt;50'</b> NEAREST WATER SOURCE: <b>&gt;1,000'</b> NEAREST SURFACE WATER: <b>&lt;1,000'</b> NIMOCOD TPH CLOSURE STD: <b>100</b> ppm		
SITE SKETCH BGT Located : off / <input checked="" type="checkbox"/> on site PLOT PLAN circle: <input checked="" type="checkbox"/> attached

NOTES: BGT = BELOW-GRADE TANK; E.D. = EXCAVATION DEPRESSION; B.G. = BELOW GRADE; B = BELOW; T.H. = TEST HOLE; ~ = APPROX.; W.H. = WELL HEAD; T.B. = TANK BOTTOM; PBGTL = PREVIOUS BELOW-GRADE TANK LOCATION; SPD = SAMPLE POINT DESIGNATION; R.W. = RETAINING WALL; NA = NOT APPLICABLE OR NOT AVAILABLE; SW - SINGLE WALL; DW - DOUBLE WALL; SB - SINGLE BOTTOM; DB - DOUBLE BOTTOM.		MISCELL. NOTES WO: REF #: <b>P - 267</b> VID: <b>VHIX0NEVB2</b> PJ #: Permit date(s): <b>06/08/10</b> OCD Appr. date(s): <b>11/25/15</b> Tank ID: <b>A</b> OVM = Organic Vapor Meter ppm = parts per million BGT Sidewalls Visible: Y / <input checked="" type="checkbox"/> N BGT Sidewalls Visible: Y / N BGT Sidewalls Visible: Y / N Magnetic declination: <b>10° E</b>

NOTES: <b>GOOGLE EARTH IMAGERY DATE: 03/15/2015.</b> ONSITE: <b>01/15/16</b>
