14492 Pit, Below-Grade Tank, or
Proposed Alternative Method Permit or Closure Plan Application OIL CONS. DIV DIST. 3

BELOW-GRADE TANK CLOSURE PLAN

Florance Gas Com I 013

API No. 3004509541

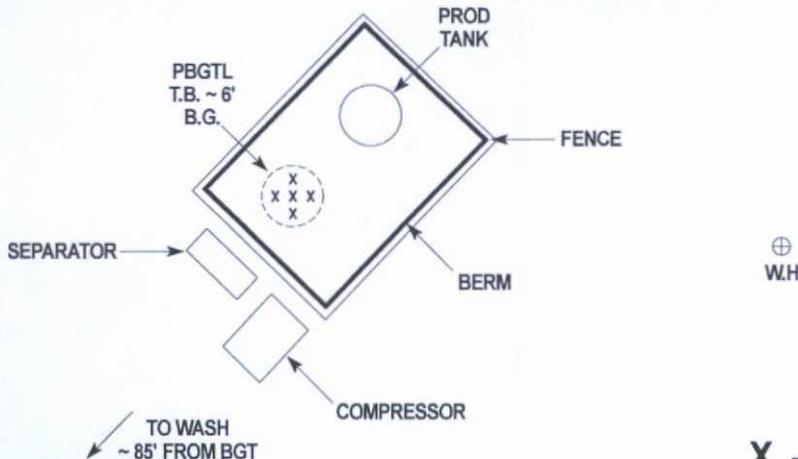
PLOT PLAN circle: **attached**

OVM CALIB. READ. = **100.2** ppm RF=0.52
OVM CALIB. GAS = **100** ppm
TIME: **10:10** (am/pm) DATE: **03/31/16**
