Release Notification and Corrective Action

Name of Company WPX Energy Production	Contact Deborah Watson	
Address PO Box 640	Telephone No. 505-386-9693	
Facility Name Rosa Unit # 379	Facility Type Well Site	
Surface Owner Federal	Mineral Owner Federal	API No. 30-039-26949

Rosa Unit #379 Produced Water Release Report
Unit Letter K, Section 8, Township 31N, Range 5W
Rio Arriba County, NM

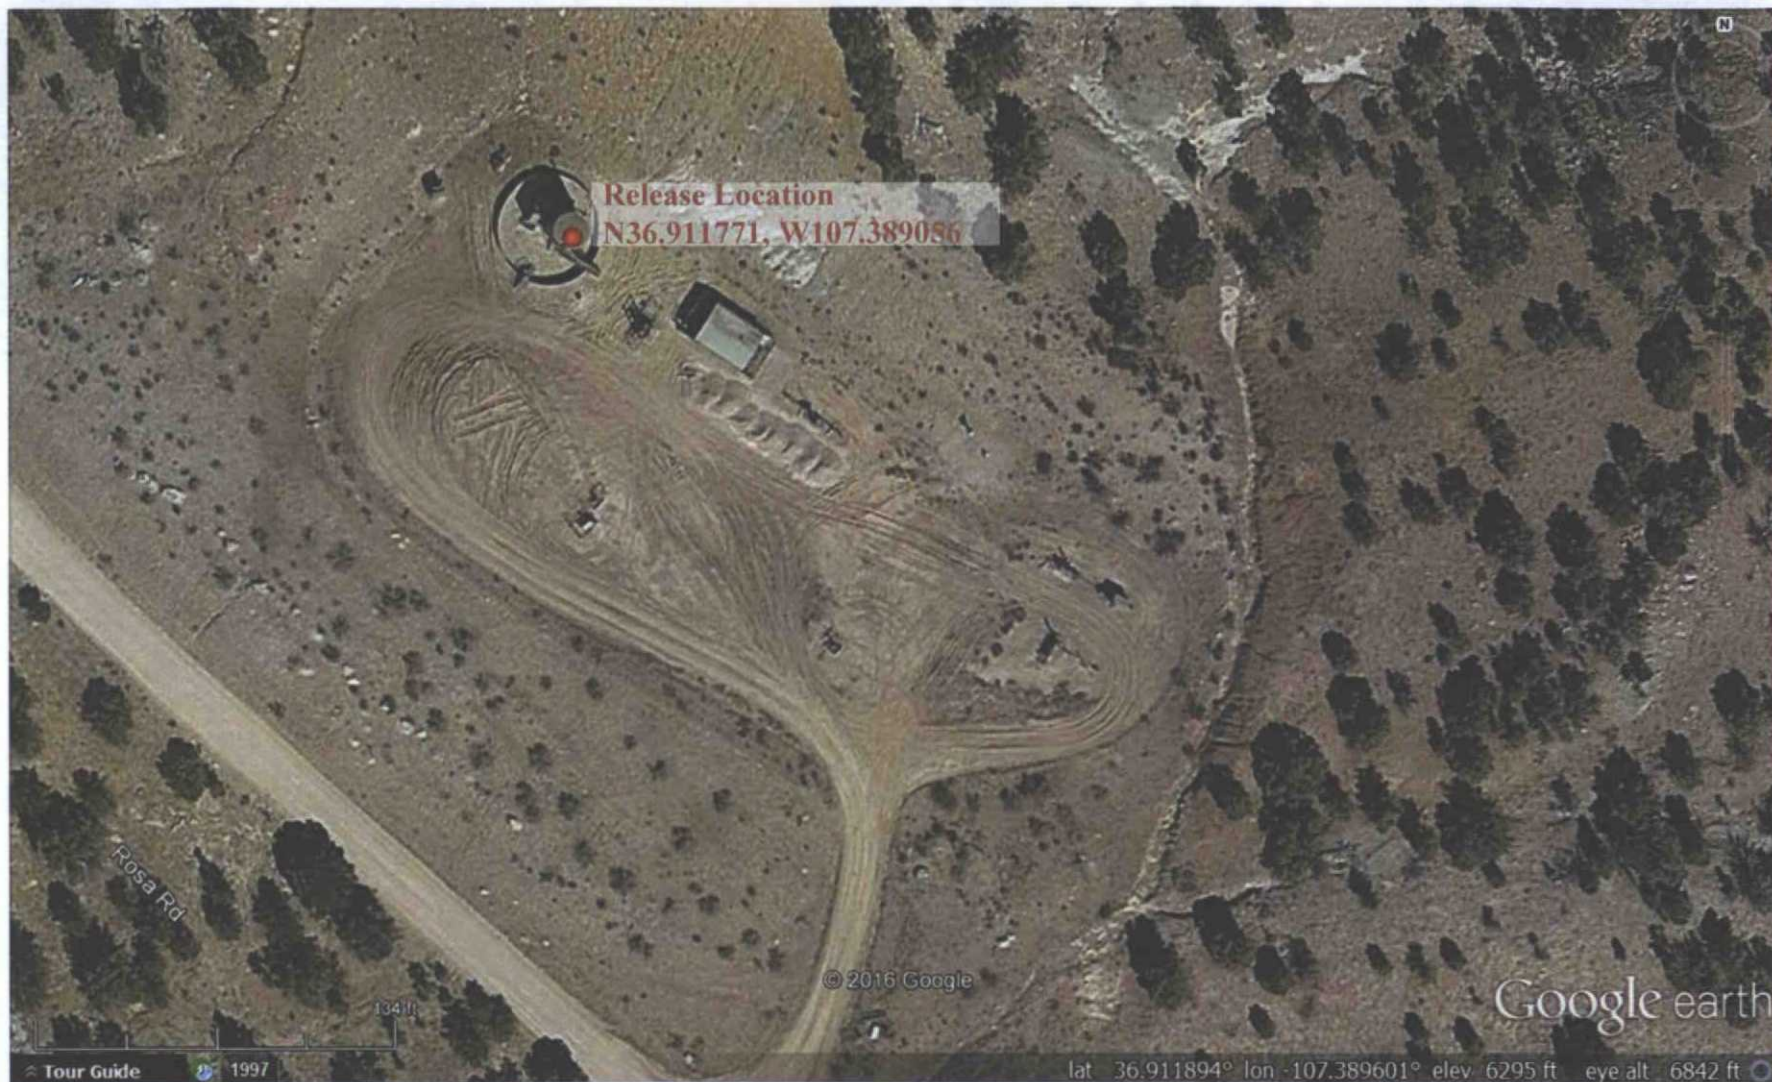
**Figure 2. Aerial Photograph
December 2015 and February 2016
Rosa Unit #379 Produced Water Release
Section 8, Township 31N, Range 5W
N36.9113846, W107.3889694
Rio Arriba County, NM**

On February 11, 2016, an estimated 200 barrels of produced water overflowed the production tank at the Rosa Unit #379 due to a fault which shut down the transfer pump. On February 11, 2016, the source of the release was stopped, the fault cleared, and the transfer pump returned to operation. A water truck was called to the location and an estimated 195 barrels of produced water was recovered from within secondary containment. All fluids remained within secondary containment and on location.

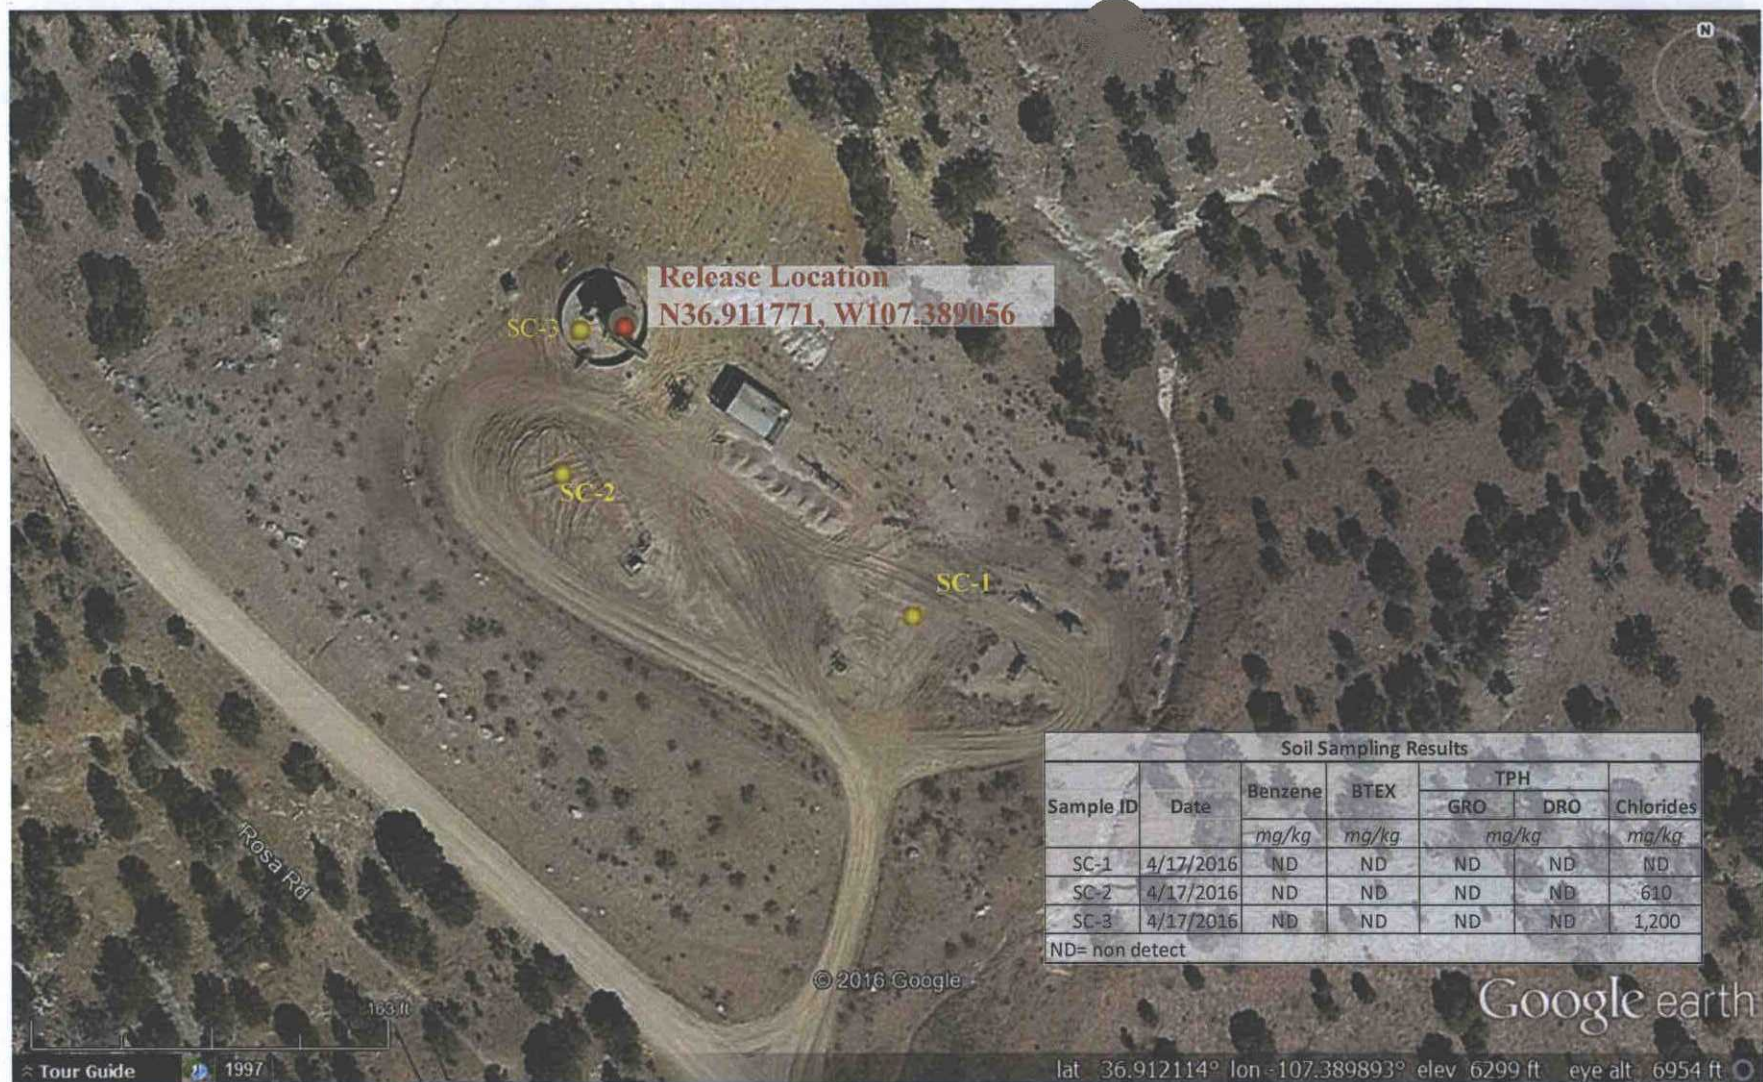
Figure 3. Soil Analytical Map
December 2015 and February 2016
Rosa Unit #379 Produced Water Release
 Section 8, Township 31N, Range 5W
 N36.9113846, W107.3889694
 Rio Arriba County, NM

Laboratory analytical results for soil confirmation samples (SC-1 through SC-3) reported benzene and BTEX concentrations below NMOCD action levels of 10 mg/kg and 50 mg/kg, respectively. All soil confirmation samples reported TPH concentrations below NMOCD action level of 100 mg/kg. Action levels are based on a NMOCD site ranking of 30. Chloride concentrations were reported at less than 30 mg/kg (SC-1), 610 mg/kg (SC-2), and 1,200 mg/kg (SC-3).
