Pit, Closed-Loop System, Below-Grade Tank, or
Proposed Alternative Method Permit or Closure Plan Application

1.
Operator: BP AMERICA PRODUCTION COMPANY OGRID #: 778
Address: 200 Energy Court, Farmington, NM 87401
Facility or well name: FLORANCE P 039
API Number: 3004509034 OCD Permit Number: _____
U/L or Qtr/Qtr B Section 35.0 Township 30.0N Range 08W County: San Juan County
Center of Proposed Design: Latitude 36.77348 Longitude -107.64220 NAD: ☐ 1927 ☒ 1983
Surface Owner: ☒ Federal ☐ State ☐ Private ☐ Tribal Trust or Indian Allotment

BELOW-GRADE TANK CLOSURE PLAN

Florance P # 39 – Tank ID: B

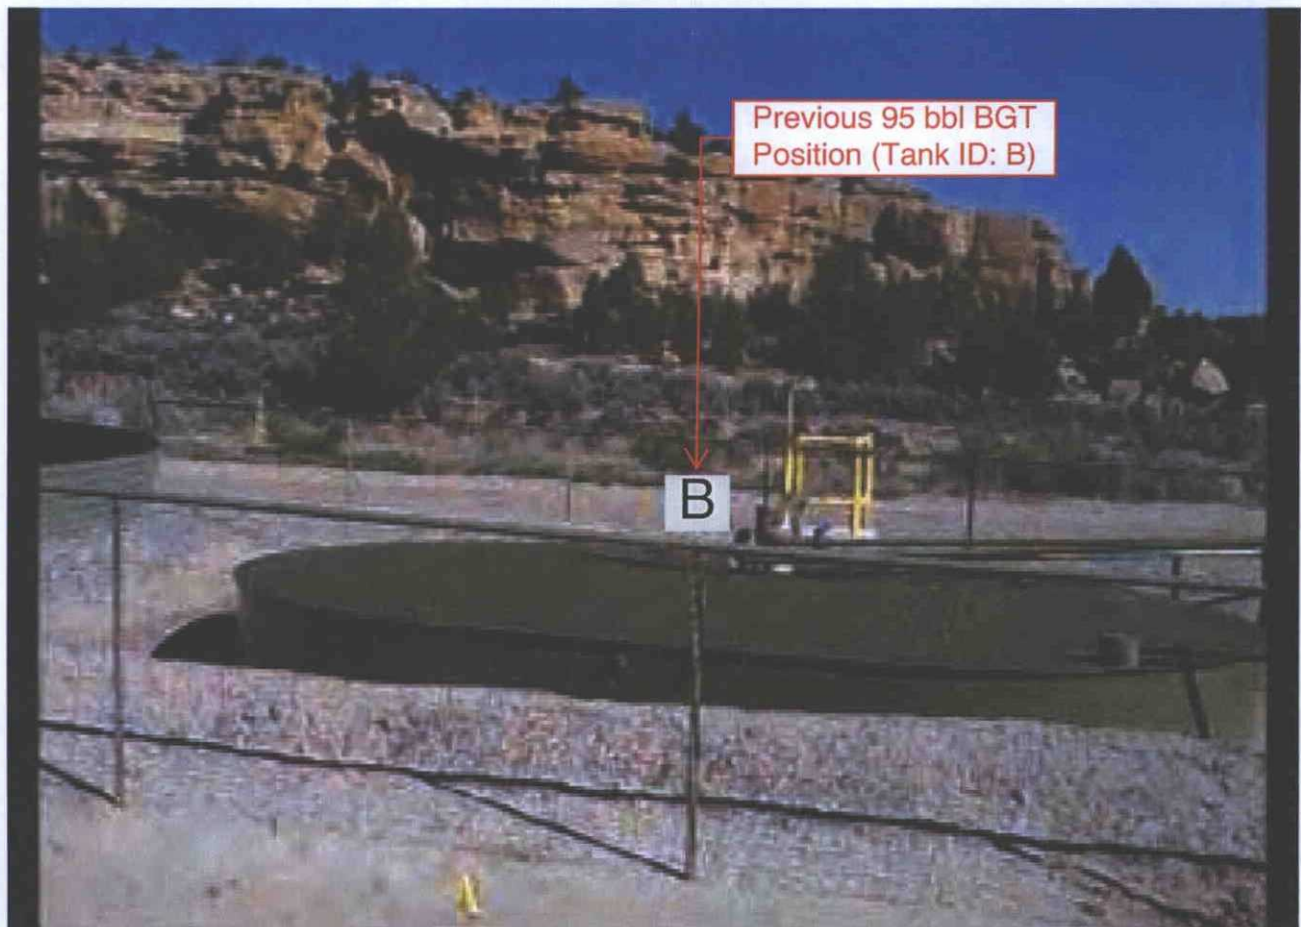
B

LAT 36° 46' 23.340"

LONG 107° 38' 30.660"

Previous 95 bbl BGT
Position (Tank ID: B)
