Pit, Closed-Loop System, Below-Grade Tank, or Proposed Alternative Method Permit or Closure Plan Application

BELOW-GRADE TANK CLOSURE PLAN

**Gallegos Canyon Unit # 354 – Tank ID: A**

**API #: 3004526471**

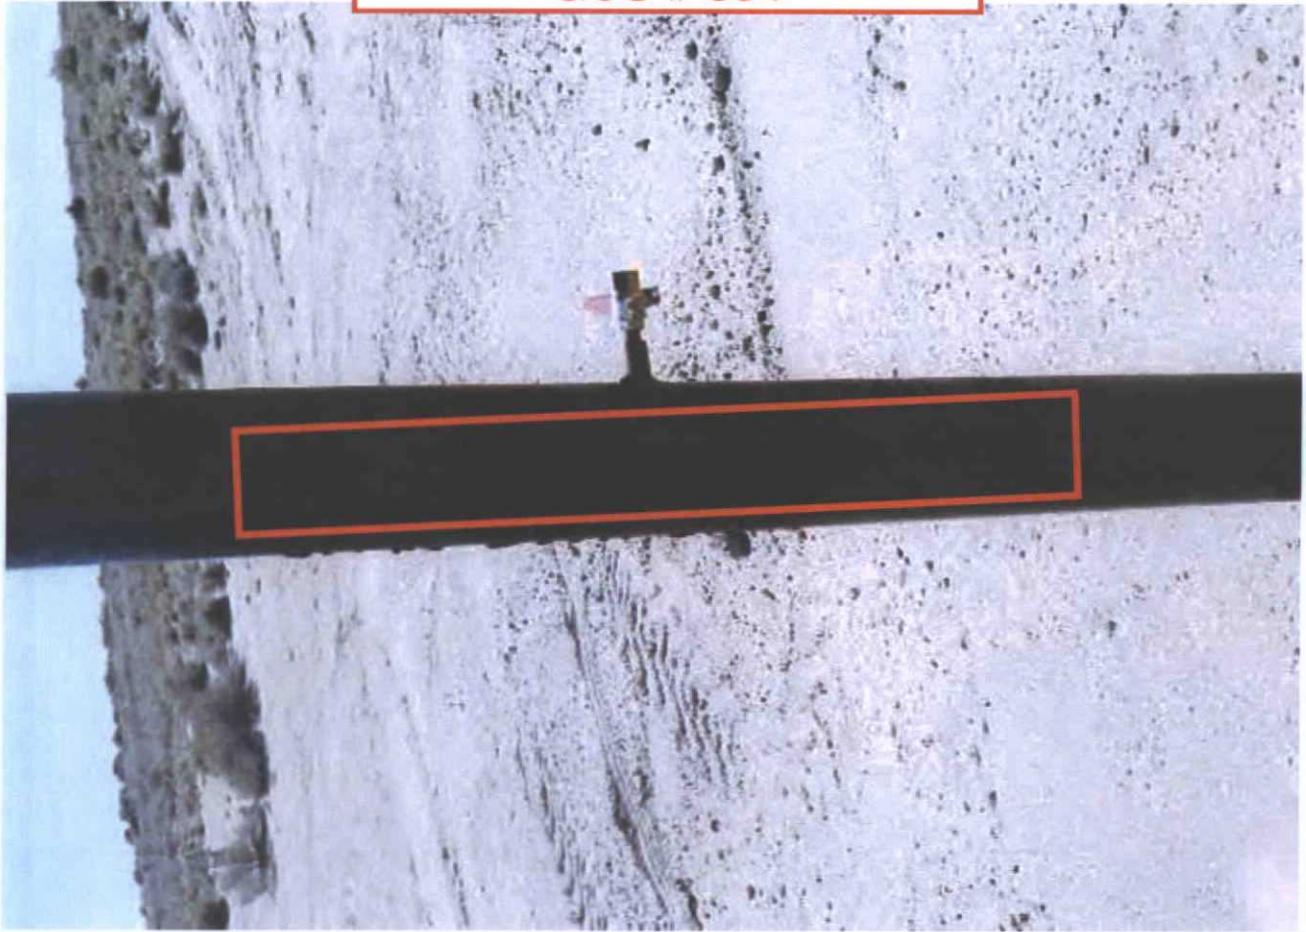
GCU # 354

Plugged & Abandoned  
Marker

Previous 95 bbl BGT  
Position (Tank ID: A)

**Sampling results reveal no evidence of a release has occurred. Area was backfilled with clean, earthen material and is within the active well pad. This area will be reclaimed since the gas well has been plugged & abandoned.**

**The area over the BGT will be part of the final reclamation since the gas well has been plugged & abandoned.**
