Pit, Closed-Loop System, Below-Grade Tank, or Proposed Alternative Method Permit or Closure Plan Application

BELOW-GRADE TANK CLOSURE PLAN

AL Elliott D # 9 – Tank ID: B

API #: 3004526138

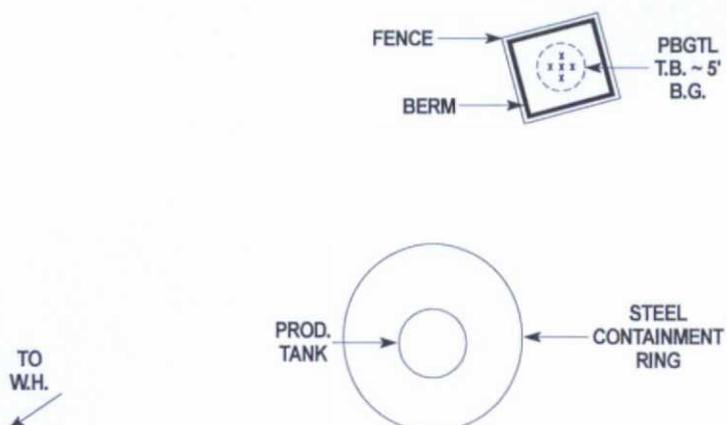
DEPTH TO GROUNDWATER: **>50'** NEAREST WATER SOURCE: **>1,000'** NEAREST SURFACE WATER: **<1,000'** NMOCD TPH CLOSURE STD: **100** ppm

SITE SKETCH	BGT Located: off <input checked="" type="checkbox"/> on site	PLOT PLAN circle: <input checked="" type="checkbox"/> attached	OVM CALIB. READ. = NA ppm RF=0.52
			OVM CALIB. GAS = NA ppm
			TIME: NA am/pm DATE: NA

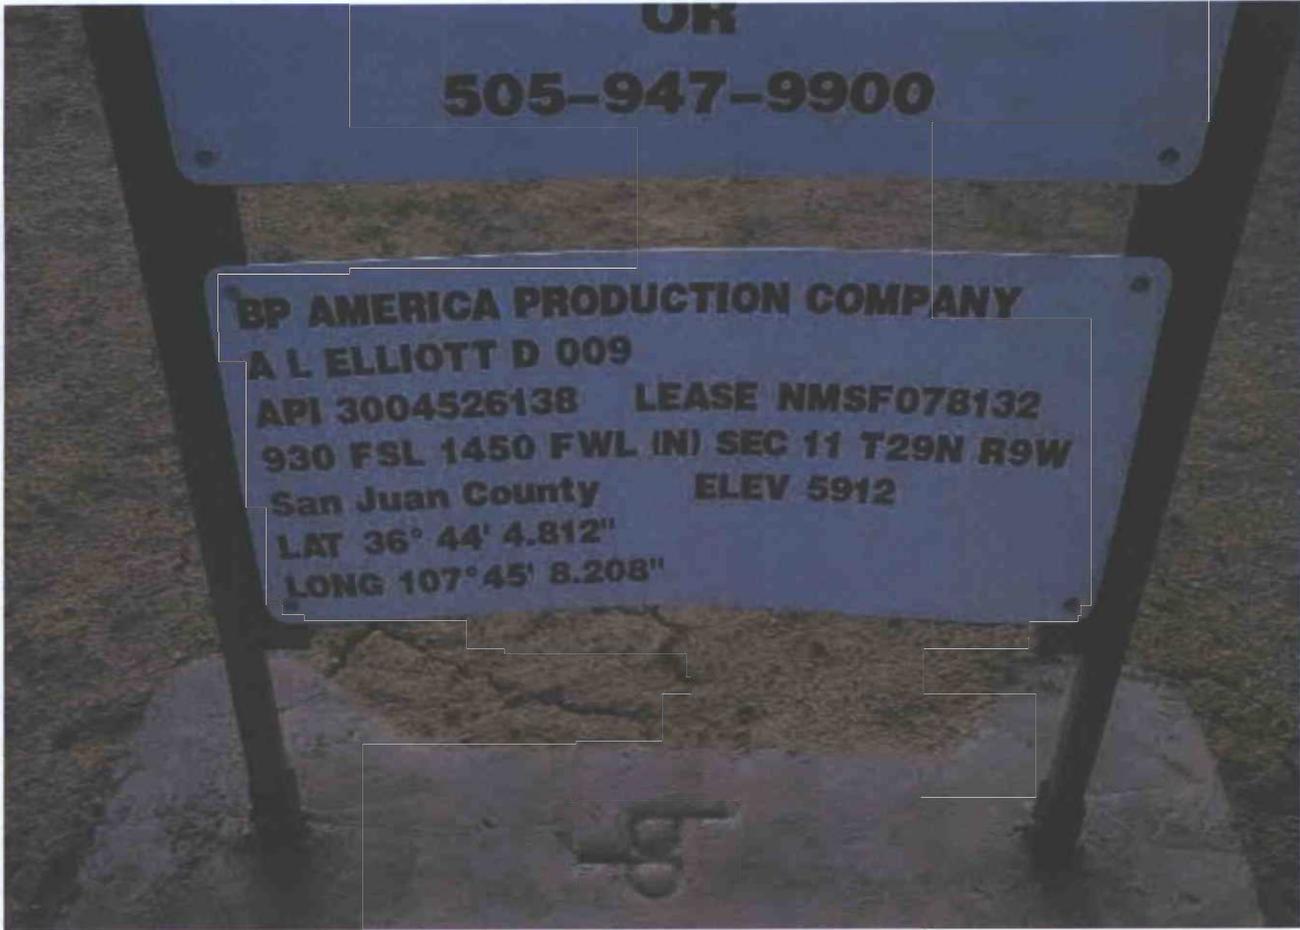
Previous 21 bbl BGT
Position (Tank ID: B)

The BGT area has been backfilled and will be reclaimed once the well has been plugged & abandoned.

- e. site reclamation, photo documentation.**Closure report on C-144 form is included & contains a photo of the reclamation completion.**
16. BP shall certify that all information in the report and attachments is accurate, truthful, and compliant with all applicable closure requirements and conditions specified in the approved closure plan.
Certification section of C-144 has been completed.
