Pit, Below-Grade Tank, or
Proposed Alternative Method Permit or Closure Plan Application

BELOW-GRADE TANK CLOSURE PLAN

Gallegos Canyon Unit 196E

API No. 3004524254

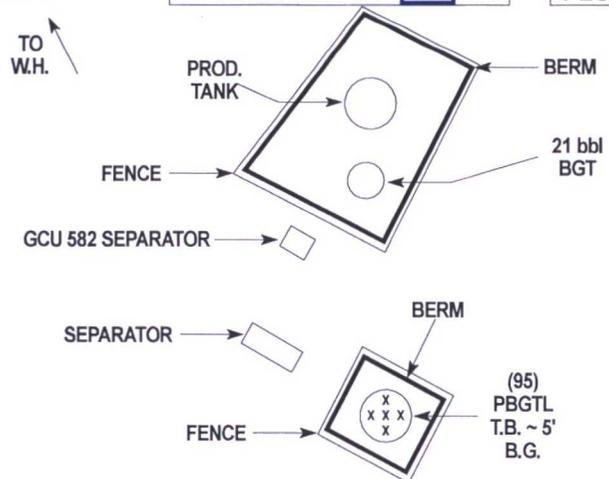
PLOT PLAN circle: attached

DISCOLORATION/STAINING OBSERVED: YES / NO EXPLANATION - **FROM BGT BASE TO APPROX. 7 FT. BELOW GRADE.**

APPARENT EVIDENCE OF A RELEASE OBSERVED AND/OR OCCURRED: YES / NO EXPLANATION: **BASED ON DISCOLORED SOILS & PHYSICAL HYDROCARBON ODOR.**
