Pit, Below-Grade Tank, or
Proposed Alternative Method Permit or Closure Plan Application

Williams Four Corners LLC
Below Grade Tank Closure Report
Facility Name: Helen Jackson 1
API Number: 3004507775

Remediation Excavation and Sampling Form

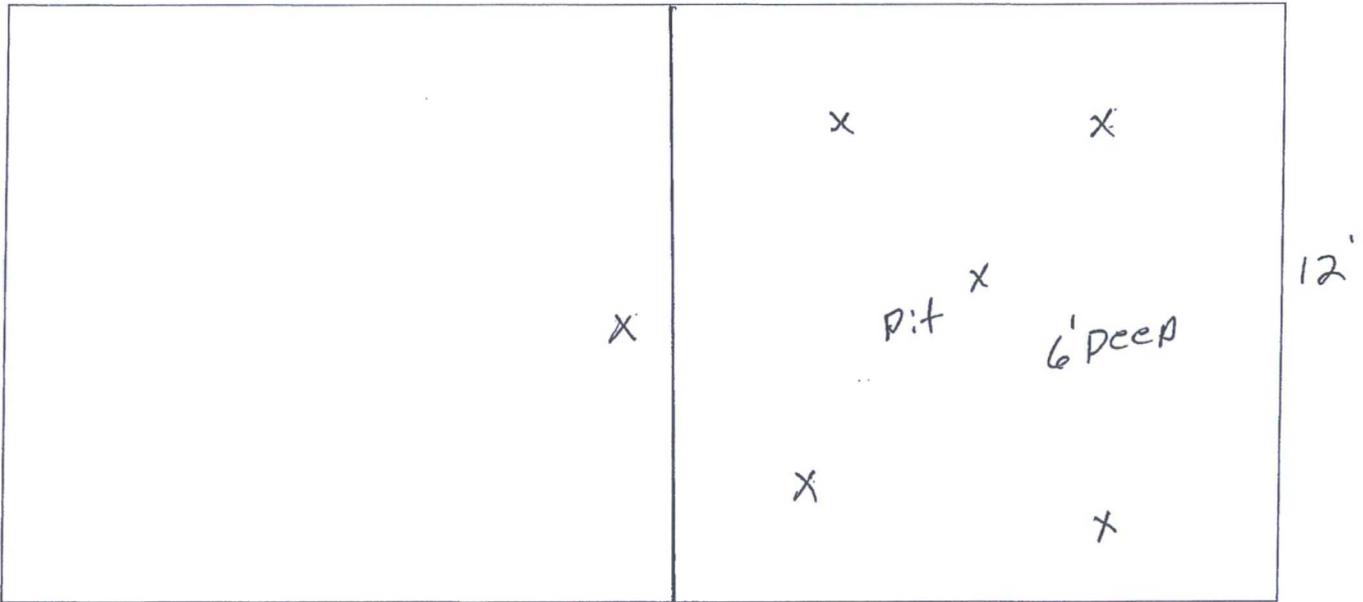
Excavation Diagram and Sample Locations

12' Length 12' Width 6' Depth

Sample ID	Sample Date	Type (Composite, Grab)	Location (Floor, Sidewall)	Comments
Helen Jackson # 1 6 point	9-12-17	Composite 6 point	Floor under Tank	1-OFF side
