16163
Pit, Below-Grade Tank, or
Proposed Alternative Method Permit or Closure Plan Application

BELOW-GRADE TANK CLOSURE PLAN

ELLIOTT GC E 001A

API No. 3004522196

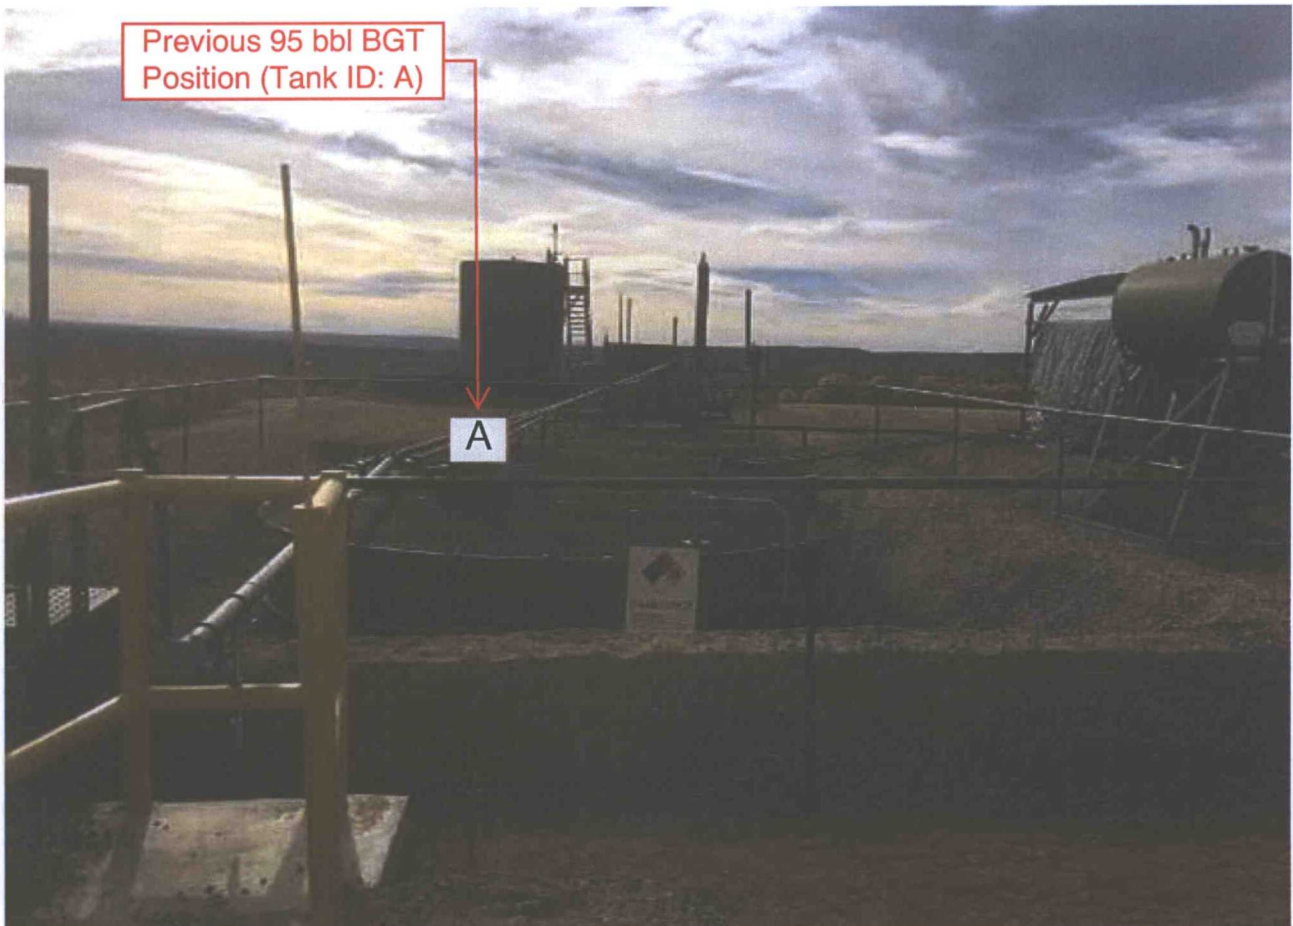
Previous 95 bbl BGT
Position (Tank ID: A)

The area has been backfilled and a 105 BBL shallow low profile above-grade tank set atop BGT location. The location will be reclaimed once the well is plugged and abandoned.
