Pit, Below-Grade Tank, or
Proposed Alternative Method Permit or Closure Plan Application

BP AMERICA PRODUCTION COMPANY
SAN JUAN BASIN, NORTHWEST NEW MEXICO

BELOW-GRADE TANK CLOSURE PLAN

JACQUES LS 001 A

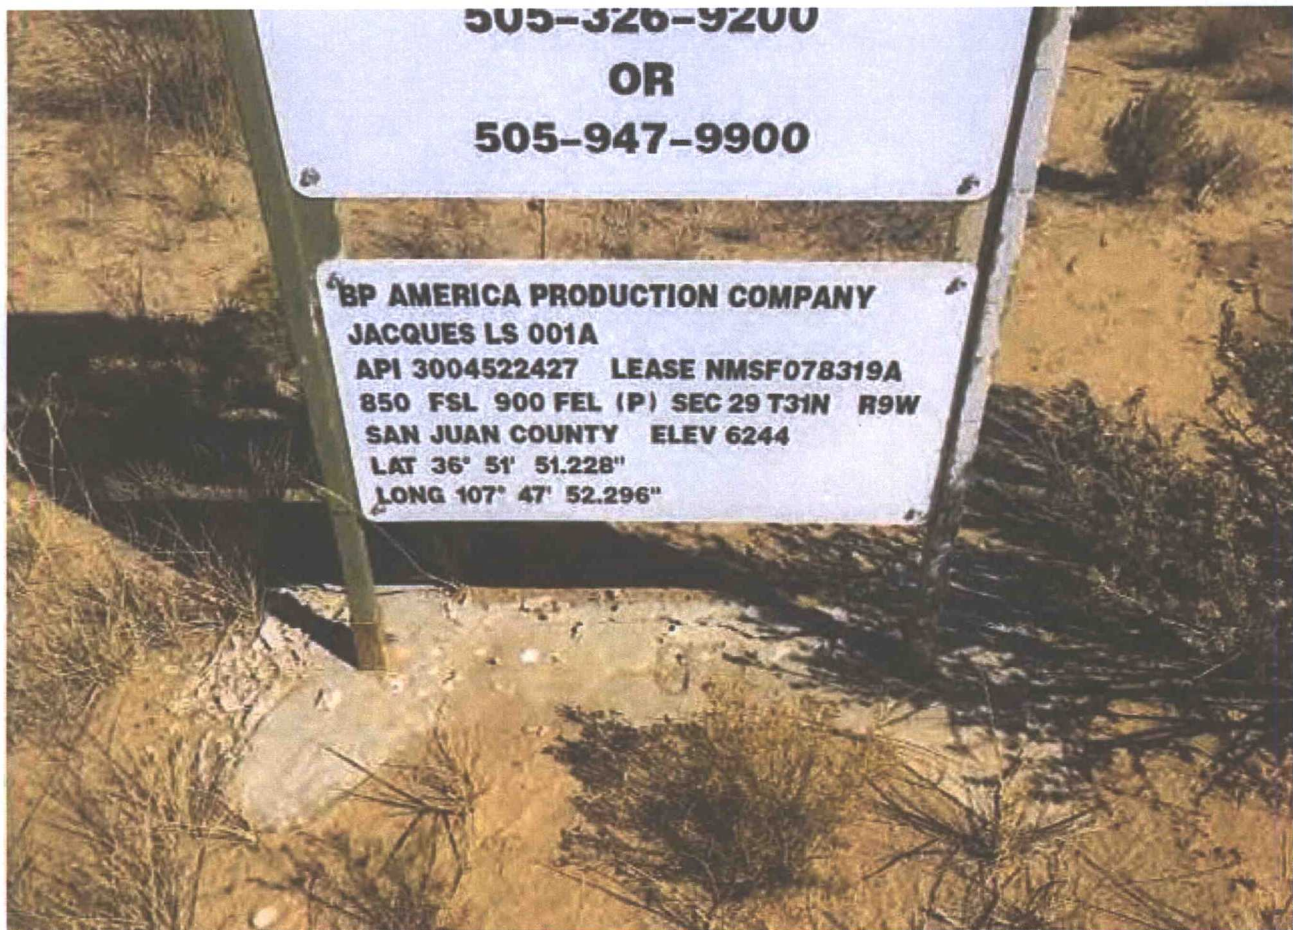
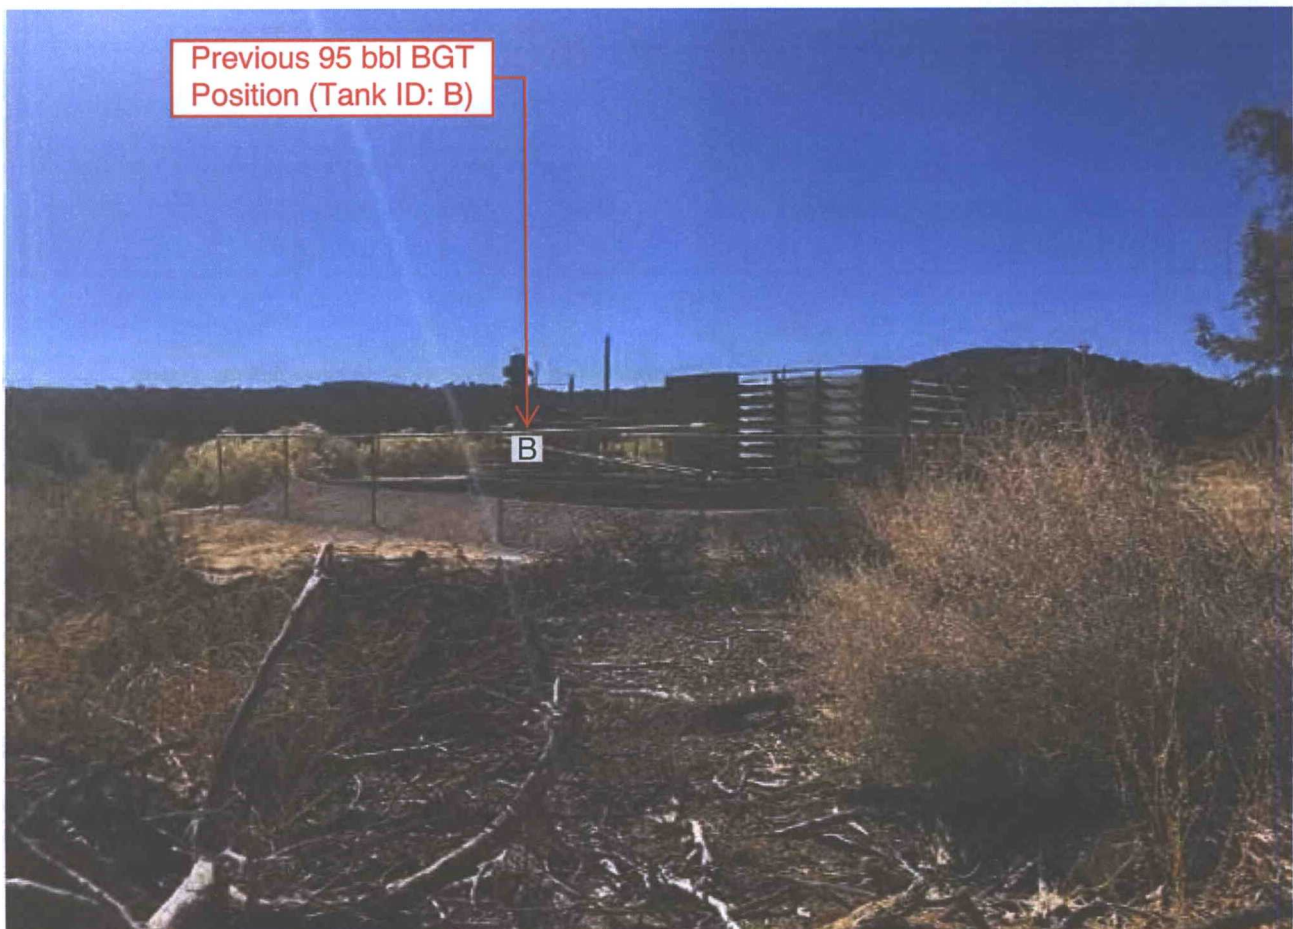
The area has been backfilled and a 105 BBL shallow low profile above-ground tank set atop BGT location. The location will be reclaimed once the well is plugged and abandoned.
