Pit, Below-Grade Tank, or
Proposed Alternative Method Permit or Closure Plan Application

1.
Operator: DJR Operating, LLC OGRID #: 371838
Address: PO BOX 156 Bloomfield, NM 87413
Facility or well name: Marcus A #15
API Number: 30-039-24065 OCD Permit Number: _____
U/L or Qtr/Qtr D Section 1 Township 23N Range 07W County: Rio Arriba
Center of Proposed Design: Latitude 36.258919 Longitude -107.533752 NAD83
Surface Owner: Federal State Private Tribal Trust or Indian Allotment

The purpose of this closure plan is to provide the details of the activities involved in the closure of the BGT at the **Marcus A 15** well site. The following scope of closure activities has been designed to meet this objective:

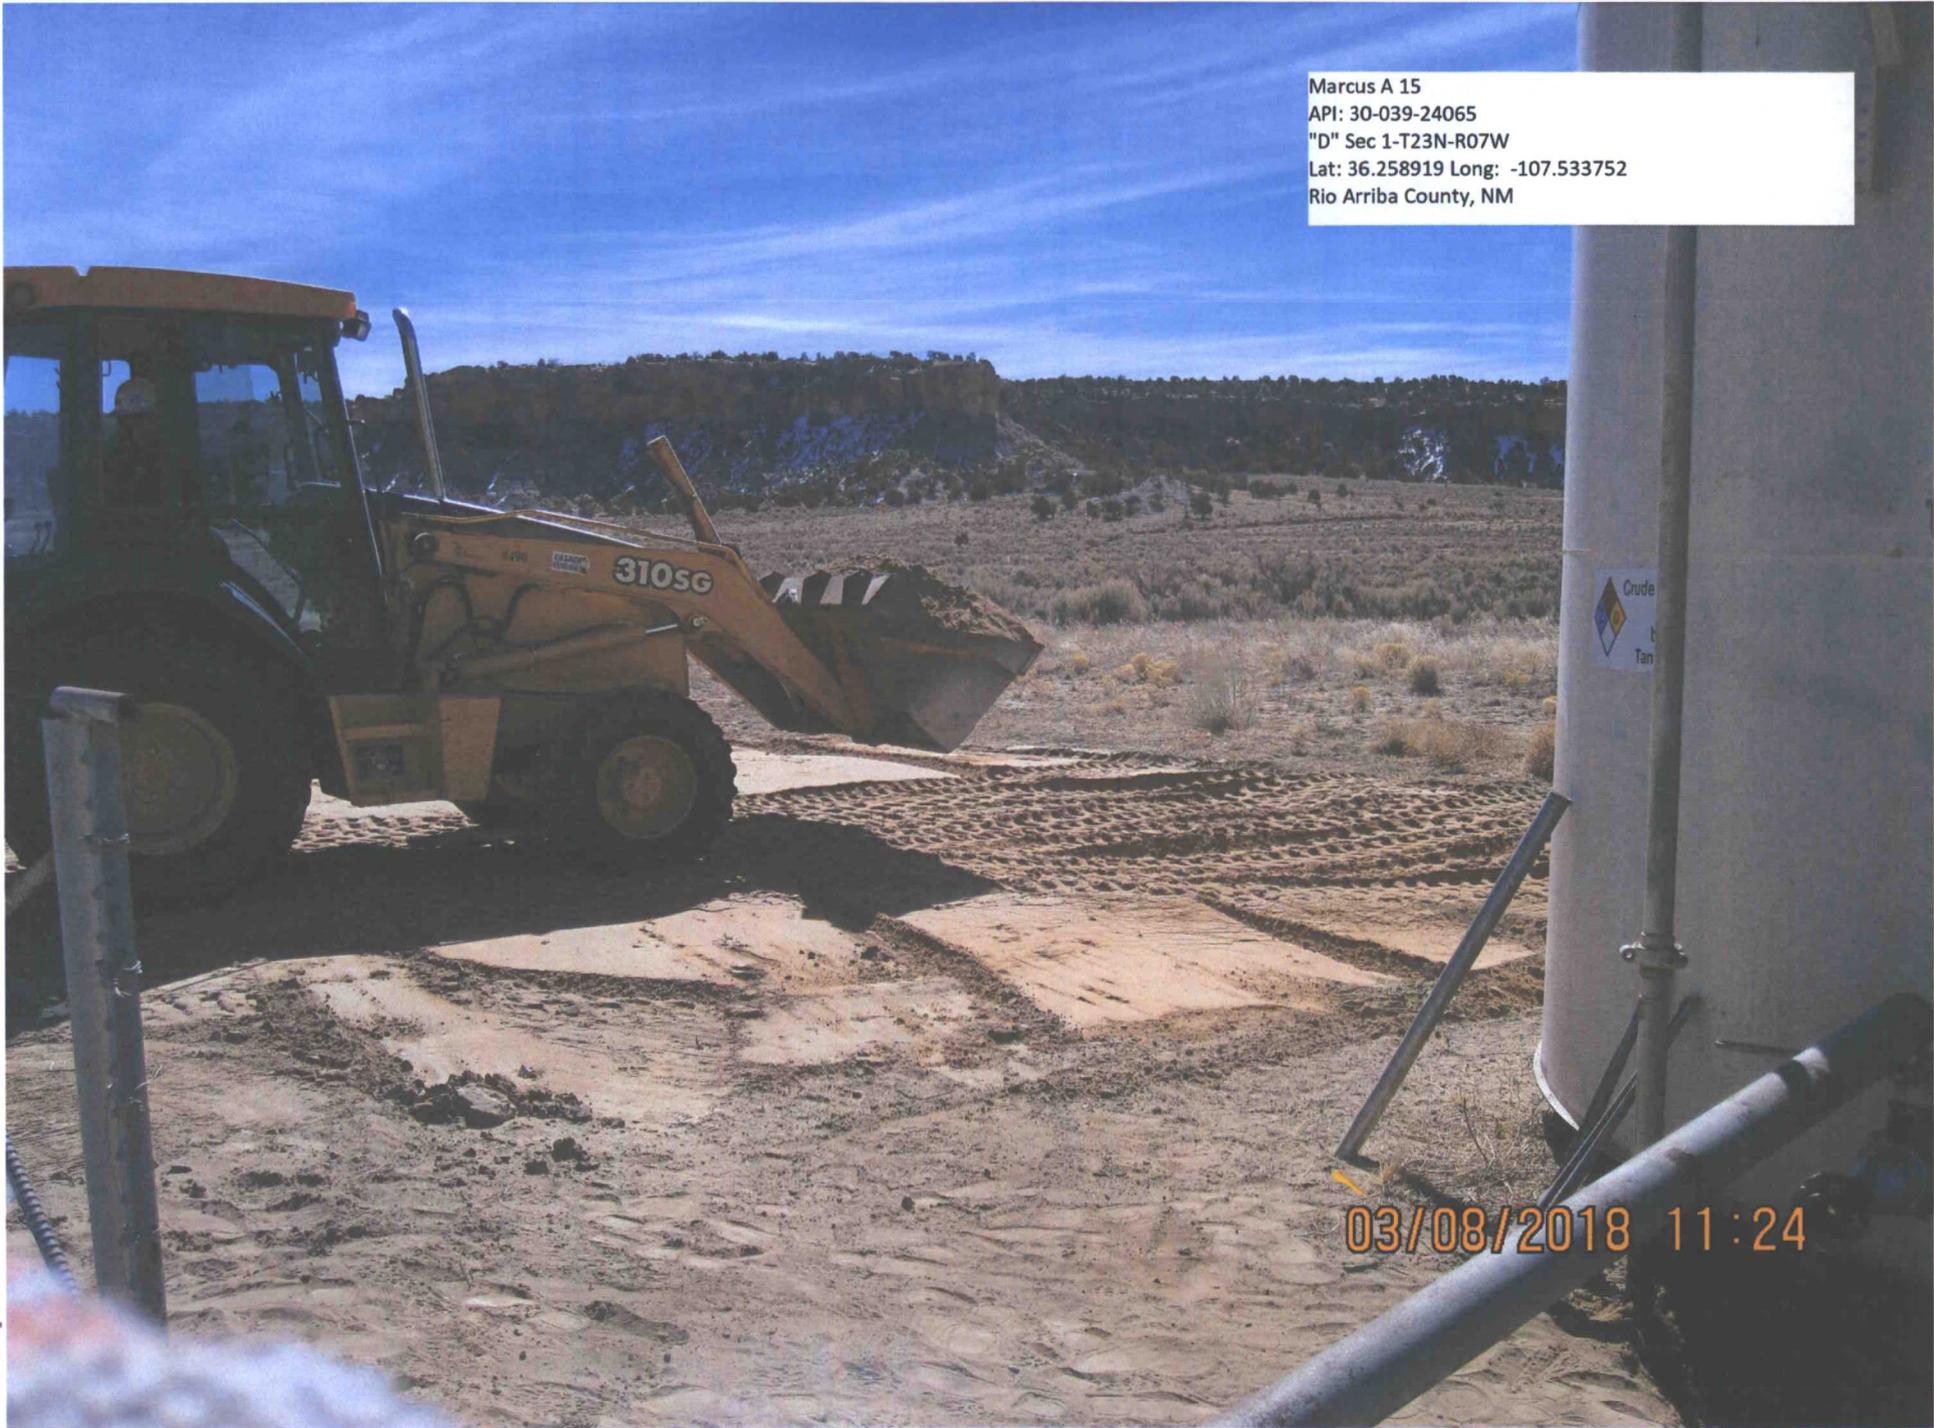
Marcus A 15
API: 30-039-24065
"D" Sec 1-T23N-R07W
Lat: 36.258919 Long: -107.533752
Rio Arriba County, NM

We went out to the **Marcus A 15** to satisfy the request from Jonathan Kelly for this well last week. The BGT is a galvanized pit and had rusted through. Because this pit is rusted through and serves no purpose we plan to close the BGT now. We have already dug out the pit to allow visibility to the sidewalls and because there were holes in the pit, the dirt inside the pit was removed as well. We believe that a release has occurred, but we are unsure. This site is ranked at zero. If the test results are above the BGT closure requirements we will divert to 19.15.29 requirements. We will pull the BGT on **Thursday February 8th at 10 am** and test the soil. I will notify the land owner (BLM) via sundry notice. A photo of the Marcus A 15 is attached. I have requested Randy Bayliss approve the C 144.

03/08/2018 11:24

All equipment related to BGT was removed.

The galvanized pit was disposed of in our iron bin at the Lybrook Yard, in Lybrook, NM.

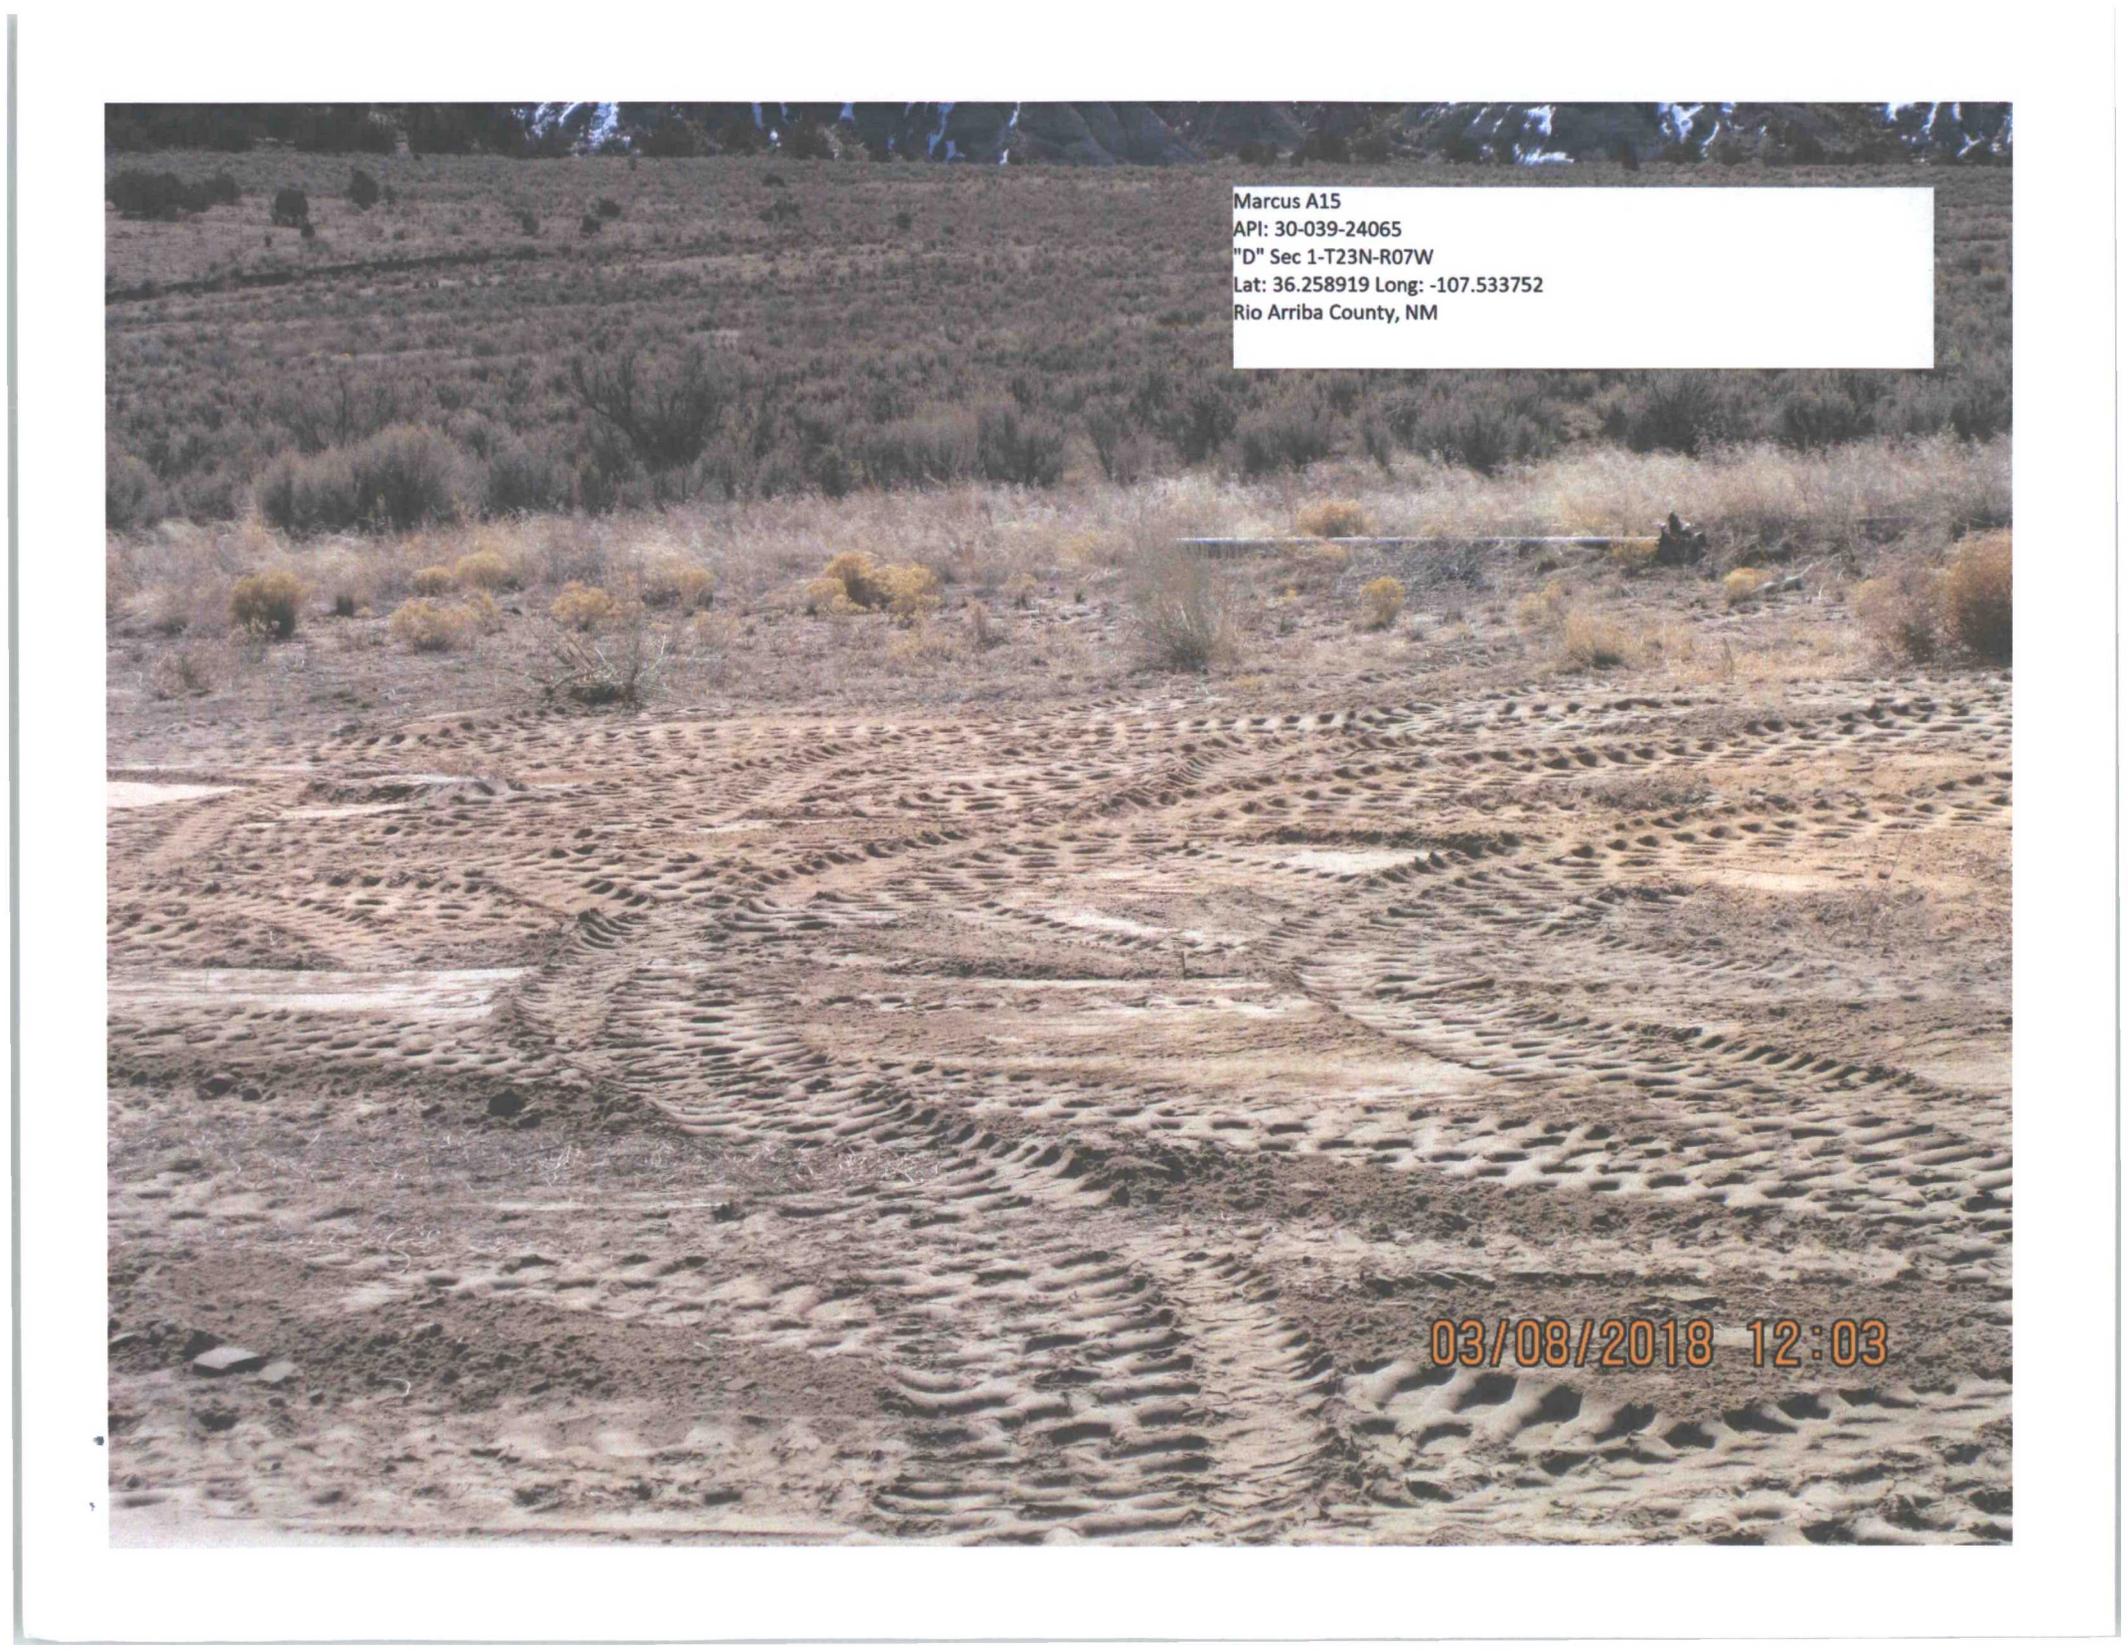
Marcus A15
API: 30-039-24065
"D" Sec 1-T23N-R07W
Lat: 36.258919 Long: -107.533752
Rio Arriba County, NM

03/08/2018 12:03
