Pit, Below-Grade Tank, or
Proposed Alternative Method Permit or Closure Plan Application

BP AMERICA PRODUCTION COMPANY
SAN JUAN BASIN, NORTHWEST NEW MEXICO

BELOW-GRADE TANK CLOSURE PLAN

PRITCHARD 008

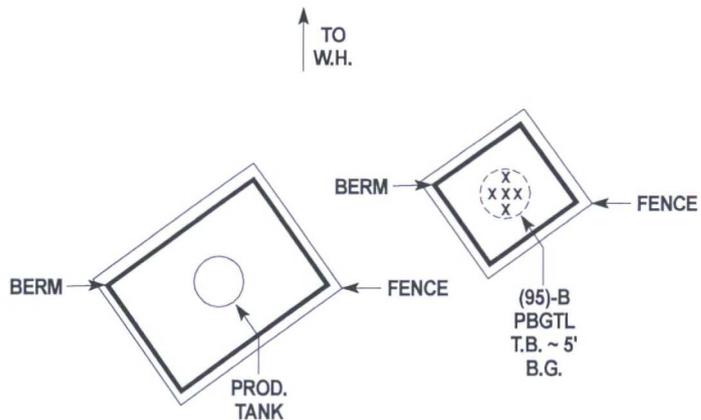
SITE OBSERVATIONS:	LOST INTEGRITY OF EQUIPMENT: YES <input type="checkbox"/> NO <input checked="" type="checkbox"/> EXPLANATION - _____
APPARENT EVIDENCE OF A RELEASE OBSERVED AND/OR OCCURRED: YES <input type="checkbox"/> NO <input checked="" type="checkbox"/> EXPLANATION: _____	EQUIPMENT SET OVER RECLAIMED AREA: YES <input type="checkbox"/> NO <input checked="" type="checkbox"/> EXPLANATION - _____
OTHER: NMOC D OR BLM REPS. NOT PRESENT TO WITNESS CONFIRMATION SAMPLING.

EXCAVATION DIMENSION ESTIMATION: **NA** ft. X **NA** ft. X **NA** ft. EXCAVATION ESTIMATION (Cubic Yards): **NA**
DEPTH TO GROUNDWATER: **>100'** NEAREST WATER SOURCE: **>1,000'** NEAREST SURFACE WATER: **<1,000'** NMOC D TPH CLOSURE STD: **1,000** ppm

SITE SKETCH	BGT Located: off <input type="checkbox"/> on <input checked="" type="checkbox"/> site	PLOT PLAN circle: <input type="checkbox"/> attached <input checked="" type="checkbox"/>	OVM CALIB. READ. = NA ppm RF=1.00
			OVM CALIB. GAS = NA ppm
			TIME: NA am/pm DATE: NA
