Pit, Below-Grade Tank, or  
Proposed Alternative Method Permit or Closure Plan Application

BP AMERICA PRODUCTION COMPANY  
SAN JUAN BASIN, NORTHWEST NEW MEXICO

BELOW-GRADE TANK CLOSURE PLAN

**FLORANCE AE 001A**

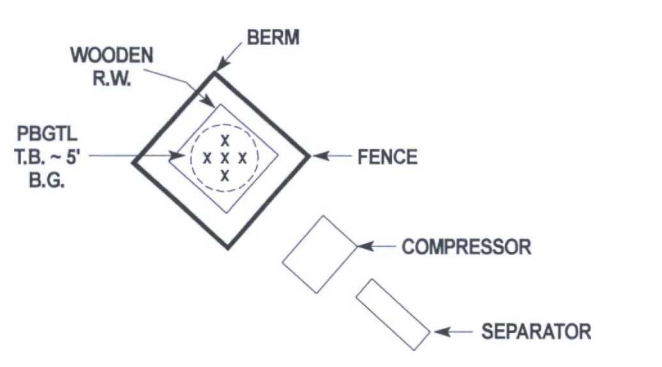
| <b>SITE SKETCH</b> | BGT Located: off / <b>on</b> site<br>PLOT PLAN circle: <b>attached</b><br> |

| <b>SOIL DESCRIPTION:</b> | SOIL TYPE: <b>SAND</b> / SILTY SAND / SILT / SILTY CLAY / CLAY / GRAVEL / OTHER<br>SOIL COLOR: <b>DARK YELLOWISH ORANGE</b><br>COHESION (ALL OTHERS): <b>NON COHESIVE</b> / SLIGHTLY COHESIVE / COHESIVE / HIGHLY COHESIVE<br>CONSISTENCY (NON COHESIVE SOILS): <b>LOOSE</b> / <b>FIRM</b> / DENSE / VERY DENSE<br>MOISTURE: DRY / <b>SLIGHTLY MOIST</b> / MOIST / WET / SATURATED / SUPER SATURATED<br>SAMPLE TYPE: GRAB / <b>COMPOSITE</b> # OF PTS. <b>5</b><br>DISCOLORATION/STAINING OBSERVED: YES <b>NO</b> EXPLANATION -<br>PLASTICITY (CLAYS): NON PLASTIC / SLIGHTLY PLASTIC / COHESIVE / MEDIUM PLASTIC / HIGHLY PLASTIC<br>DENSITY (COHESIVE CLAYS & SILTS): SOFT / FIRM / STIFF / VERY STIFF / HARD<br>HC ODOR DETECTED: YES <b>NO</b> EXPLANATION -<br>ANY AREAS DISPLAYING WETNESS: YES <b>NO</b> EXPLANATION - |

| <b>SITE OBSERVATIONS:</b> | LOST INTEGRITY OF EQUIPMENT: YES <b>NO</b> EXPLANATION -<br>APPARENT EVIDENCE OF A RELEASE OBSERVED AND/OR OCCURRED: YES <b>NO</b> EXPLANATION:<br>EQUIPMENT SET OVER RECLAIMED AREA: <b>YES</b> NO EXPLANATION - <b>105 BBL SHALLOW LOW PROFILE ABOVE-GRADE TANK TO BE SET ATOP BGT LOCATION.</b><br>OTHER: <b>NMOCD REP. NOT PRESENT TO WITNESS CONFIRMATION SAMPLING.</b> |

| EXCAVATION DIMENSION ESTIMATION: <b>NA</b> ft. X <b>NA</b> ft. X <b>NA</b> ft.<br>DEPTH TO GROUNDWATER: <b>&gt;100'</b> NEAREST WATER SOURCE: <b>&gt;1,000'</b> NEAREST SURFACE WATER: <b>&lt;1,000'</b> NMOCD TPH CLOSURE STD: <b>1,000</b> ppm | EXCAVATION ESTIMATION (Cubic Yards): <b>NA</b> |
