Form 3160-5
(June 2015)

8. Well Name and No. ROSA UNIT 14

**WELLHEAD TEST & REPAIR
PROCEDURE**

ROSA UNIT 014
30-039-07958

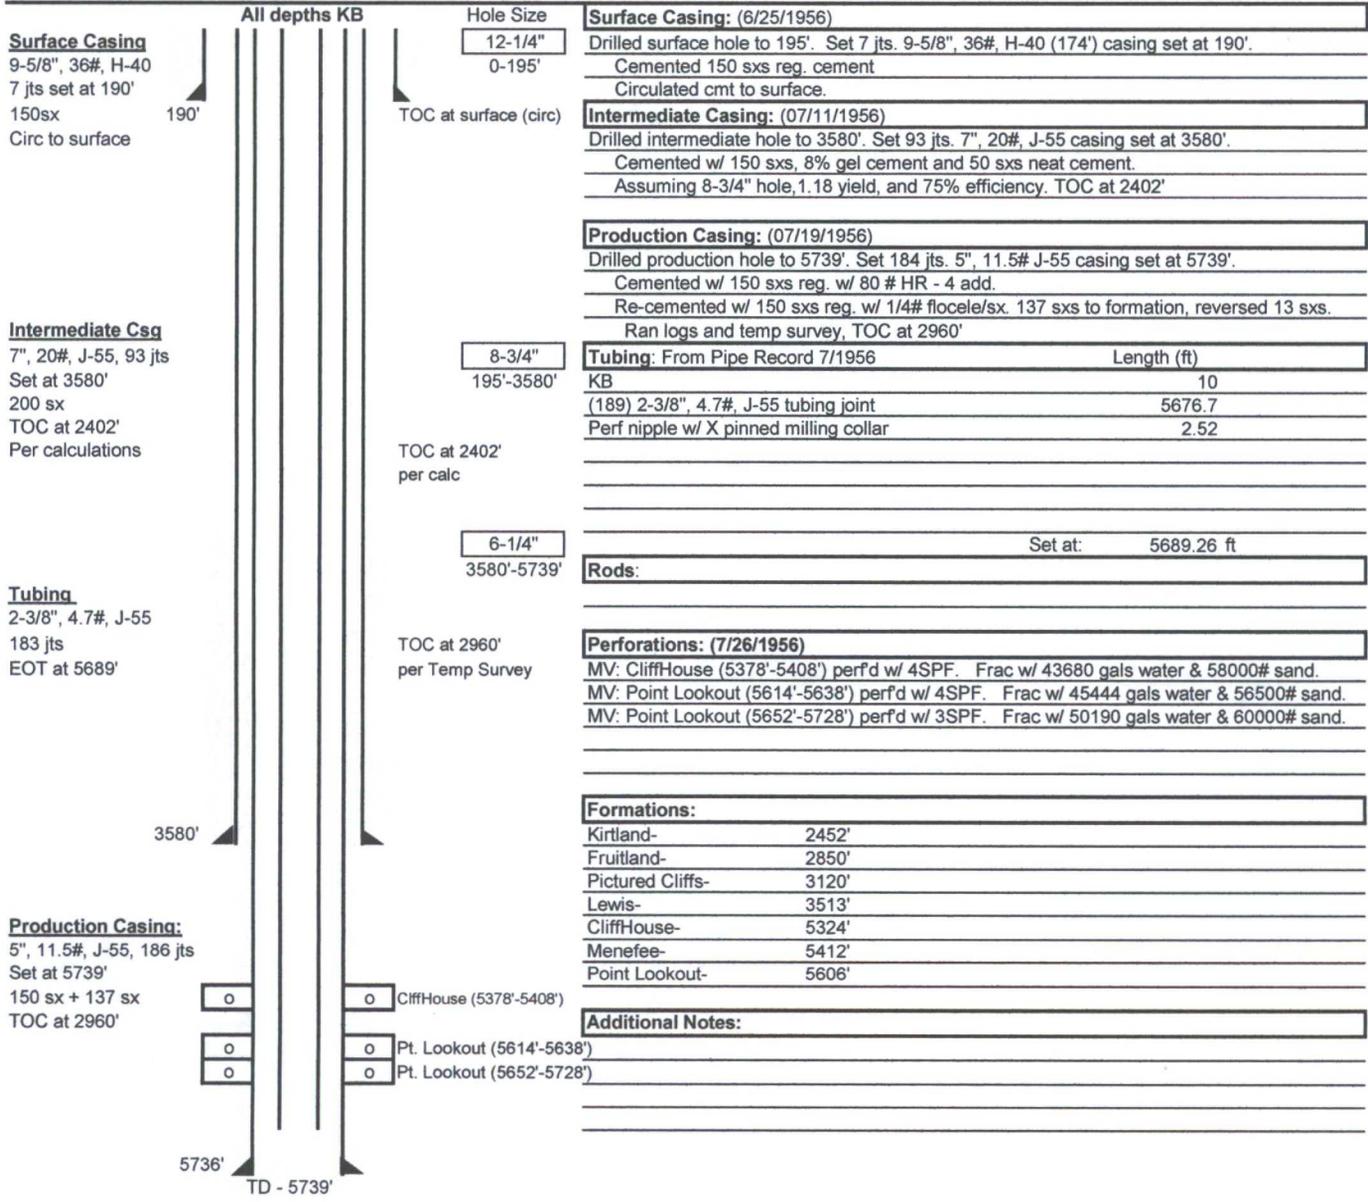
Wellbore Schematic

Well Name: Rosa Unit 14
 Location: Sec 23, T-31N, R-6W 930' FNL & 1830' FEL
 County: Rio Arriba
 API #: 30-039-07958
 Co-ordinates: Lat 36.8898659 Long -107.4293823 NAD83
 Elevations: GROUND: 6292'
 KB: 6302'
 Depths (KB): PBTD:
 TD: 5739'

Date Prepared: 3/21/2018 Hespe
 Last Updated:
 Spud Date: 6/25/1956
 Completion Date: 8/7/1956
 Last Workover Date:
