Pit, Below-Grade Tank, or
Proposed Alternative Method Permit or Closure Plan Application

BP AMERICA PRODUCTION COMPANY
SAN JUAN BASIN, NORTHWEST NEW MEXICO

BELOW-GRADE TANK CLOSURE PLAN

GCU 089E

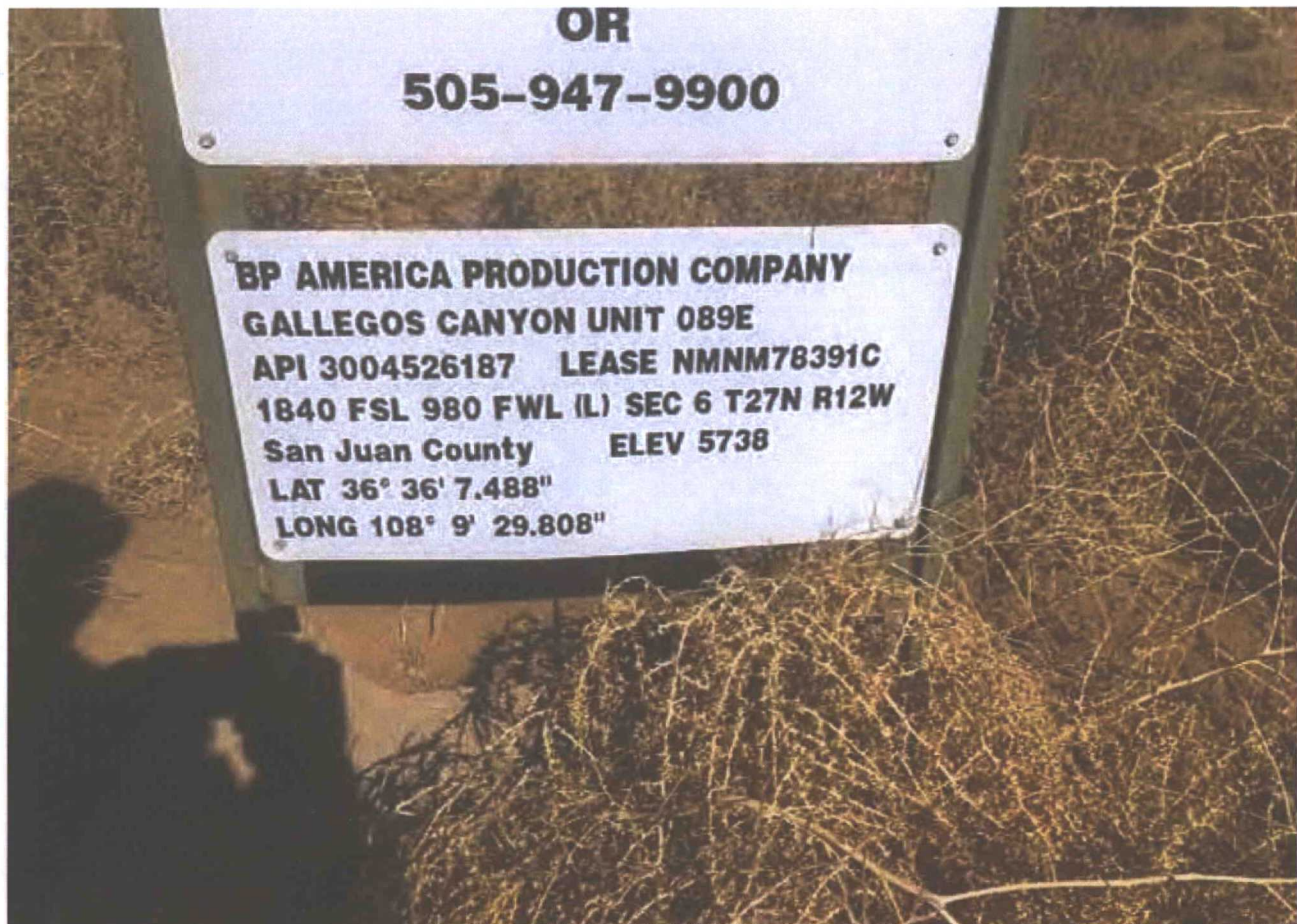
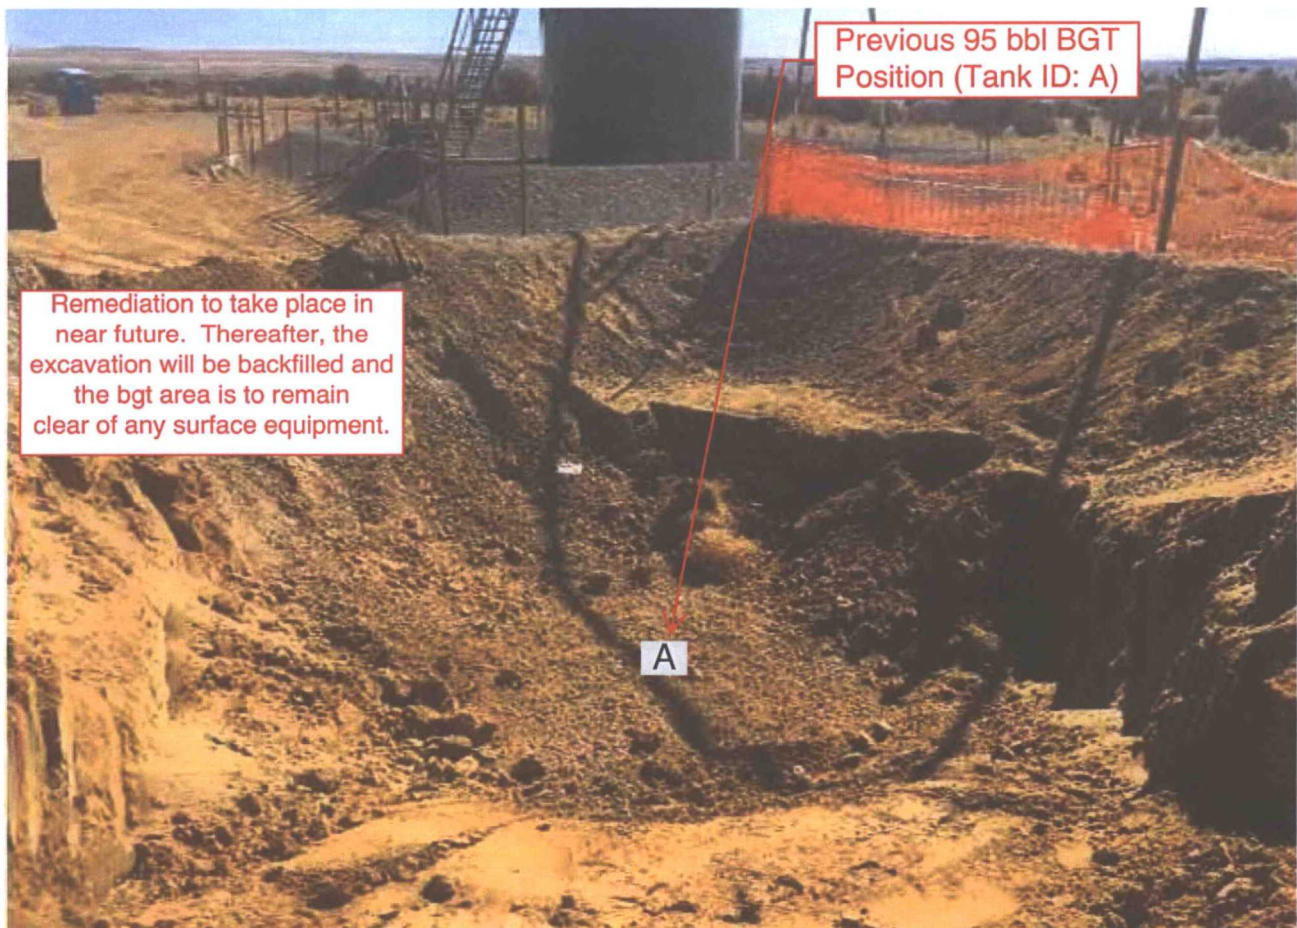
The area has been backfilled and the BGT location's surface condition will be clear of any surface equipment, but remain within the operational area of the well pad. The location will be reclaimed once the well is plugged and abandoned.
