Proposed Alternative Method Permit or Closure Plan Application

BP AMERICA PRODUCTION COMPANY  
SAN JUAN BASIN, NORTHWEST NEW MEXICO

BELOW-GRADE TANK CLOSURE PLAN

STATE COM LL 013

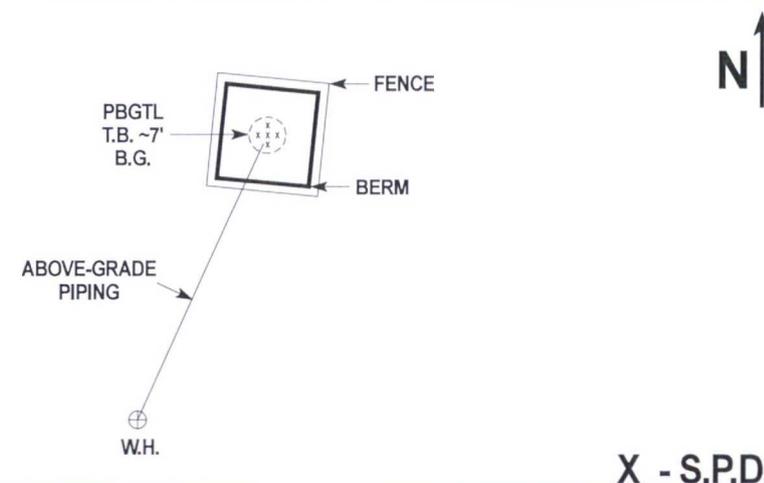
**SITE SKETCH**

BGT Located: off  on site PLOT PLAN circle: attached
