16367  
Pit, Below-Grade Tank, or  
Proposed Alternative Method Permit or Closure Plan Application

BELOW-GRADE TANK CLOSURE PLAN

**HUBBARD GC A 001**

**API No. 3004527907**

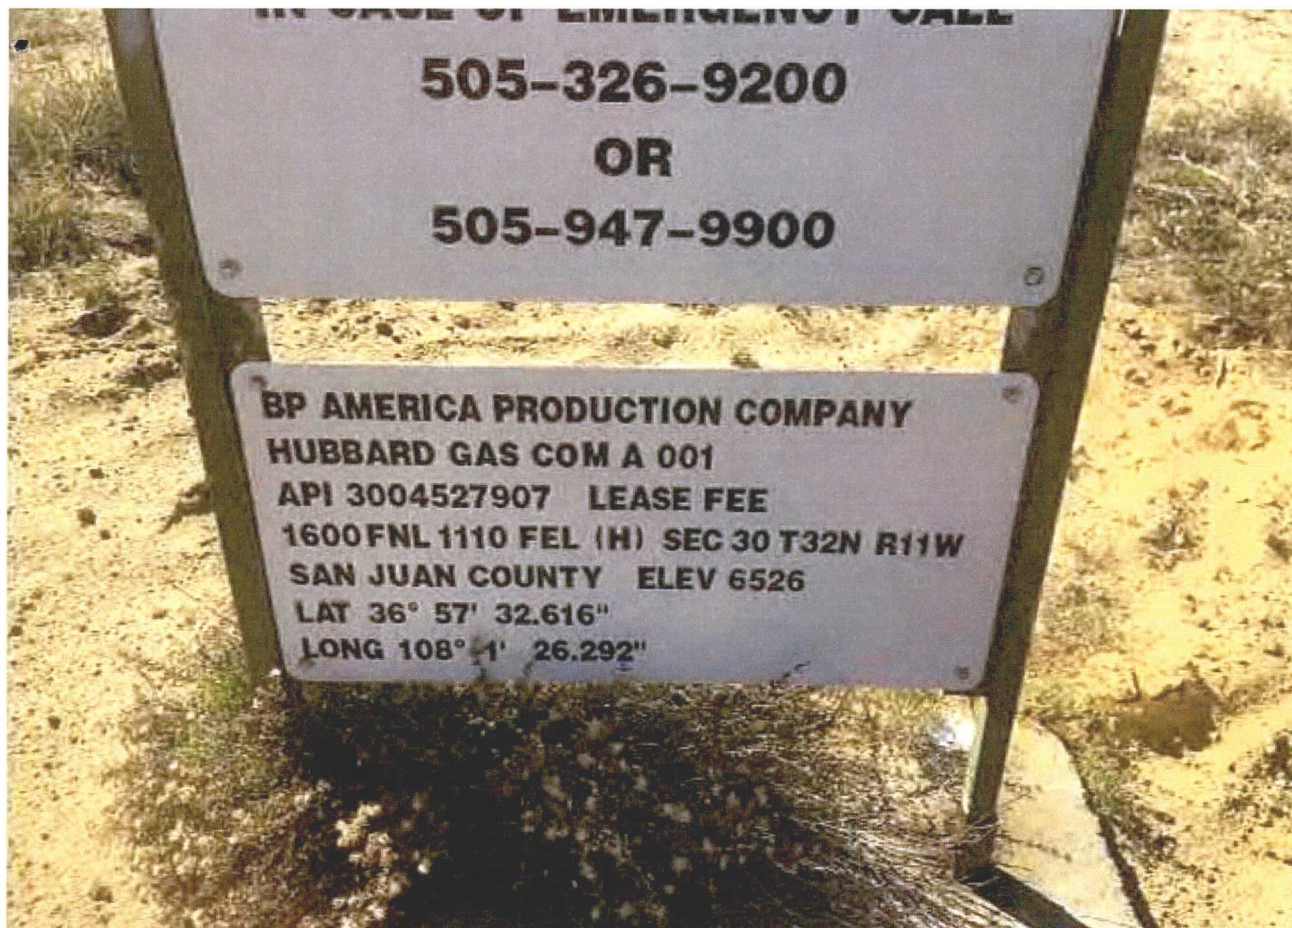
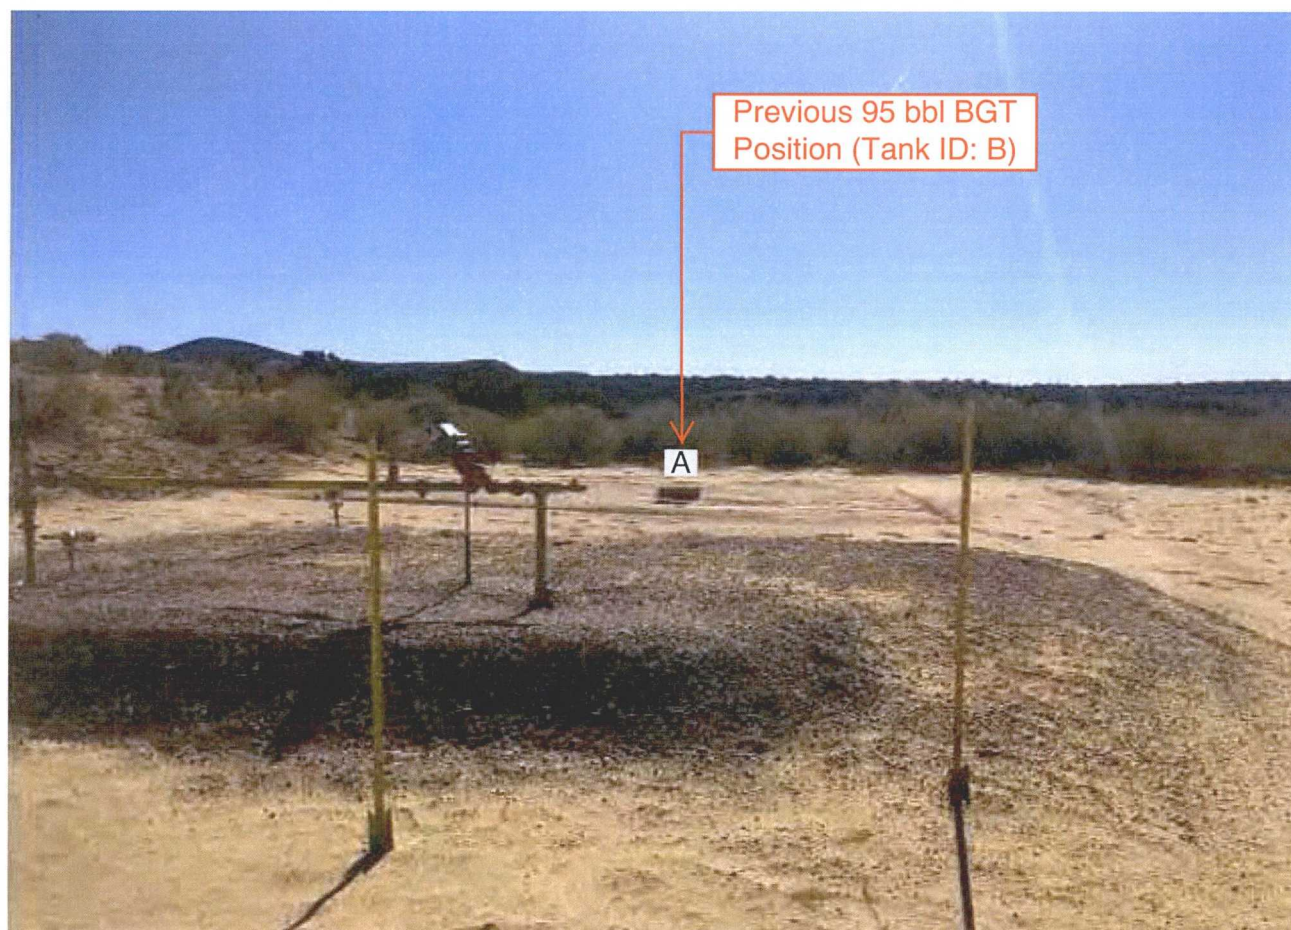
**The area has been backfilled and BGT location's surface condition is clear, but within the site's operational area.. The location will be reclaimed once the well is plugged and abandoned.**
